ON-SITE CERTIFIED ADVANCED 208-COMPLIANT VEHICLE INVESTIGATION

CASE NUMBER - IN09006
LOCATION - MISSOURI
VEHICLE - 2008 FORD FOCUS SE
CRASH DATE - February 2009

16. <i>Abstract</i> This report covers an on-site investigation of a crash that involved a 2008 Ford Focus SE and a 1999 Ford Crown Victoria LX, which were involved in an offset frontal crash on a 2-lane state highway. This investigation focused on the frontal air bag system of the Focus and the sources of the injuries sustained by the driver. The Focus was certified by the manufacturer to be compliant to the Advanced Air Bag portion of Federal Motor Vehicle Safety Standard (FMVSS) No. 208. The Focus was occupied by an unrestrained 40-year-old male driver. He was traveling north when his vehicle crossed into the southbound lane. The front of the Focus impacted the front of the Crown Victoria in a left offset configuration. The direction of force of the Focus was within the 12 o'clock sector and the impact force was sufficient to deploy the driver's frontal air bag. The driver's seat back-mounted side impact air bag and the side impact inflatable curtain air bags also deployed. The driver's knees contacted the lower left i

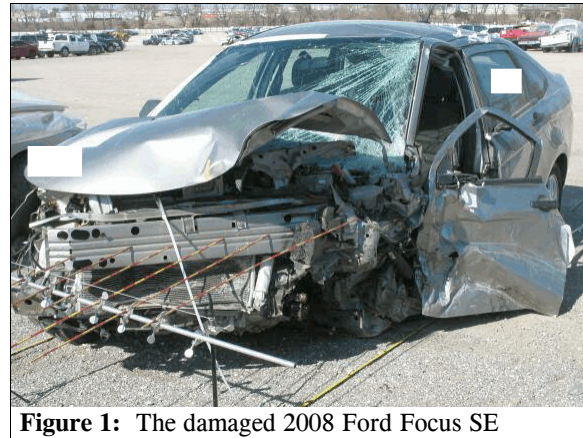
Figure 1: The damaged 2008 Ford Focus SE

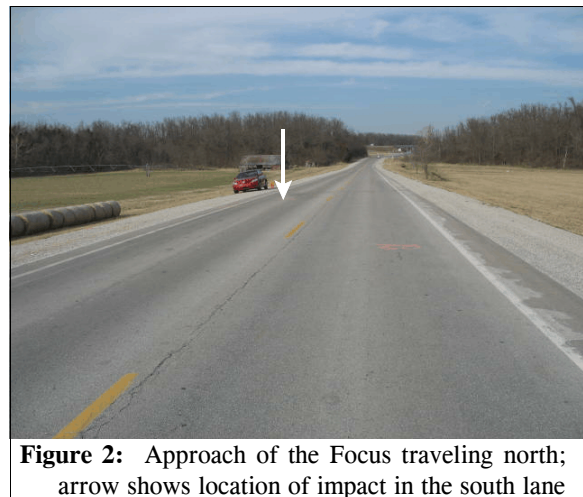
Pre-Crash: The Focus was occupied by an unrestrained 40-year-old male driver. He was traveling north (**Figure 2**) and intended to continue north. The Crown Victoria was occupied by a restrained 49-year-old female driver. She was traveling south and intended to continue south. The driver of a vehicle that was traveling south in front of the Crown Victoria told police that the Focus suddenly entered the southbound lane. The driver of the southbound vehicle

Figure 2: Approach of the Focus traveling north; arrow shows location of impact in the south lane

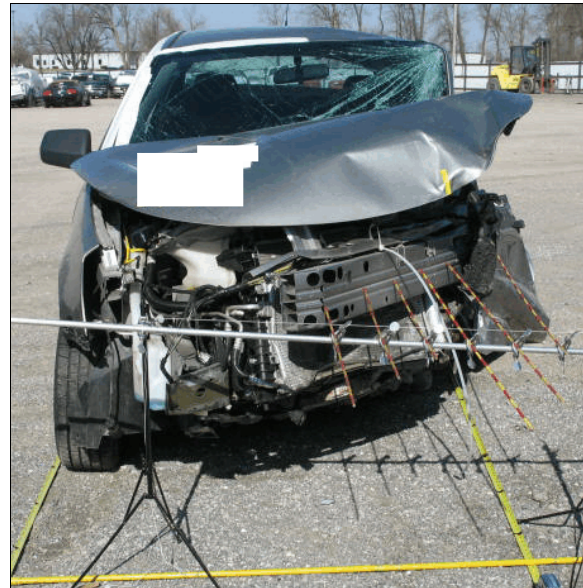
Crash: The front plane of the Focus (**Figure 3**) impacted the Crown Victoria's (**Figure 4**) front plane in a left offset configuration. The direction of force on the Focus was within the 12 o'clock sector and the impact force was sufficient to trigger a deployment of the driver's frontal air bag. The side impact inflatable curtain (IC) air bags and front left seat back-mounted side impact air bag also deployed. The two vehicles remained engaged and the damage extended down the left side of each vehicle (**Figures 5 and 6**), and the left front wheel of the Focus was broken off. The Focus separated from impact and rotated counterclockwise toward the east side of the roadway. The vehicle traversed 24.6 m (80.7 ft) across the road and down the east embankment while rotating counterclockwise approximately 430 degrees. It came to final rest at the bottom of the embankment heading northwest (**Figure 7**). The Crown Victoria traversed 23.2 m (76.1 ft) in a southwest direction across the road and down the west embankment while rotating counterclockwise 170 degrees. It came to final rest at the bottom of the embankment heading northeast (**Figure 8**).

Figure 3: Damage to the front of the Focus from impact with the Crown Victoria

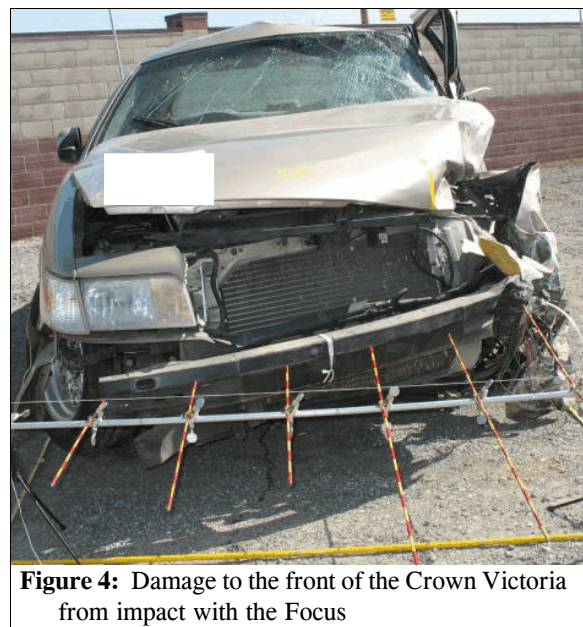
Figure 4: Damage to the front of the Crown Victoria from impact with the Focus

Exterior Damage: The impact with the Focus involved the Crown Victoria's front plane and occurred at the front left corner. The front bumper, hood, left fender, left front wheel, left front door and left rear door were directly damaged. The direct damage began at the front left bumper corner and extended 40 cm (15.7 in) across the bumper. The direct damage extended down the left side of the vehicle to the back of the left rear door. The crush measurements were taken at the bumper bar, and the maximum residual crush was 51 cm (20.1 in) occurring at C₁. The vehicle's left side wheelbase was reduced 45 cm (17.7 in) while the right side wheelbase was extended 2 cm (0.8 in). The induced damage involved the hood, windshield, left A-pillar, and roof. The vehicle's crush profile is shown in the table below.

Damage Classification: The CDC for the front impact was **12-FLEE-9 (0 degrees)**. The Damage algorithm of the WinSMASH program calculated the total Delta V of the Crown Victoria as 39.0 km/h (24.2 mph). The longitudinal and lateral velocity changes were -39.0 km/h (-24.2 mph) and 0.0 km/h, respectively. Based on the damage to both vehicle, the WinSMASH results appeared reasonable.

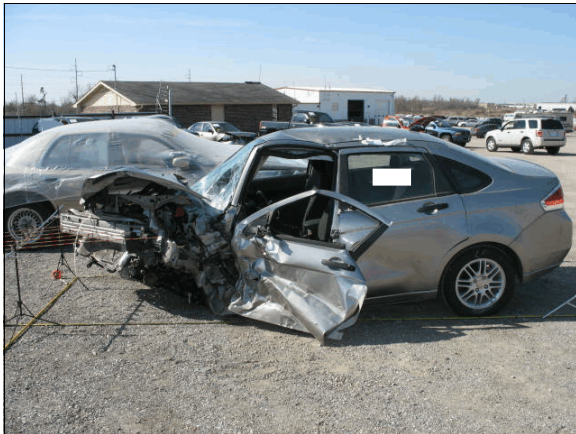
Figure 5: The damage extended down the left side of the Focus breaking off the left front wheel and crushing the left front door

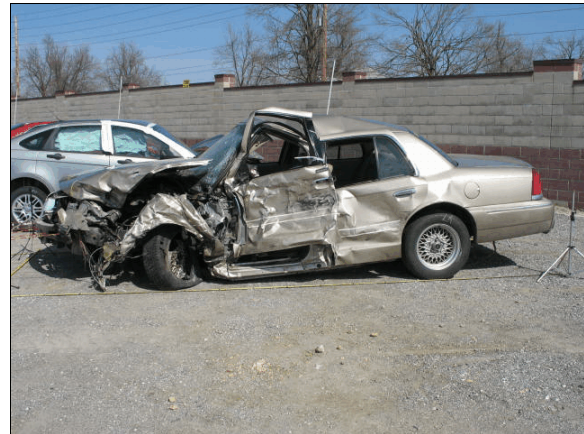
Figure 6: The damage extended down the left side of the Crown Victoria displacing the left front wheel rearward and crushing the left front door

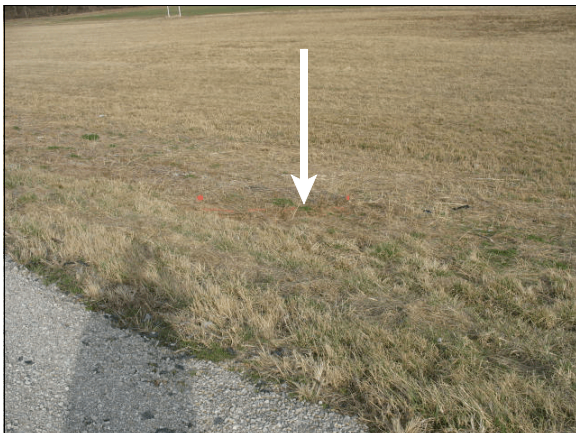
Figure 7: View from east shoulder to the rest position of the Focus (arrow); photo taken along approximate path to the rest position

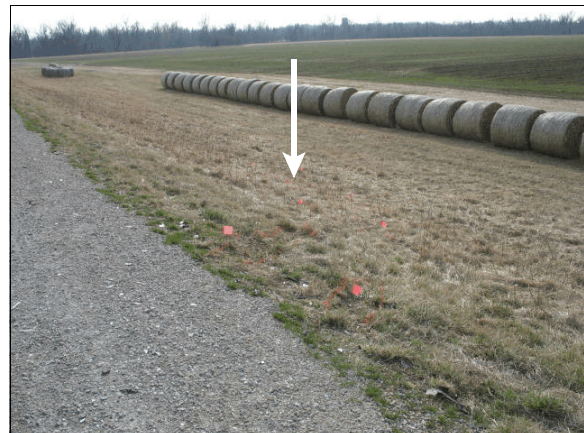
Figure 8: View from the west shoulder to the rest position of the Crown Victoria (arrow); orange paint and flags shows tire marks leading to the rest position

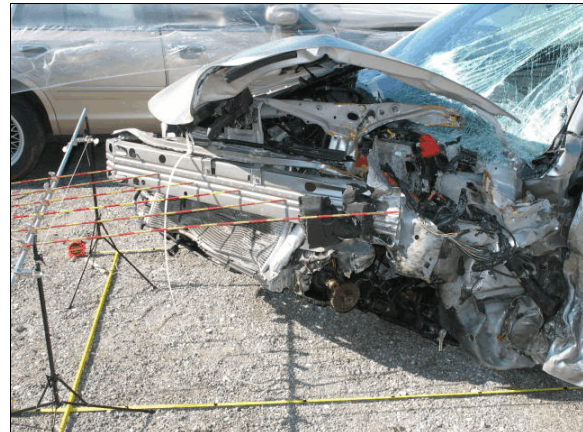
Exterior Damage: The impact with the Crown Victoria involved the front plane of the Focus and occurred at the front left corner. The front bumper, hood, left fender, left front wheel and left front door were directly damaged. The direct damage began at the front left bumper corner and extended 40 cm (15.7 in) across the bumper. It also extended down the left side of the vehicle to the back of the left front door (**Figure 5**). The crush measurements were taken at the bumper bar, and the maximum residual crush was 88 cm (34.6 in) occurring at C₁ (**Figure 9**). The table below shows the vehicle’s front crush profile.

Figure 9: Left side view of the Focus’ front crush

Damage Classification: The Collision Deformation Classification (CDC) for the front impact was **12-FLEE-8 (0 degrees)**. The Damage algorithm of the WinSMASH program calculated the total Delta V of the Focus as 57.0 km/h (35.4 mph). The longitudinal and lateral velocity changes were -57.0 km/h (-35.4 mph) and 0.0 km/h, respectively. Based on the damage sustained by both vehicles, the results of the WinSMASH program appeared reasonable.

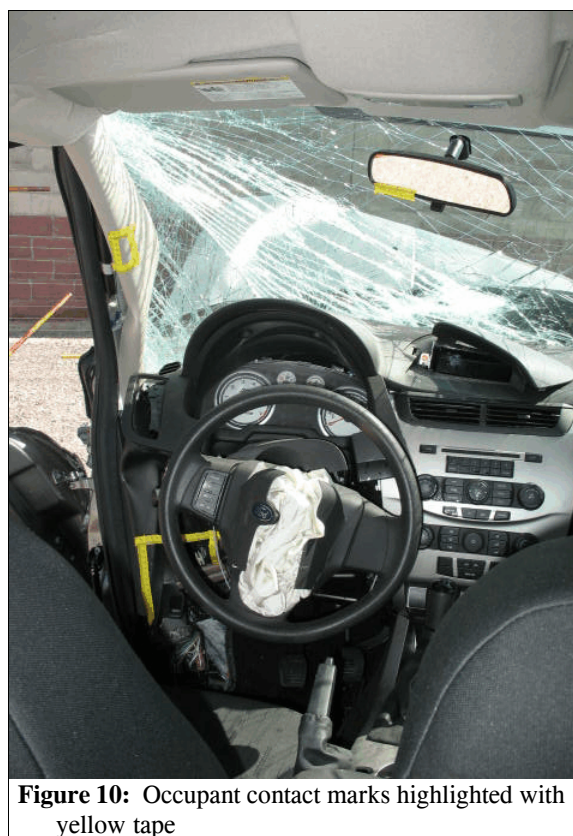
Vehicle Interior: Inspection of the Focus' interior revealed scuffs and deformation on the lower instrument panel left of the steering column due to contact by the driver's left knee (**Figure 10**). The instrument panel right of the steering column was also probably loaded by the driver's right knee; however, the panel was dislodged and was not present at the time of the inspection. The left A-pillar was abraded, probably due to contact by the driver's left hand. A scuff was located on the driver's frontal air bag, which was probably the result of the driver's face loading the air bag. The top half of the steering wheel rim was displaced forward 1 cm (0.4 in), which was the result of the unrestrained driver loading through the air bag and contacting the steering wheel. Based on measurements of the damaged steering column and from an exemplar vehicle, it was determined that the steering column was compressed 5 cm (2 in). Damage to the instrument panel and intrusion of the side panel forward of the A-pillar prevented inspection of the lower steering column.

Figure 10: Occupant contact marks highlighted with yellow tape

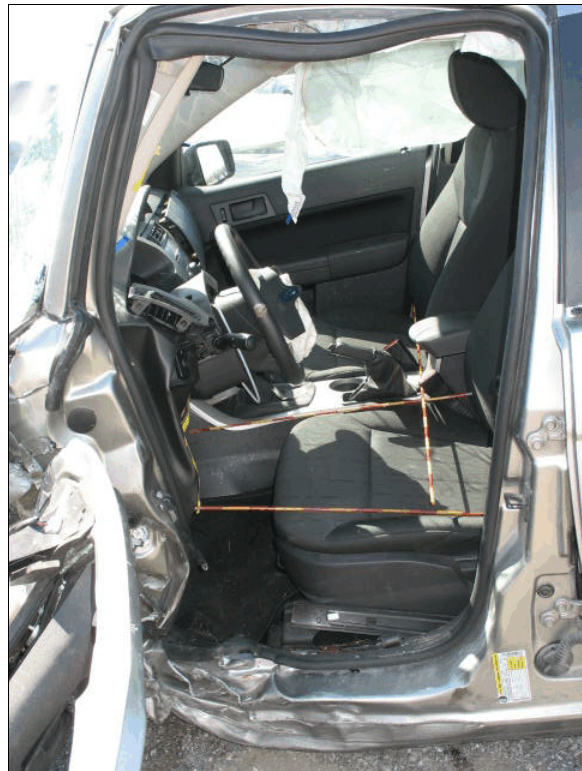
The Focus sustained nine passenger compartment intrusions into the front row (**Figures 11 and 12**). The most severe intrusions into the driver's space involved the side panel forward of the left A-pillar, the windshield, toe pan, left A-pillar, left instrument panel, and the steering assembly. The side panel intruded 25 cm (9.8 in) laterally while the windshield, toe pan, left A-pillar, instrument panel, and steering assembly intruded longitudinally 19 cm (7.5 in), 17 cm (6.7 in), 16 cm (6.3 in), 11 cm (4.3 in), and 5 cm (2 in), respectively.

Figure 11: Passenger compartment intrusion

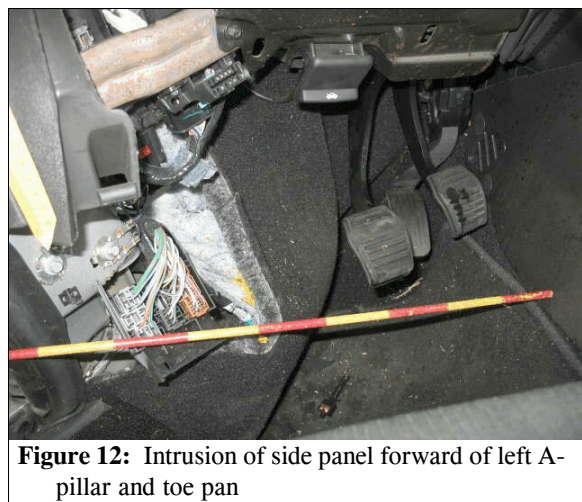
Figure 12: Intrusion of side panel forward of left A-pillar and toe pan

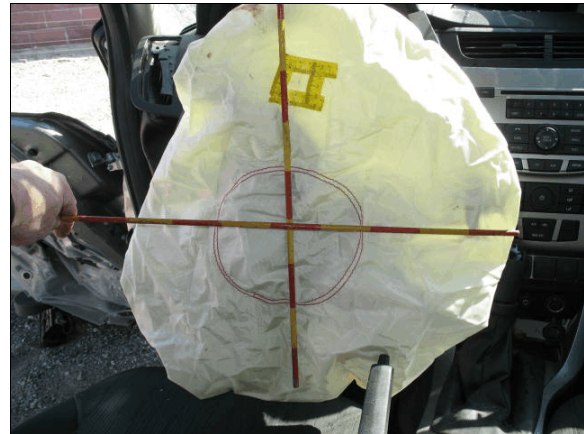
The driver's frontal air bag was located within the steering wheel hub and the module cover was a two flap configuration constructed of pliable vinyl. Each cover flap was 7 cm (2.3 in) in width and 15 cm (5.9 in) in height, and they opened at the designated tear points. The deployed air bag (**Figure 13**) was 48 cm (19 in) in diameter and was designed with two 3 cm (1.2 in) diameter vent ports and one tether, which was 12 cm (4.7 in) in width. The vent ports were located at the 11 and 1 o'clock positions. Inspection of the air bag revealed no damage and a probable occupant contact scuff located 17 cm (6.7 in) above and 3 cm (1.2 in) to the right of the center of the air bag. There were also several other scuffs on the air bag, which appeared to be related to the deployment or post-crash handling of the air bag.

Figure 13: The driver's frontal air bag; yellow tape shows probably occupant contact scuff

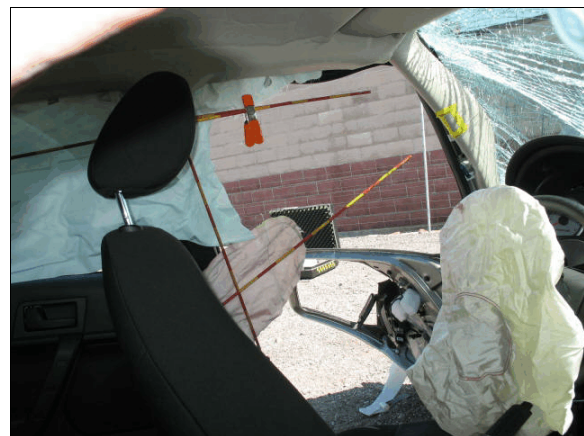
The left IC was located along the left roof side rail (**Figure 14**), within the head liner and extended from the A-pillar to the C-pillar. The IC was 150 cm (59.1 in) in width and 35 cm (13.8 in) in height and was anchored to the A-pillar by a nylon rope tether and a triangular section of fabric. The nylon rope was 8 cm (3.1 in) in length and the fabric was 32 cm (12.5 in) in length. The IC was anchored to the C-pillar by a nylon rope tether 5 cm (2 in) in length. A section of the IC 38 cm (15 in) in width and 32 cm (12.9 in) in height had been cut out of the front portion of the IC, probably by rescue personnel. The remainder of the IC was unremarkable. The right IC was of the same dimensions and was unremarkable except for a cut on the inside front portion, which did not appear to be crash related.

Figure 14: The left side impact curtain air (front portion cut away), seat back mounted side impact air bag and the frontal air bag

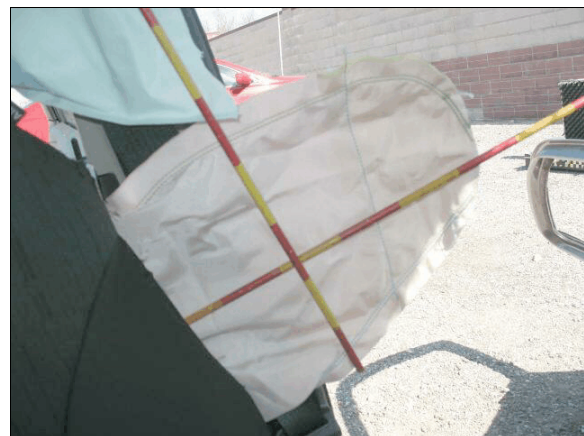
The front left seat back-mounted side impact air bag was located within the outboard side of the seat back and deployed through a tear seam. The deployed air bag (**Figure 15**) was oval and was 27 cm (10.6 in) in width and 22 cm (8.7 in) in height. It was designed without tethers or vent ports. Inspection of the air bag revealed no evidence of occupant contact and there was no damage to the air bag.

Figure 15: The deployed front left seat back-mounted side impact air bag

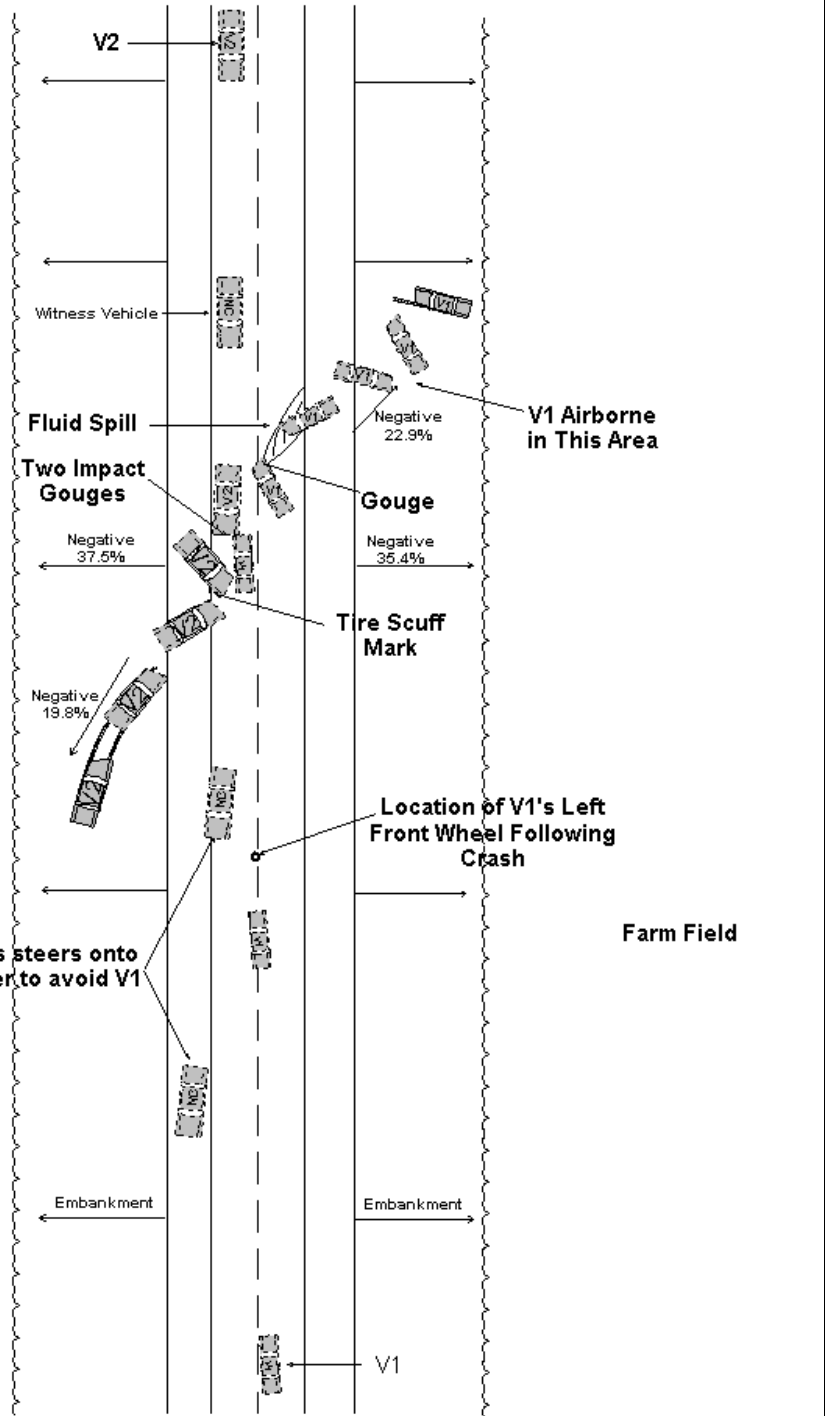
Witness steers onto
shoulder to avoid V1
