ON-SITE HYBRID VEHICLE INVESTIGATION

CASE NUMBER - IN09009

VEHICLE - 2006 TOYOTA PRIUS

CRASH DATE - October 2008

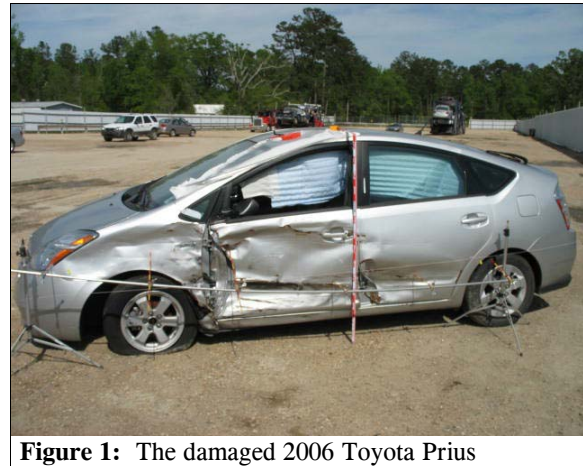
Figure 1: The damaged 2006 Toyota Prius

Exterior Damage: The Prius’ impact with the Dodge involved the Prius’ left side plane. The left fender, left front wheel, left side doors, and side view mirror were all directly damaged. The direct damage began 25 cm (9.8 in) forward of the left rear axle and extended 285 cm (112.2 in) along the left side. The crush measurements were taken at the lower door level. The maximum residual crush was 11 cm (4.3 in) occurring at C₄ (**Figure 4**). The height of the vehicle’s sill was 21 cm (8.3 in) and the height of the maximum door crush was 66 cm (26 in). The Door Sill Differential was 4 cm (1.6 in). The left side wheelbase was shortened 10 cm (3.9 in) and the right side wheelbase was extended 1 cm (0.4 in). The induced damage involved the left fender and left rear door. The table below shows the vehicle’s left side plane crush profile.

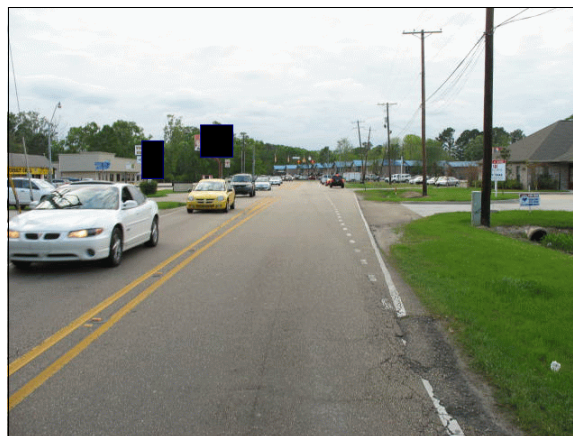
Pre-Crash: The Prius was occupied by a restrained 62-year-old male driver. The driver stated during the SCI interview that he was traveling west at approximately 40 km/h (25 mph) and was changing lanes to the right turn lane (**Figure 2**) and intended to continue west to the intersection. The Dodge was occupied by a restrained 18-year-old male driver who intended to continue eastbound (**Figure 3**). The Sienna was occupied by a restrained 62-year-old female driver who intended to continue westbound, directly behind the Prius. The Dodge's driver told police that he lost control of his vehicle and entered the west travel lane where the crash occurred. The driver of the Prius driver took no actions to avoid the crash.

Figure 2: Prius' approach to the impact area

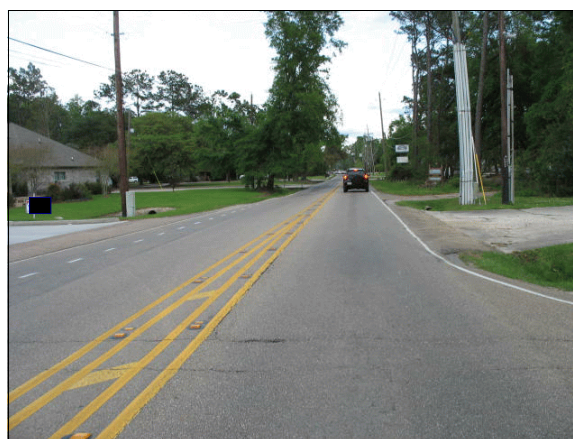
Figure 3: Dodge's approach to impact area

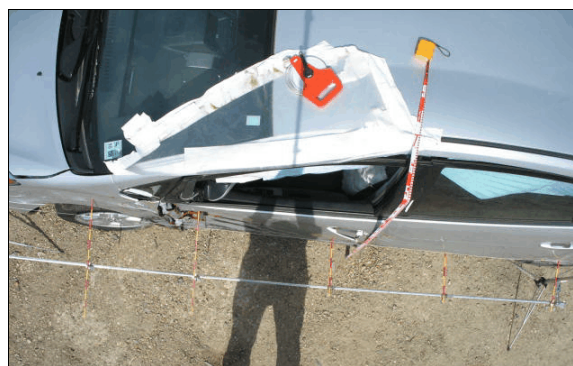
Figure 4: Top view of the Prius’ left side crush

Damage Classification: The Prius’ Collision Deformation Classification was **11-LYES-2 (340 degrees)** for the impact with the Dodge. The WinSMASH program could not be used to calculate a Delta-V for the Prius since sideswipe impacts are out of scope for the program. The WinSMASH program was used to calculate a Barrier Equivalent Speed (BES) based on the vehicle’s crush, and the BES was 16.3 km/h (10.2 mph).

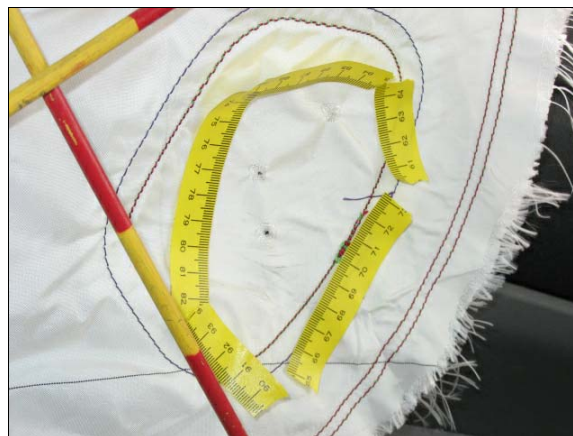
Vehicle Interior: Inspection of the Prius' interior revealed a scuff mark on the inboard side of the left front seat-mounted side impact air bag (**Figure 5**), possibly from contact by the driver's left arm. No other occupant contacts were observed.

Figure 5: Scuffs on driver's seat-mounted side impact air bag

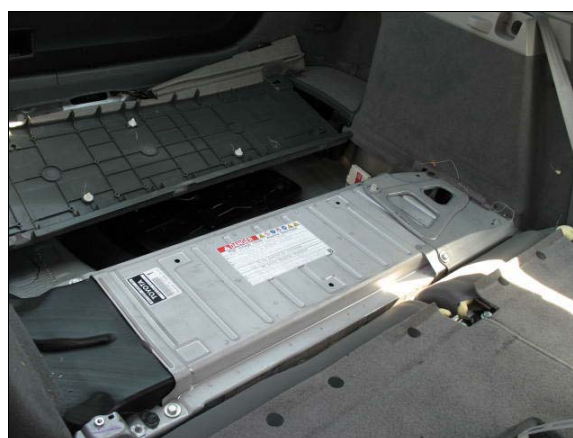
The Prius' NiMH propulsion battery pack was located behind the second row seat (**Figure 6**). It was enclosed in a metal case, which was rigidly mounted to the cargo area floor pan cross member and electrically isolated from high voltage. The 201-volt NiMH battery pack consisted of 28 low voltage modules, each 7.2 volts, connected in series. Each battery module is non-spillable and sealed in a plastic case. The electrolyte used in the battery modules is an alkaline of potassium and sodium hydroxide. The electrolyte is absorbed into the battery cell plates and will form a gel that will not normally leak, even in a collision¹. Inspection of the propulsion battery revealed no evidence of movement and no evidence of arcing or melting of any of the components of the battery pack. The battery was equipped with a high voltage service disconnect plug, which was located on the left side of the battery pack (**Figures 7 and 8**). At the time of the inspection, the plug was in the locked position. The plug was removed and both leads on the battery pack were tested for voltage with a multimeter. The voltage reading was zero volts.

Figure 6: Prius' NiMH propulsion battery case located immediately behind second row seat

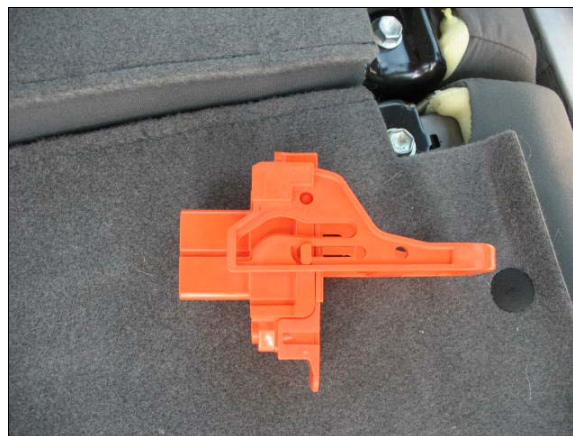
Figure 8: High voltage disconnect plug

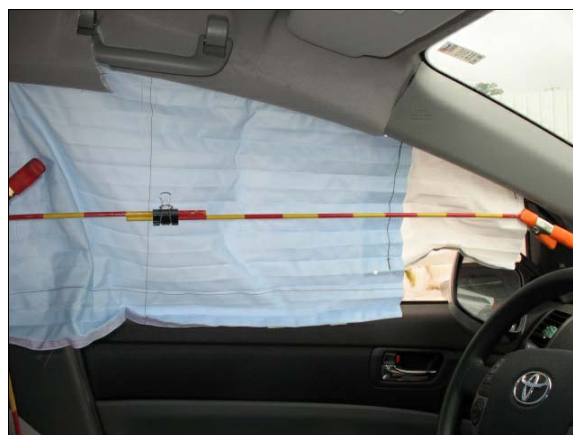
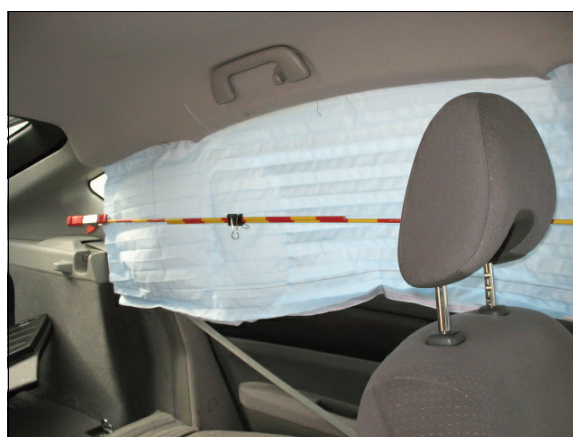
The left IC (**Figures 9 and 10**) was 183 cm (72 in) in length and 35 cm (13.8 in) in height. It was not equipped with any visible vent ports. A non-inflatable fabric panel, 22 cm (8.7 inches) in width, connected the IC to the A-pillar. The back of the IC was not attached to the C-pillar by neither fabric nor a tether. Inspection of the IC revealed no damage and no discernable evidence of occupant contact.

Figure 9: Front portion of the left IC air bag

Figure 10: Rear portion of the left IC air bag

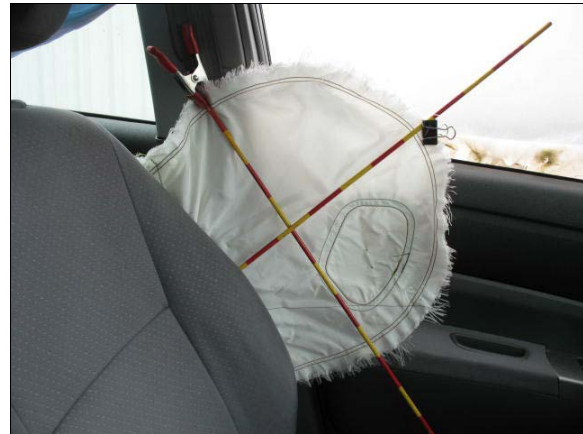
The front left seat-mounted side impact air bag (**Figure 11**) was oval-shaped and was 32 cm (12.6 in) in width and 40 cm (15.7 in) in height. Scuffs, possibly due to contact by the driver's left arm, were found on the inboard side of the air bag (**Figure 5**). There was no damage to the air bag.

Figure 11: Driver's seat-mounted side impact air bag
