ON-SITE HYBRID VEHICLE INVESTIGATION

CASE NUMBER - IN09011
LOCATION - TEXAS
VEHICLE - 2006 HONDA CIVIC HYBRID CVT
CRASH DATE - January 2009

16. <i>Abstract</i> This report covers an On-Site Hybrid Vehicle Investigation that involved a 2006 Honda Civic Hybrid CVT, which departed the roadway and rolled over. The focus of this on-site investigation was the crash performance of the Honda's Nickel-Metal Hydride (NiMH) propulsion battery. The Honda was occupied by a restrained 37-year-old male driver who was traveling south on a 2-lane county roadway approaching a 90 degree right turn. The vehicle began to rotate clockwise as he was negotiating the right turn. The vehicle continued to rotate clockwise as it departed the roadway and impacted a woven wire fence. As the vehicle penetrated the fence, it rolled over left side leading 6 quarter turns and came to rest on its roof. The vehicle's NiMH battery sustained no damage or leakage. The driver was not injured.

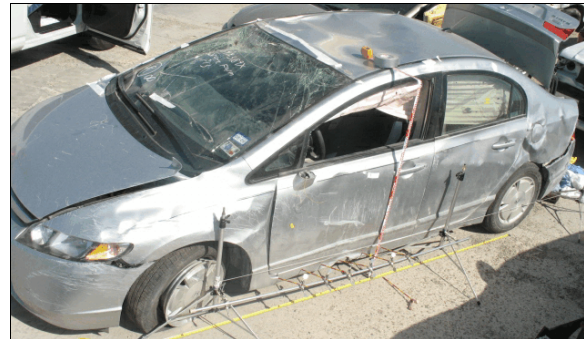
Figure 1: The damaged 2006 Honda Civic Hybrid CVT

The direct damage on the left side plane (event 2, **Figure 1**) consisted primarily of scratches, which began 64 cm (25 in) forward of the left front axle and extended 238 cm (93.7 in) rearward along the left fender, left side doors, and the left roof side rail. While the majority of the damage consisted of scratches from the fence wire, there was a crush pocket on the left sill and left front

The damage from the rollover (event 3) involved the left side, top, and right side planes (**Figures 1 and 5**). The direct damage on the left side plane overlapped the damage from the fence impact and involved the fender, both doors, roof side rail, and the quarter panel. The direct damage on the right side plane involved the right front door. The direct damage on the top plane involved the hood, and roof. It extended the full width of the roof, 111 cm (43.7 in). The maximum vertical crush was 9 cm (3.5 in), which occurred on the roof 190 cm (74.8 in) rear of the right front axle and 46 cm (18.1 in) left of the right roof side rail. There was no lateral displacement of the roof structure.

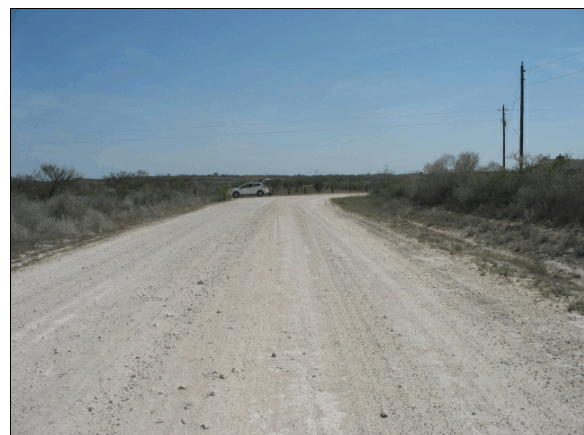
Pre-Crash: The Honda was occupied by a restrained 37-year-old male driver. He was traveling south (**Figure 2**) down a negative 5% grade approaching a 90 degree right turn. The driver lived in the area and was familiar with the roadway. He was on his way to an airport and was in a hurry. He lost control of the vehicle while negotiating the right turn and the vehicle began to rotate clockwise. The driver stated in the interview that he steered right and applied hard braking in an attempt to avoid a crash.

Figure 2: Approach of the Honda south to the area of roadway departure in the right curve

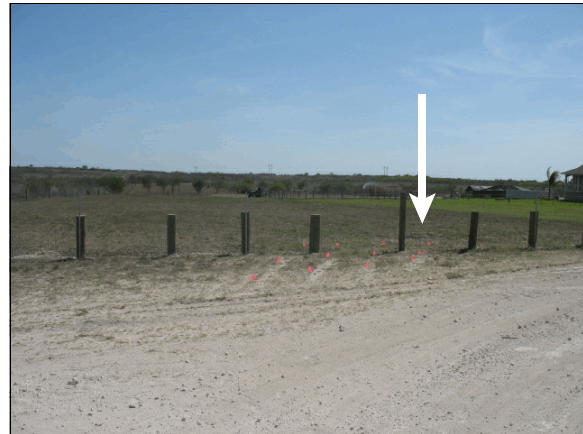
the south side of the roadway and approached the fence (**Figure 3**). The vehicle traveled 3.8 m (12.5 ft) off the roadway and the front left corner and left side plane impacted a woven wire fence in a penetrating type impact (events 1 and 2). A fence post engaged the sill and left front door (**Figure 4**) as the vehicle penetrated the fence. While this damage did not appear significant, there was sufficient engagement to crush the sill 5 cm (2 in). One of the vehicle's two left side impact sensors was located in the lower B-pillar, which was near the impact site on the sill. As a result, it is probable that the deployments of the vehicle's left front seat back-mounted side impact air bag and left side curtain air bag were triggered by this impact (event 2). As the vehicle penetrated the fence it rolled over (event 3) with the left side leading. The vehicle remained engaged with the fence and dislodged it and some of the fence posts. The dislodged fence scratched and dented the hood and punched a small hole in the hood and right portion of the windshield (event 4, **Figure 5**) during the rollover. The vehicle rolled over 6 quarter turns and came to final rest on its top in a farm field heading north (**Figure 3**).

Figure 3: Approach of the Honda to the impact with the fence and rollover initiation; flags show tire furrow marks; original fence replaced with large fence posts; arrow shows area of final rest in the farm field

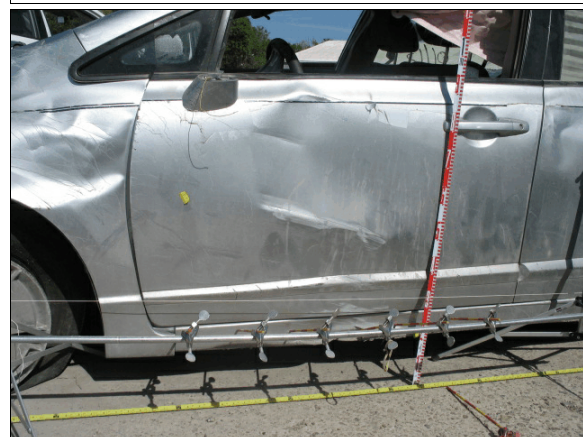
Figure 4: Damage to the left front door from a fence post

door (**Figure 4**) due to engagement with one of the fence posts. The crush pocket began 214 cm (84.3 in) forward of the left rear axle and extended rearward 77 cm (30.3 in). The crush involved primarily the sill and the crush measurements were taken at that level. The maximum residual crush was 5 cm (2 in) occurring at C₃. The table below shows the crush profile for event 2.

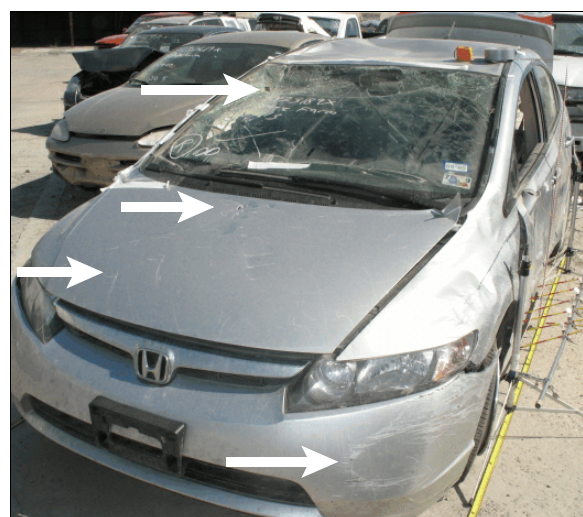
Figure 5: Damage from the rollover on the top and left side planes; arrow at bottom shows damage on the front plane from fence impact (event 1); other arrows show damage on the hood and windshield from the fence that occurred during the rollover (event 4)

Exterior Damage: The Honda sustained damage from the penetrating type impact with the fence on the front, left side and top planes (events 1, 2 and 4). The direct damage on the front plane (event 1) involved the front left corner (**Figure 5**) and consisted of scratches on the bumper fascia and headlamp/turn signal assembly. The direct damage began at the front left bumper corner and extended 25 cm (9.8) to the right on the bumper. There was no residual crush as a result of this impact.

The direct damage from the fence that occurred during the rollover (event 4) involved the hood and windshield (**Figure 5**). A small hole was punched in the hood and right portion of the windshield, probably from one of the fence posts. The Honda's wheelbase was unchanged. The induced damage involved the hood, roof, and left quarter panel.

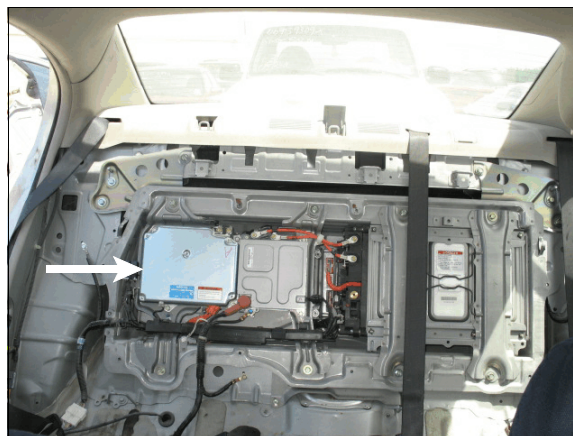
The Honda's propulsion battery pack was housed within a sealed metal box (**Figure 6**) located within a metal compartment behind the second row seat back (**Figure 7**). The battery box was completely insulated and electrically isolated from the vehicle body. The battery pack consisted of battery cells, each about the size of a standard D-cell battery. The total voltage of the battery pack was 158 volts. Small quantities of a highly alkaline liquid electrolyte are used in the manufacture of each cell; however, in the finished cell the electrolyte is non-liquid and sealed in a metal case¹.

Figure 6: Arrow shows the NiMH propulsion battery box

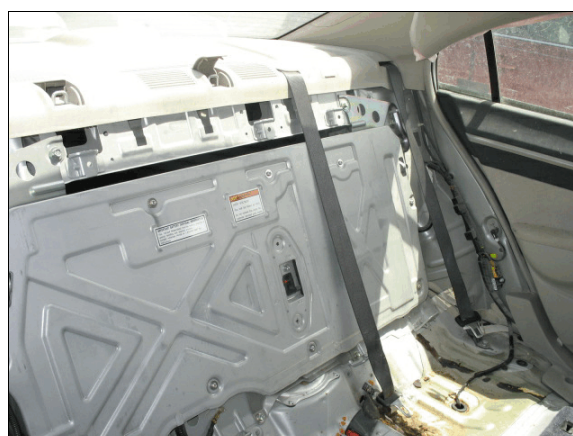
The cover to the metal compartment, which contained the propulsion battery box and other electrical components, was removed and the components were visually inspected. There was no evidence of damage or movement of the propulsion battery box or any of the components, and no evidence of electrical arcing or melting of any components. A voltage measurement was taken at the junction board terminal of the DC/DC converter, and the voltage reading was zero volts. Other associated high voltage cables, connectors, and components (that were accessible) within the engine compartment (**Figure 8**) were also examined and there was no evidence of damage, electrical arcing, or melting of components.

Figure 7: The metal compartment located behind the second row seat back, which contained the NiMH propulsion battery box

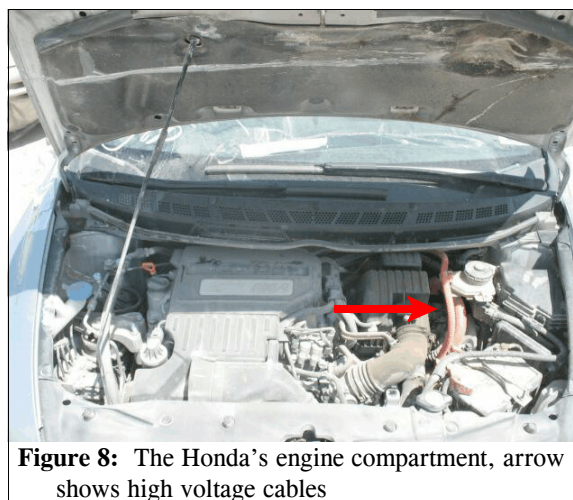
Figure 8: The Honda's engine compartment, arrow shows high voltage cables

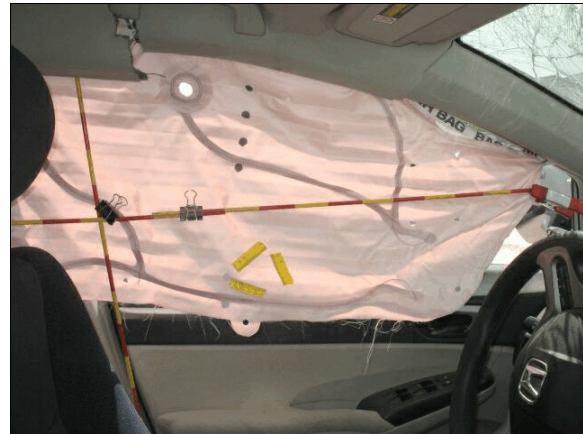
The Honda's side curtain air bags were located along the roof side rails inside the headliner, and extended from the A-pillar to the C-pillar. The deployed left side curtain air bag (**Figure 9**) was 180 cm (70.9 in) in width and 38 cm (15 in) in height. The air bag was not tethered to the A-pillar or C-pillar. The space between the front of the air bag and the A-pillar was 15 cm (6 in) at the approximate center of the air bag. The air bag was designed with inflation

chambers adjacent to the front left and second row left seat position, and appeared to have a vent port at the front and rear of the air bag. The fold creases on the air bag indicated that it had been folded accordion fashion within the headliner. A possible occupant contact scuff was located 45 cm (17.3 in) rear of the front of the air bag and 7 cm (2.8 in) above the bottom of the air bag.

Figure 9: The front portion of the left side curtain air bag, yellow tape shows a possible occupant contact scuff from the driver's left arm

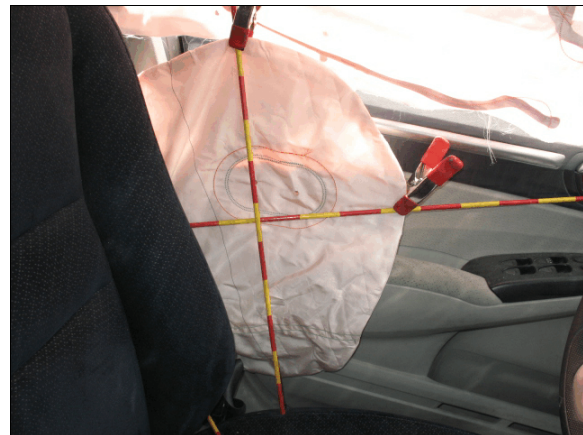
The driver's seat back-mounted side impact air bag was located in the outboard side of the seat back (**Figure 10**) and deployed through a tear-seam. The deployed air bag was oval and had a single tether where both sides of the air bag were sewn together. The sewn area was 15 cm (5.9 inches) in width and 8 cm (9.4 in) in height, and was located in the center of the air bag. There was also a 5 cm (2 in) diameter vent port located on the outboard side of the air bag. The deployed air bag was 49 cm (19.3 in) in height and 29 cm (11.4 in) in width. Inspection of the air bag revealed no discernable evidence of occupant contact and no damage.

Figure 10: The front left seat back-mounted side impact air bag
