CALSPAN ON-SITE ROLLOVER CRASH INVESTIGATION
SCI CASE NO.:CA09013

VEHICLE: 2008 CHEVROLET SILVERADO

LOCATION: NORTH CAROLINA

CRASH DATE: JANUARY 2009

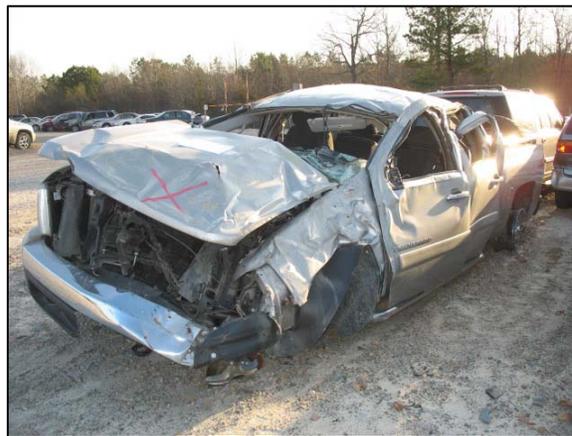
Figure 1: Chevrolet Silverado case vehicle.

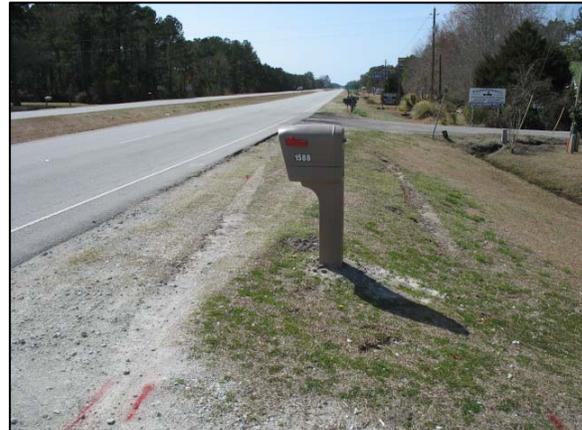
The right plane of the Chevrolet impacted a wheeled trash can and a wood mailbox post with the right door area (Events 1 and 2). The directions of force for both impacts were within the 2 o'clock sector. **Figure 2** is a trajectory view at the points of impact for the events. The wood mailbox post had been replaced prior to the scene inspection. The Chevrolet's right side tire impressions are visible in the image. Due to the overlapping damage from the subsequent rollover event, it was not possible to obtain a crush profile for these two impacts. These impacts did not alter the trajectory of the vehicle.

Figure 2: POI events 1 and 2 (Trash can removed).

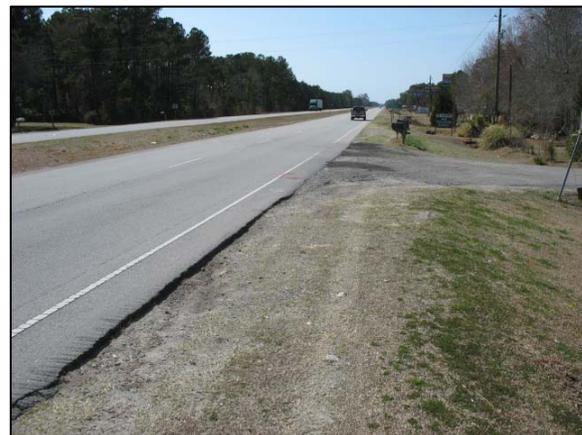
After the impact with the mailbox, the Chevrolet continued an additional 17.6 m (57.7 ft) and yawed an additional 30 degrees CCW along the road side. The right side tire impressions indicated that the vehicle was on an arcing trajectory heading back toward the road. As the vehicle encountered the pavement edge, the right front wheel rim tripped on an 11 cm (4.3 in) drop off between the asphalt and the dirt/grass roadside. The interaction at the road/rim interface caused the Chevrolet to initiate a right side leading tripped rollover. The location of the edge drop and the start of the rollover are depicted in **Figure 3**.

Figure 3: Location of start of rollover.

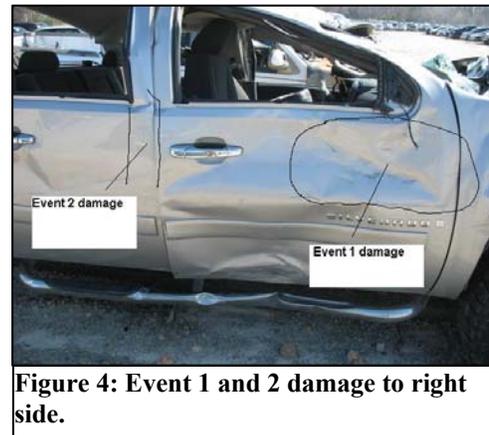
The exterior of the Chevrolet sustained moderate severity damage to the side, top and front planes as a result of the multiple impact crash. The right plane sustained two impacts from the plastic trash can (Event 1) and the mailbox (Event 2). The contact damage from these events was overlapped by the damage from the rollover (Event 3). **Figure 4** depicts the right side damage to the Chevrolet. The first impact occurred to the right front door. The direct damage measured 46 cm (18.1 in) in length and began 67 cm (26.4 in) rearward of the right front axle, extending rearward to 113 cm (44.5 in) rear of the RF axle. The Collision Deformation Classification (CDC) for this impact was 02RPEW01. The second impact to the right plane occurred to the forward aspect of the right rear door. The direct damage measured 5 cm (2 in) in length and began 179 cm (70.5 in) rear of the right front axle, extending rearward to 184 cm (72.4 in) rear of the front right axle. The CDC for this impact was 02RPEN01

Figure 4: Event 1 and 2 damage to right side.

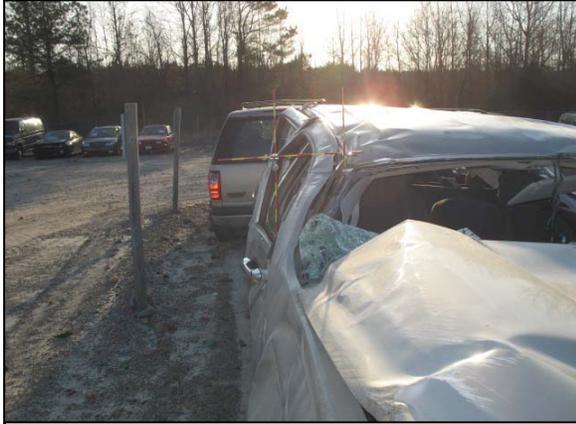
The rollover resulted in body panel abrasions and deformation to the left and right sides, roof and hood of the vehicle. The abrasions overlapped in multiple directions, indicating that the Chevrolet rolled over multiple times. The left front wheel separated from the suspension during the impact sequence. The left rear and right rear wheel rims fractured and the rims separated from the vehicle during the impact. The right rear rim was found to be embedded with grass of the same type found at the crash scene. The right front tire was de-beaded but the tire and rim were still attached to the Chevrolet. The location of the maximum crush, both vertically and laterally, was located at the junction of the right roof side rail and the right A-pillar. The maximum vertical and lateral crush was 17 cm (6.7 in) and 8 cm (3.2 in), respectively. (The left C-pillar area was also measured for the extent of rollover damage, but it did not exceed the crush to the right A-pillar area.) The left front, left rear and right front doors were jammed shut. The right rear door remained closed during the crash and was operational. The windshield was fractured and all the side glazing disintegrated. The CDC assigned for the rollover was 00TYDO3. **Figures 5 and 6** depict the rollover damage to the Chevrolet.

Figure 5: Maximum crush location.

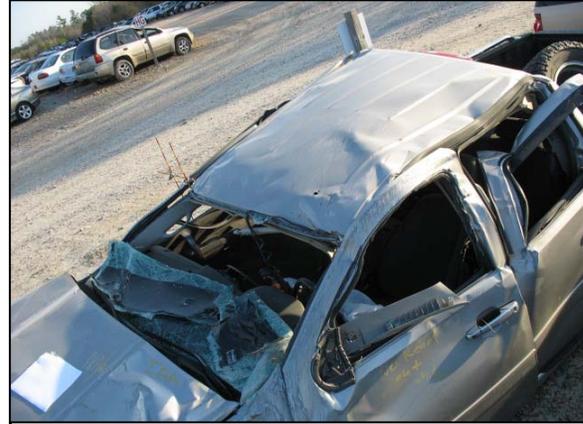
Figure 6: Rollover damage to roof.

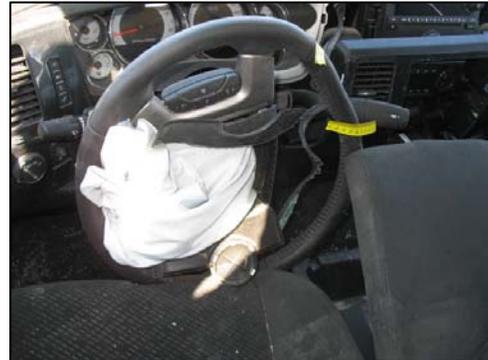
The driver seat was adjusted to the full-rear position. The seat back angle measured 22 degrees aft of vertical. The recline adjustment mechanism was jammed. The steering column was completely separated from the shear capsules and the rim was resting on the driver seat cushion (**Figure 7**). The front right seat was adjusted to a mid-track position. The front right seat back angle measured 8 degrees forward of vertical. The recline adjustment mechanism of this seat was also jammed. The second row of the Chevrolet was relatively undamaged. The split-rear bench seats maintained their pre-crash position.

Figure 7: View of the steering assembly.

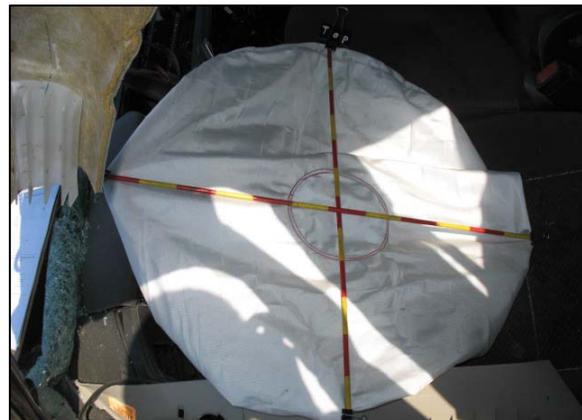
Figure 8: Deployed driver's frontal air bag.

The driver air bag (**Figure 8**) deployed from an I-configuration module located in the hub of the four-spoke steering wheel rim. The air bag measured 62 cm (24.4 in) in its deflated state. It was tethered by two straps sewn to the face of the bag that were located at the 3 and 9 o'clock positions. There was a small 4 cm (1.6 in) tear along the tether seam on the face of the bag in the 5 o'clock sector. The air bag was vented by two ports located at the 11 and 1 o'clock positions on the back side of the bag. The 1 o'clock vent port was surrounded by melted fabric from the driver's seat cushion. A 5 cm (2 in) diameter burn pattern was observed on the driver's seat. A similar burn pattern was observed on the cushion of the front center seat. This burn pattern was related to the 11 o'clock vent port. The orientation of the burned/melted seat cushions indicated that the steering wheel rim was rotated approximately 180 degrees at the time of the air bag deployment. The driver air bag must have deployed during the later stages of the rollover sequence, after the driver had loaded and compressed the steering column separating the shear capsules, and after he was ejected. **Figures 9 and 10** depict the residual evidence and burn from the driver air bag deployment to the cushions of the center and driver seat.

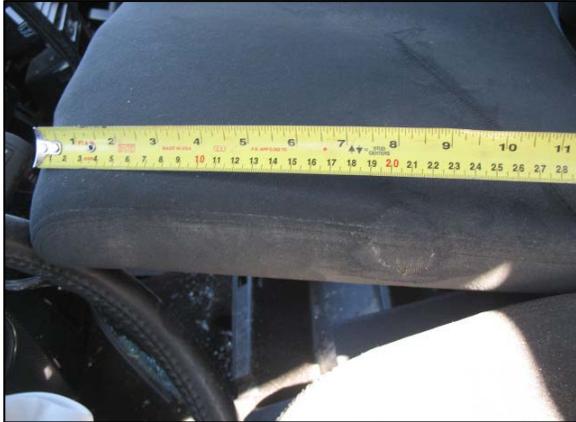
Figure 9: Residual evidence to the center seat cushion from the 11 o'clock vent port.

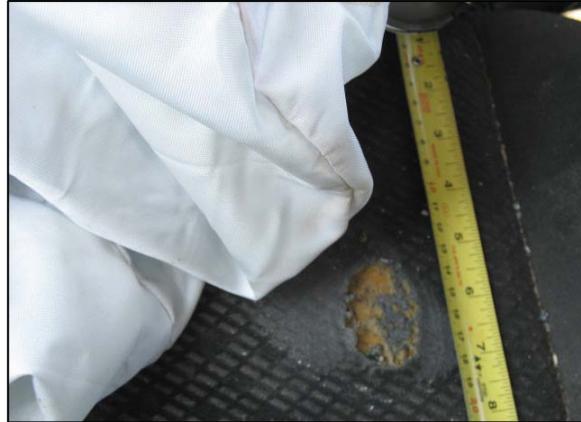
Figure 10: Burn to the driver seat cushion from the 1 o'clock vent port of the driver air bag.

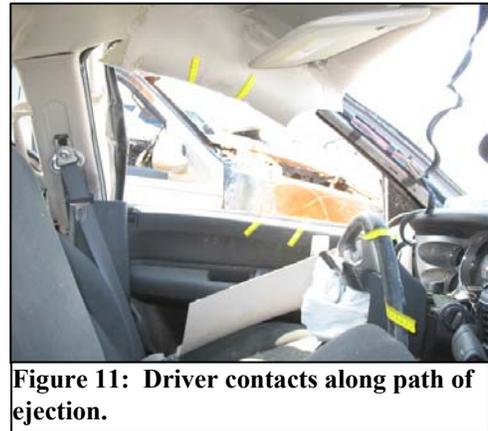
The Chevrolet departed the roadway to the right and the driver applied an evasive left steering maneuver to regain the road. The rapid steering maneuver initiated a CCW yaw. As the vehicle rotated and decelerated during the yaw, the driver was displaced to the right. The vehicle tripped as it came back to the edge of the asphalt shoulder and initiated a right side leading rollover. As the rollover began, the driver continued the right trajectory across the front center seating position and loaded the front right occupant. This contact resulted in the soft tissue injuries to the driver’s right shoulder and arm. As the vehicle rolled over, the driver initiated a left and forward trajectory. The driver loaded the steering wheel and separated the column from the shear capsules. The force of the rollover caused the driver to be ejected through the front left window opening. During the ejection sequence, the driver contacted the door panel with the left side of his chest and flank. This contact was evidenced by the scuffed panel and resulted in the rib fracture and soft tissue flank abrasions. His right flank contacted and was abraded by the left roof side rail. The driver’s lower extremities contacted the steering wheel rim evidenced by the rim deformation and soft tissue injuries to his lower extremities. **Figure 11** depicts the trajectory of the driver as he was ejected.

Figure 11: Driver contacts along path of ejection.

The ejected driver contacted the ground with his head and back. This contact resulted in the identified brain hemorrhages, the lumbar vertebrae fracture and multiple soft tissue injuries. The abrasions were described as being embedded with dirt and gritty material. The driver did not know his position of final rest in relation the final rest of the vehicle.

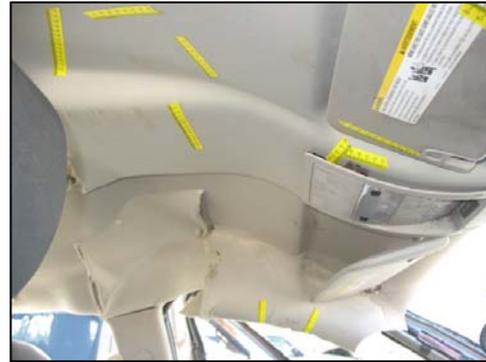
The 17-year-old male front right passenger was seated in a mid-track position and was not restrained at the time of the crash. The driver reported that the passenger was wearing a sweatshirt, denim jeans and tennis shoes at the time of the crash. Additionally, the driver reported that the front passenger braced for the crash by holding the right side grab-handle, pushing his feet to the floor, and pushing his back into the front right seat back. At the initiation of the rollover, the front right passenger began a right trajectory and loaded the right front door panel. He was then loaded by the driver as the driver passed across the front bench. This contact resulted in the soft tissue injuries to the left lateral chest. As the Chevrolet rolled inverted, the front right passenger began a vertical trajectory and contacted the right sun visor and center roof console with his head. As the rollover continued, the vehicle returned to its wheels and impacted the ground. The front right passenger responded with a downward trajectory back into the seat. The passenger loaded the floor with his foot resulting in the small avulsion fractures. His loading of the seat back resulted in the lumbar and cervical strain. **Figure 12** depicts the contacts left by the front right passenger. The vehicle came to rest on its roof with the passenger was still inside. He self-extricated through an unknown portal and attempted to assist the other occupants before EMS and police arrived.

Figure 12: Contacts to the roof over the front right seating position.
