Hybrid Vehicle Investigation  
Dynamic Science, Inc. (DSI), Case Number DS09014  
2007 Toyota Prius  
California  
September 2008

1. Report No. DS09014	2. Government Accession No.	3. Recipient Catalog No.	
4. Title and Subtitle  On-Site Hybrid Vehicle Investigation		5. Report Date September 15, 2009

**Dynamic Science, Inc.**  
**Crash Investigation**  
**Case Number: DS09014**

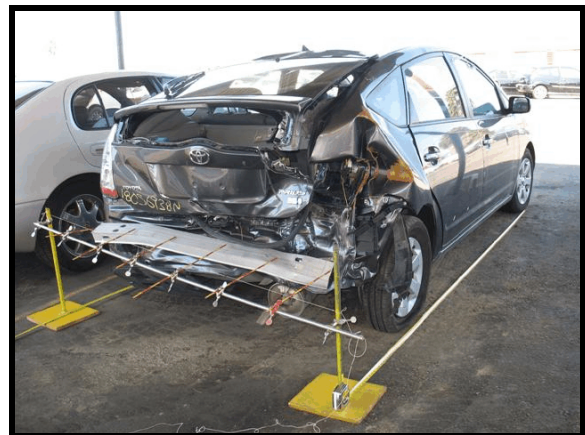
The Toyota sustained moderate back end damage from the impact with the Jeep (**Figures 4-5**). The direct damage began at the right bumper corner of the bumper fascia and extended 77 cm (30.3 in) to the left. The Field L began at the right bumper corner and extended 130 cm (51.1in) to the left bumper corner. The bumper fascia was displaced from the vehicle and the bumper reinforcement had rotated forward; the crush measurements were taken to the mid-point of the reinforcement. Six crush measurements were documented along the rear bumper reinforcement as follows: C1 = 5 cm (1.9 in), C2= 13 cm (5.1 in), C3 = 21 cm (8.3 in), C4 = 28 cm (11.0 in), C5 = 30 cm (11.8 in), C6 = 33 cm (12.9 in). The Collision Deformation Classification (CDC) for the impact with the Jeep was 06BZEW3.

**Figure 4.** Rear end damage

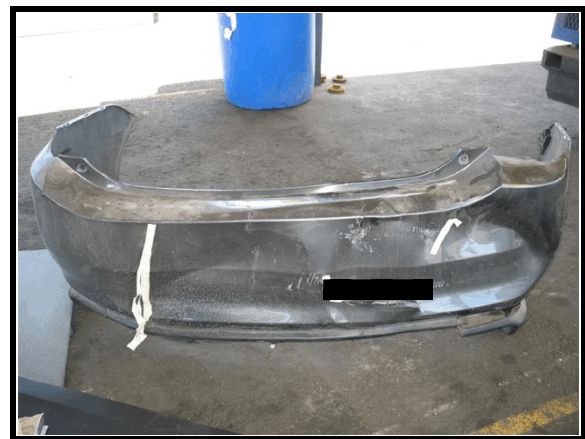
**Figure 5.** Contact to rear bumper fascia

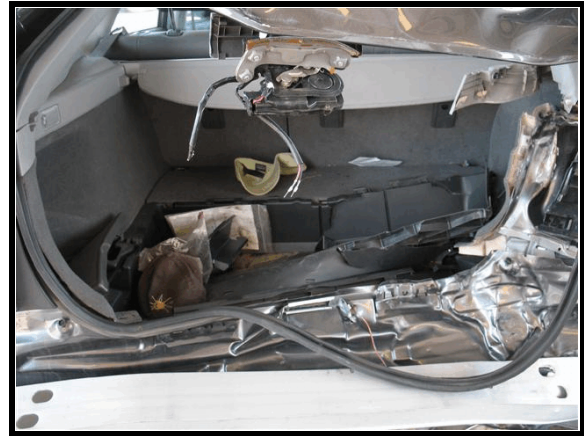
There was damage to the cargo area aft of the rear seat and the traction battery (**Figure 6**). Aft of the battery, the Toyota was configured with a plastic liner that was situated above the spare tire. The liner was normally covered by a deck lid. The lid was located in the rear of the vehicle. The plastic liner was cracked and deformed forward, primarily on the right. The aft portion of the cargo area was deformed forward. The longitudinal distance from the seat back to the aft portion of the cargo area measured 90 cm (35.4 in) on the left and 53 cm (20.8 in) on the right. Since the left side was largely undamaged, the depth of crush was 37 cm (14.6 in). The distance between the aft portion of the battery and aft portion of the cargo compartment measured 46 cm (18.1 in) on the left and 19 cm (7.5 in) on the right.

**Figure 6.** Damage to cargo area

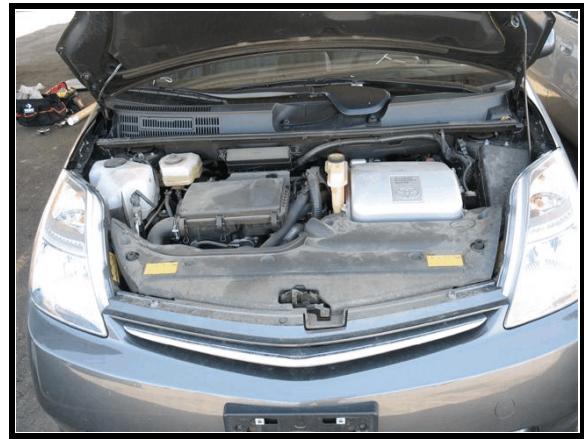
linked to an electronically controlled continuously variable transmission. An inverter/converter in the engine compartment boosts and inverts the high voltage electricity from the traction battery pack to 3-phase AC electricity that drives the electric motor. The gasoline engine was positioned on the right side of the engine compartment with the electric motor mounted left of the engine (**Figure 7**).

**Figure 7.** Engine compartment configuration

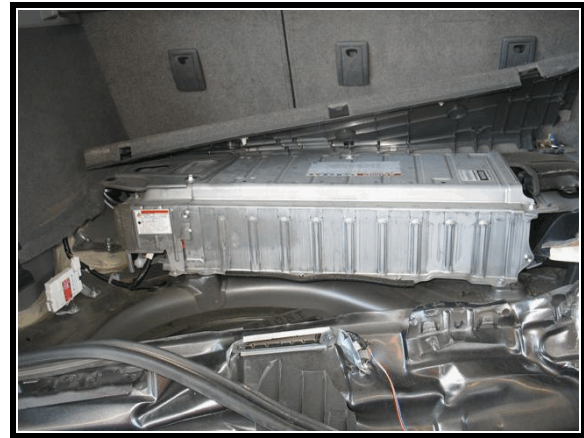
The battery system was a 201-volt Nickel Metal-Hydride (NiMH) battery that was mounted in the rear cargo floor, aft of the second row seat (**Figure 8**). This high-voltage (HV) battery system was mounted lateral to lateral in the vehicle and was concealed and protected by an aluminum cover that was bolted to the rear floor of the vehicle. Orange-colored power cables carry high voltage direct current between the HV battery pack and the inverter/converter. The cables extended along the left side of the vehicle, from the cargo area to the engine compartment.

**Figure 8.** Traction battery

- There were no indications of electrolyte spillage from the propulsion battery.
- There was no movement of the battery module.
- The isolation test was not conducted; there was no power to the vehicle.
- There were no indications of any arcing, fire or component meltdown.

This moderate severity crash was isolated to the right rear of the vehicle. There was no damage to the battery pack area and the battery had not moved. The engine compartment was not damaged. There was no evidence of damage by the first responders to the crash site.
