CALSPAN ON-SITE ROLLOVER CRASH INVESTIGATION

SCI CASE NO.: CA09015

VEHICLE: 2007 HONDA CIVIC SI COUPE

CRASH DATE: FEBRUARY 2009

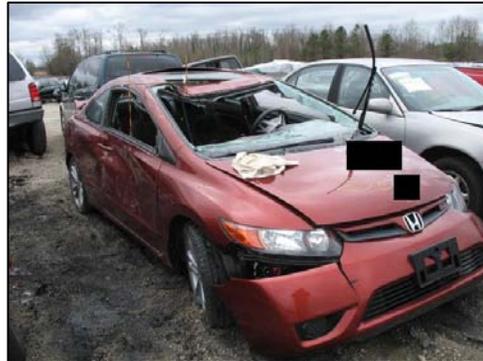
Figure 1: 2007 Honda Civic case vehicle

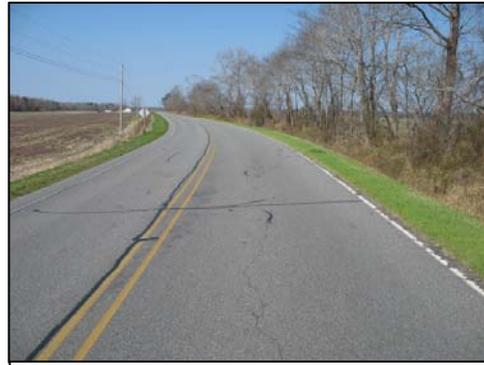
The restrained 20-year-old female driver of the Honda was on her way home from work and was traveling west on the two-lane roadway, entering the left curve (**Figure 2**). The driver stated to family, emergency, and hospital personnel that a deer ran out in front of her vehicle. The driver steered to the right to avoid the animal. The vehicle departed the right road edge at a departure angle of 10 degrees of her initial heading. A rotating tire mark from the right side tires was present on the grass shoulder and the negatively sloped embankment. The driver attempted to steer left to regain the roadway; however, the slope of the embankment induced a counterclockwise (CCW) yaw as the Honda traveled off the north road side.

Figure 2: Honda's pre-crash trajectory

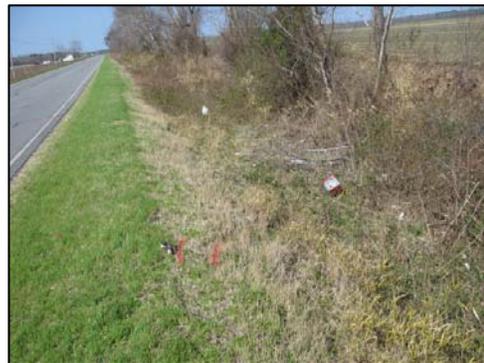
The Honda was traveling diagonal to the embankment and initiated a right side leading rollover event. Due to the slope of the embankment, the rollover initiation type was classified as a fall-over. The Honda rolled five-quarter turns to the right and rotated approximately 50 degrees counterclockwise, coming to rest on its right side at the bottom of the embankment 5.8 m (19 ft) north of the road edge. The distance from the initiation of the rollover to final rest was approximately 14 m (46 ft). **Figure 3** depicts the rollover site. The rollover site was surfaced with grass and marsh grass with weeds and thin brush.

Figure 3: Embankment and rollover site

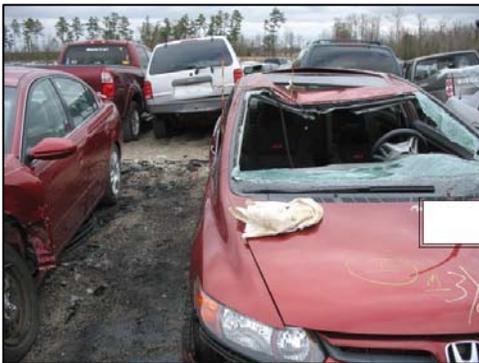
Figure 4: Vertical displacement of the windshield header.

The Honda sustained moderate severity interior damage that resulted from intrusion and driver contact. The roof and windshield header were displaced vertically, bowing more deeply towards the center of the vehicle than the outboard edges. The damaged windshield had been partially cut out of the vehicle and was unavailable for inspection.

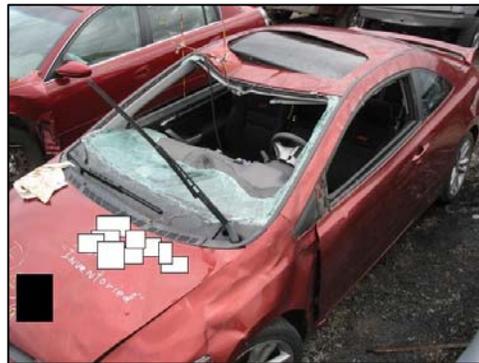
The exterior of the Honda sustained moderate severity damage to the top, right, and left side planes as a result of the rollover crash. The scratches on the roof were oriented laterally, indicating that the vehicle had rolled onto the roof only one time. The direct contact damage to the roof of the vehicle extended 119 cm (46.9 in) laterally from side rail to side rail. The longitudinal direct contact damage extended from the leading edge of the hood rearward 282 cm (111 in) to a point aft of the sunroof opening. The maximum vertical crush to the roof was 11 cm (4.3 in), located on the windshield header 30 cm (11.8 in) inboard of the right A-pillar/side rail junction. The maximum lateral crush was 2 cm (0.8 in) located at the junction of the left A-pillar and the windshield header. **Figures 4 and 5** depict the rollover damage sustained by the Honda. The Collision Deformation Classification for this rollover event was 00-TYDO-3.

Figure 5: Overall view of the rollover damage.

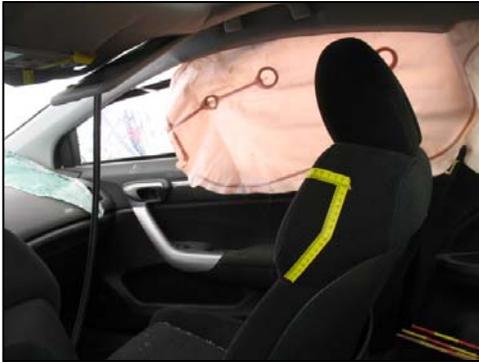
The interior of the Honda sustained damage attributed to occupant contact. There was a scuff and hair on the inboard side of the front right seat back (**Figure 6**), located 9-16 cm (3.5-6.3 in) below the top of the seat back. This contact was attributed to the right side of the driver's head. There was a body fluid transfer on the interior aspect of the left side curtain air bag, located 10-17 cm (3.9-6.7 in) up from the bottom of the curtain and 15-30 cm (5.9-11.8 in) rear of the front edge of the curtain air bag (**Figure 7**). There was a scuff and hair at the front right corner of the map light/overhead console that was also attributed to the driver's head. Her right hip/flank area engaged the center console during the rollover, displacing the console 2 cm (0.8 in) to the right.

Figure 6: Driver's head contact to the front right seat back.

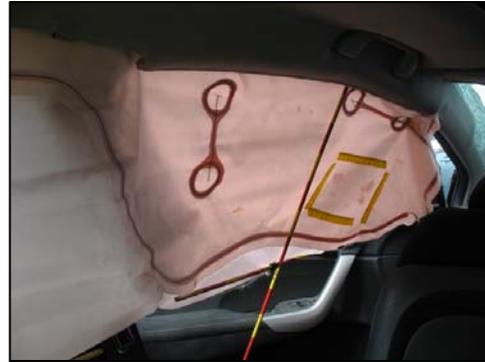
Figure 7: Body fluid transfer on the forward aspect of the left curtain air bag.

A body fluid transfer was present on the inboard side of the left IC air bag. This transfer was located 10-17 cm (3.9-6.7 in) up from the lower edge of the air bag and 15-30 cm (5.9-11.8 in) rearward of the front edge of the bag. There was a horizontally oriented plastic-type deployment transfer from the roof side rail trim located 0-18 cm (0- 7.1 in) from the top of the air bag and 23-37 cm (9.1-14.6 in) from the front edge of the IC, on the inboard side. A scuff mark was present on the outboard aspect of the IC air bag from the disintegrated glazing. This scuff mark was located 6-22 cm (2.4-8.7 in) from the top of the IC and 13-46 cm (5.1-18.1 in) rearward of the leading edge.

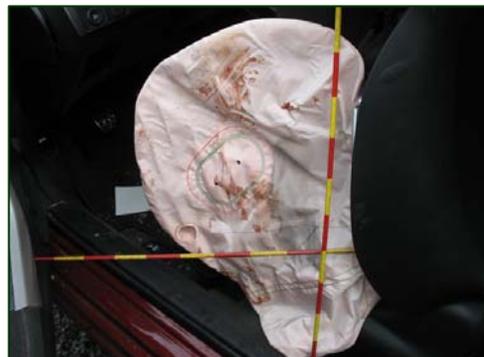
The front left side impact air bag deployed from a panel in the upper outboard aspect of the seat back that measured 37 cm (14.6 in) in height, along the front outboard edge of the seat back. The air bag was 28 cm (11 in) in width and 48 cm (18.9 in) in height and contained one tether and one vent port on the outboard side at the 8 o'clock position. There was a black plastic transfer on the outboard side of the air bag that resulted from expansion against the cover flap. This transfer was located 13-30 cm (5.1-11.8 in) from the top of the membrane, and 0-12 cm (0-4.7 in) from the back of the air bag, on the outboard side. Body fluid was present on the outboard side of the air bag, distributed full

Figure 8. Deployed left side impact air bag.

width and height of the air bag. There was no damage or contact evidence on the inboard side of the air bag. The front right seat back air bag did not deploy. **Figure 8** is a view of the deployed left side impact air bag.

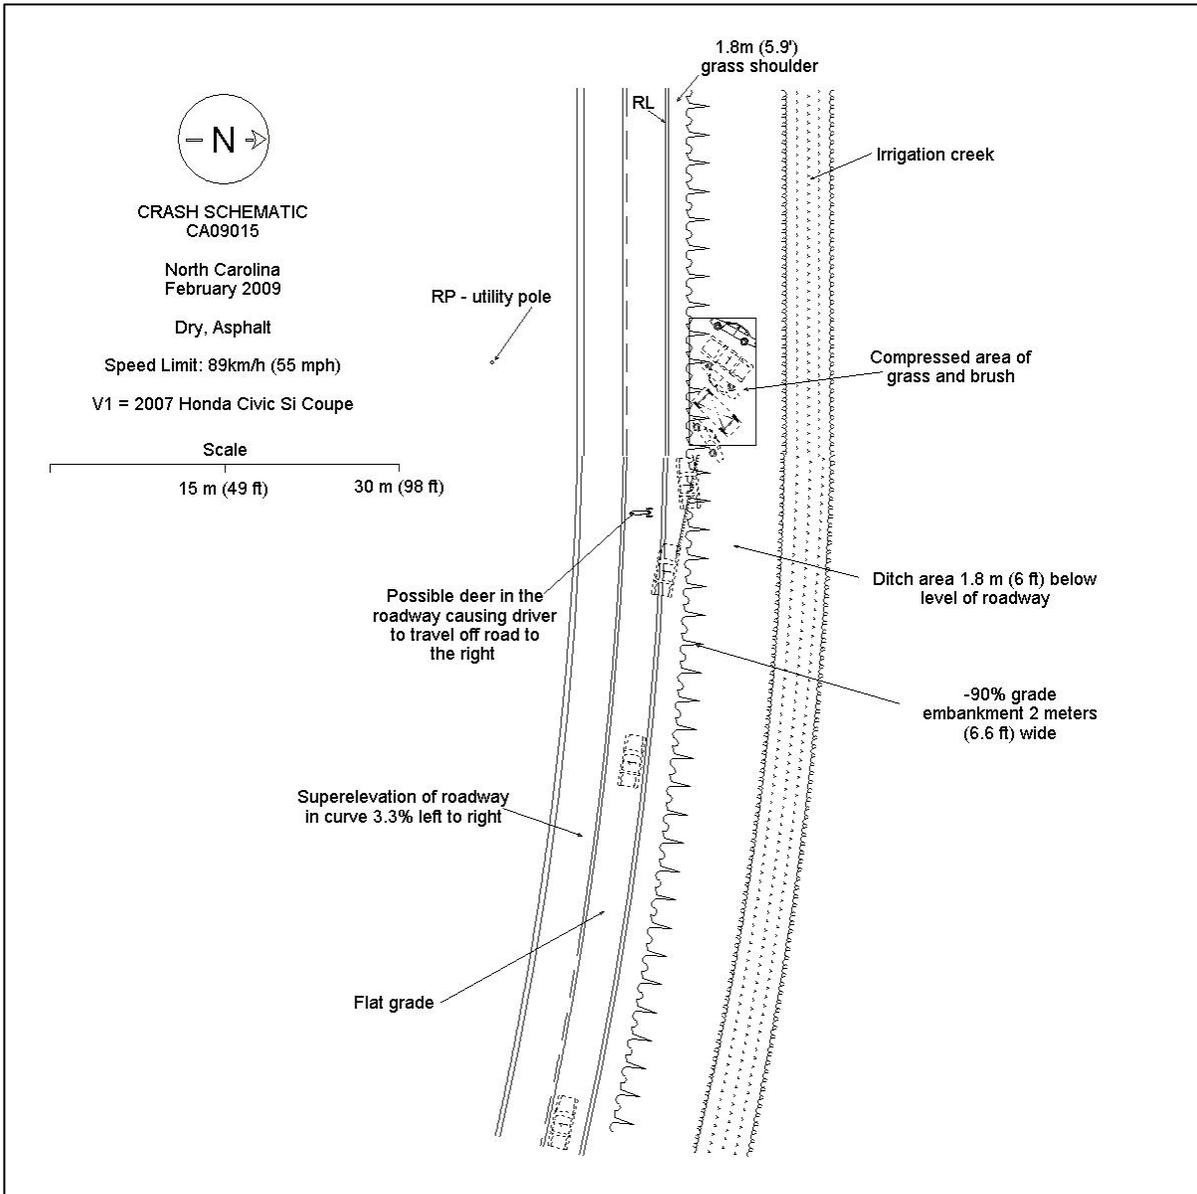
Figure 9. Crash Schematic

This crash occurred during evening hours on a two-lane east-west roadway. The traffic lanes were 3.5 m (11.5 ft) in width and were surfaced with asphalt. Narrow asphalt shoulders bordered both sides of the roadway. The north shoulder was 0.3 m (1 ft) in width and the south shoulder was 0.6 m (1.9 ft) wide. Outboard of the north shoulder was a level grass shoulder that was 1.8 m (5.9 ft) in width. This shoulder transitioned to an embankment that was 2 m (6.5 ft) in width and dropped 1.8 m (5.9 ft) for a negative grade of -90 percent. At the bottom of this embankment was a grass area with a slight negative grade of -1.6 percent. This grass area was 6.4 m (21 ft) wide and was bordered on the north side by trees and an irrigation canal. The conditions at the time of the crash were police reported as clear, dry and dark. The area was not lighted. The driver of the Honda was westbound, negotiating a curve with a documented radius of curvature of 307 m (1007

ft). The roadway was banked in the curve with a superelevation of 3.2 percent from south to north. The Crash Schematic is included as **Figure 9** of this report.
