ON-SITE ROLLOVER INVESTIGATION

CASE NUMBER - IN09016
LOCATION - TEXAS
VEHICLE - 2007 FORD F150 SUPERCREW
CRASH DATE - April 2009

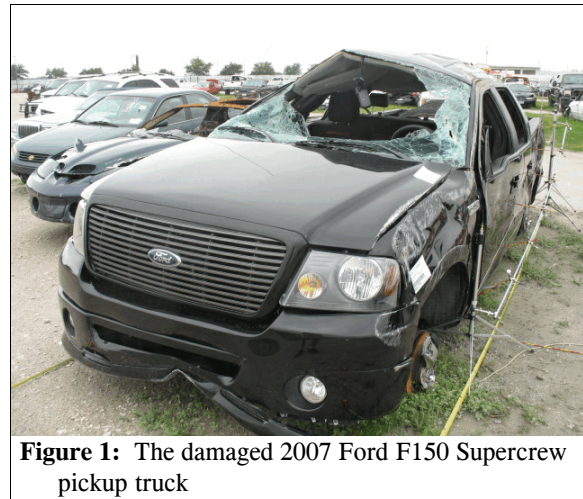
Figure 1: The damaged 2007 Ford F150 Supercrew pickup truck

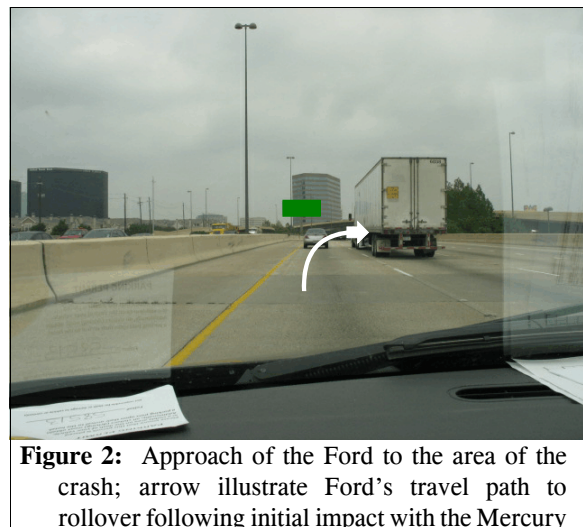
Pre-Crash: The Ford's restrained 34-year-old male driver was traveling north in the inside lane (**Figure 2**) of the roadway. The Mercury's 21-year-old male driver was traveling north in the outside lane. The police crash report stated that the Mercury's driver initiated a passing maneuver into the second lane from the right. Simultaneously, a non-contact vehicle in the third lane from the right was moving into the same lane. The Mercury's driver braked and steered and avoided a crash with the non-contact vehicle. However, the Mercury lost directional control and entered the Ford's travel lane.

Figure 2: Approach of the Ford to the area of the crash; arrow illustrate Ford's travel path to rollover following initial impact with the Mercury

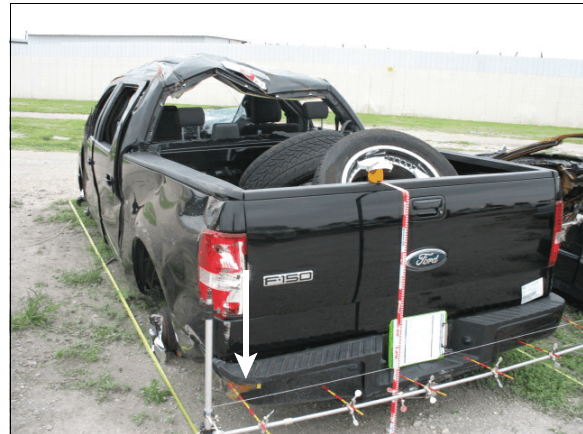
Figure 3: Arrow shows damage to Ford's back bumper from the impact with concrete traffic barrier (event 4)

The initial barrier impact (event 4) involved the back plane. The direct damage began at the left bumper corner and extended 11 cm (4.3 in) along the bumper. The crush measurements were taken at the bumper level (**Figure 3**) and the maximum residual crush was 6 cm (2.4 in) occurring at C_1 . Induced damage from this impact involved the lower left bed, directly forward of the back bumper, and the remainder of the back bumper. The table below shows the back bumper crush profile.

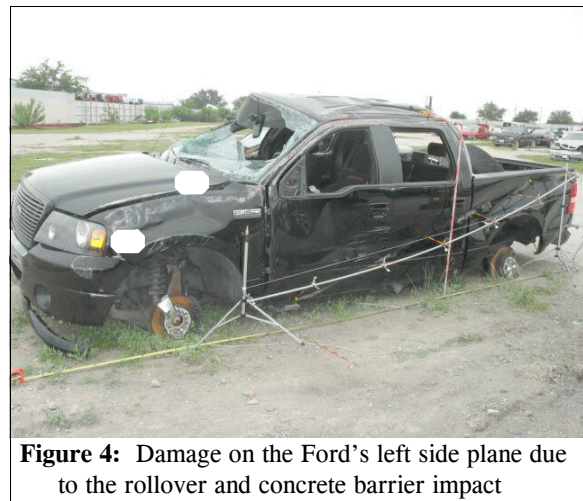
Figure 4: Damage on the Ford's left side plane due to the rollover and concrete barrier impact

The direct damage on the left side plane (**Figure 4**) began at the front left bumper corner and extended, 532 cm (209 in) rearward to the back of the truck bed. The left fender, both doors, and the left side of the truck bed were directly damaged.

The second impact to the same barrier (event 5) involved the Ford's left side plane (**Figure 4**). The direct damage involved both doors and the truck bed. The direct damage began 94 cm (37 in) rear of the left front axle and extended 285 cm (112.2 in) rearward along the left side. Due to the angle of the damage, the crush measurements were taken diagonally from just above the sill to the top of the bed. The maximum residual crush was 6 cm (2.4 in) occurring at C_1 . The induced damage involved the left side doors and the bed. The table below shows the left side crush profile.

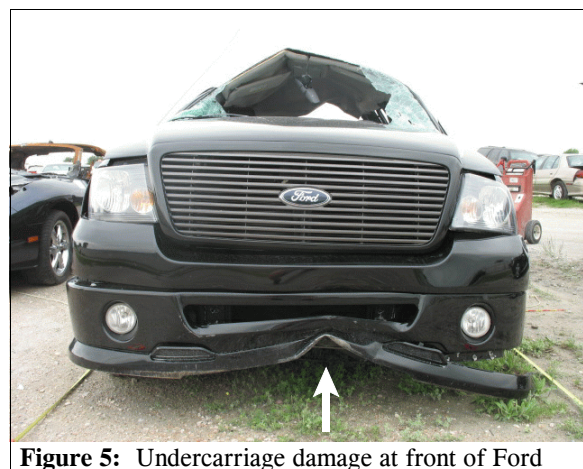
Figure 5: Undercarriage damage at front of Ford

The third impact to the same barrier involved the undercarriage (event 6). The lower portion of the front spoiler (**Figure 5**) and the undercarriage were directly damaged.

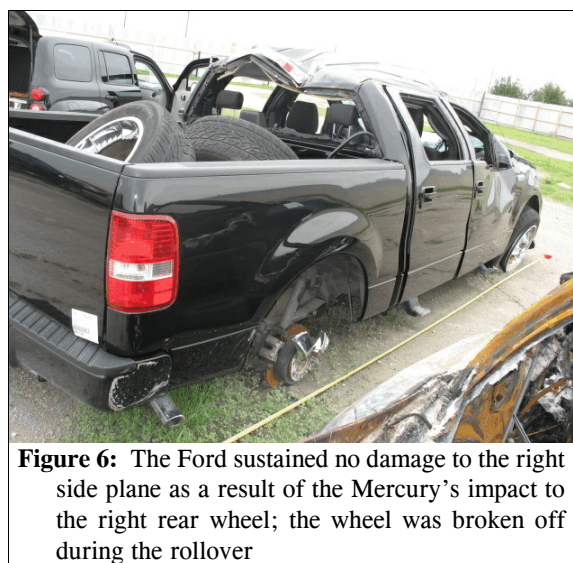
Exterior Damage: The damage from the impact with the Mercury (event 1) involved the right rear wheel. The wheel broke off the vehicle during the rollover and there was no crush on the right side plane related to this impact (**Figure 6**).

The damage from the rollover (event 3) involved the vehicle's top plane and both side planes (**Figures 4 and 6**). The direct damage on the top plane began at the front left corner of the hood and extended 522 cm (206 in) to the back left corner of the truck bed. It involved the full width of the roof, 127 cm (50 in). The hood, roof, and the top left side of the truck bed were directly damaged.

Figure 6: The Ford sustained no damage to the right side plane as a result of the Mercury's impact to the right rear wheel; the wheel was broken off during the rollover

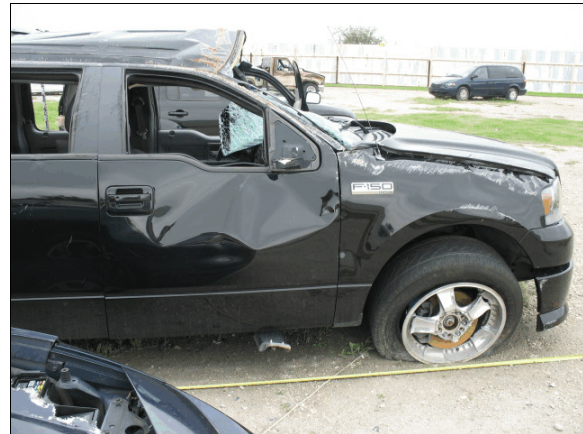
The direct damage on the right side (**Figures 6 and 7**) began 52 cm (20.5 in) forward of the right front axle and extended 382 cm (150 in) rearward along the upper right side to the end of the passenger compartment. There was no other direct damage on the right side plane except for the right side of the rear bumper (**Figure 6**). The induced damage involved the right front door. The maximum lateral and vertical crush occurred at the top of the right A-pillar (**Figure 8**) and were 13 cm (5.1 in) and 10 cm (3.9 in), respectively.

Figure 7: Damage from the rollover on the vehicle's right side and roof

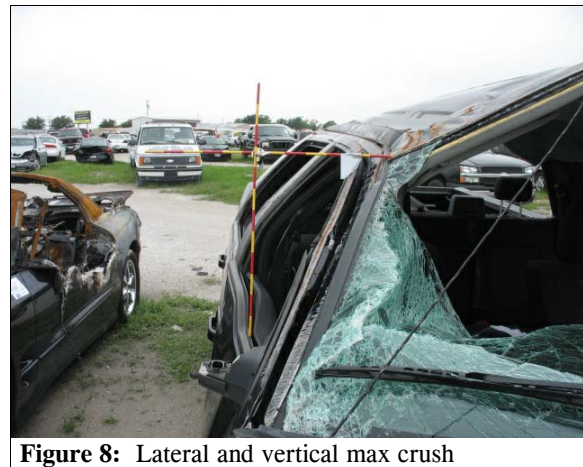
Figure 8: Lateral and vertical max crush

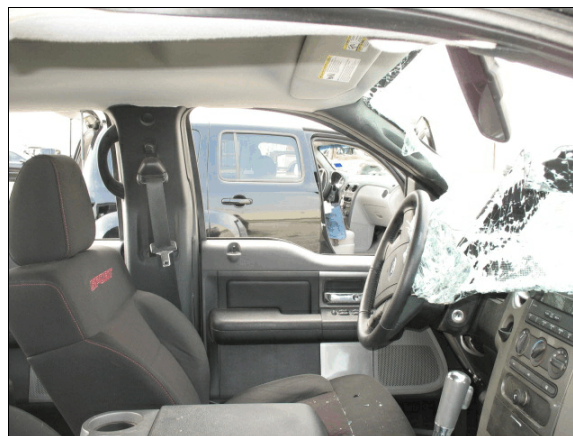
Vehicle Interior: The inspection of the Ford's interior (**Figure 9**) revealed no discernable evidence of occupant contact. The Ford's left rear door was jammed shut. The remaining doors remained closed and operational. The pre-crash status of all the window glazings was either closed or fixed. The windshield was in place and cracked from impact forces, while all the remaining window glazings were disintegrated due to impact forces.

Figure 9: The driver's seating area

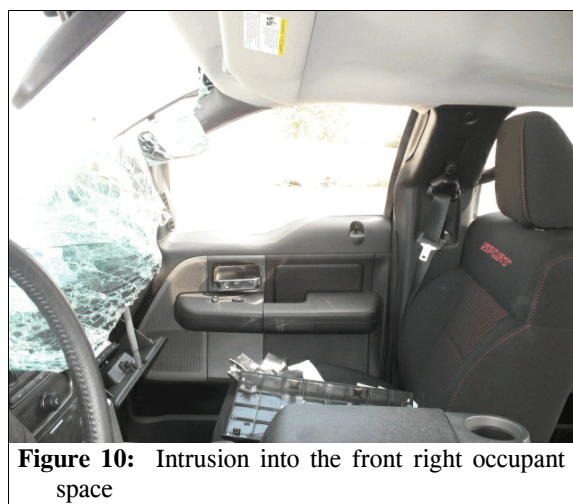
The vehicle's passenger compartment sustained 14 intrusions. The most severe intrusions involved the right A-pillar, B-pillar, and roof. The B-pillar and roof intruded vertically (**Figure 10**) into the front right occupant space 40 cm (15.7 in) and 28 cm (11 in), respectively. The A-pillar intruded laterally 13 cm (5.1 in).

Figure 10: Intrusion into the front right occupant space
