On-Site Hybrid Vehicle Investigation  
Dynamic Science, Inc. (DSI), Case Number DS09018  
2007 Toyota Prius  
California  
January 2009

1. Report No. DS09018		2. Government Accession No.		3. Recipient Catalog No.	
4. Title and Subtitle  On-Site Hybrid Vehicle Investigation				5. Report Date April 7, 2010

**Dynamic Science, Inc.  
Crash Investigation  
Case Number: DS09018**

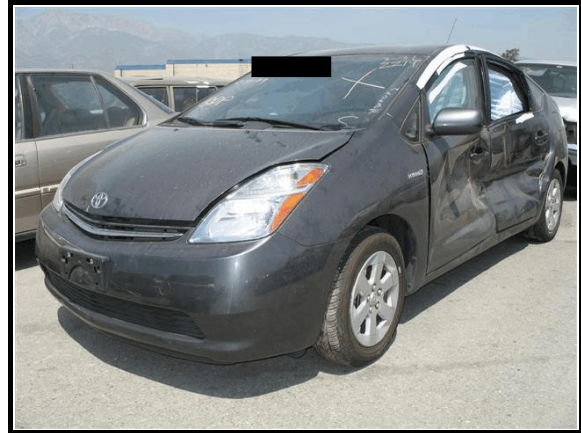
**Figure 1.** 2007 Toyota Prius, left side damage

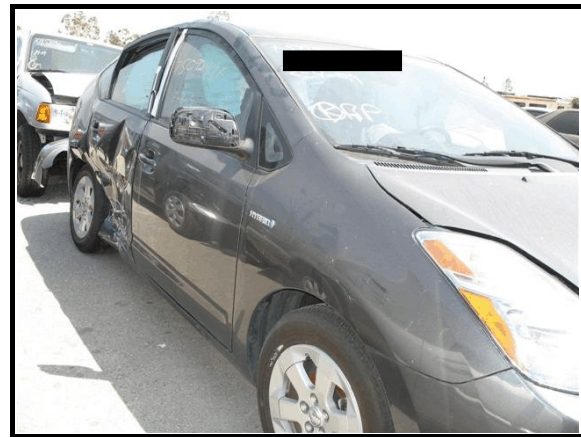
**Figure 2.** 2007 Toyota Prius, right side damage

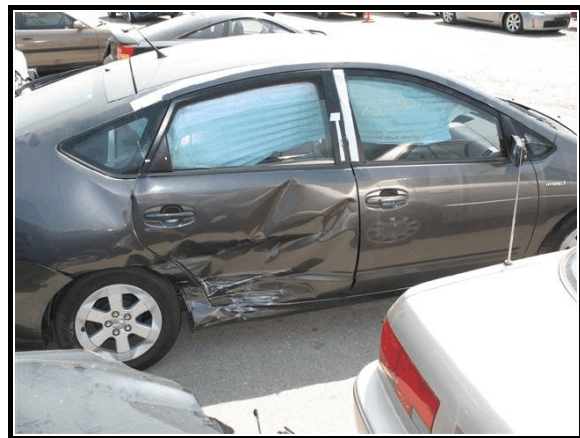
The Prius sustained minor right side plane damage from the impact with the Camry (**Figure 5**). The direct damage began 47.0 cm (18.5 in) aft of the rear axle and extended 140.0 cm (55.1 in) forward along the right side plane. The right rear tire was deformed and had a negative camber of 9 degrees. The combined direct and induced damage began 47.0 cm (18.5) aft of the rear axle and extended 168.0 cm (66.1 in) forward along the right side plane. Six crush measurements were documented at the mid-door level as follows:  $C_1 = 0$  cm,  $C_2 = 2.0$  cm (0.8 in),  $C_3 = 6.0$  cm (2.4 in),  $C_4 = 11.0$  cm (4.3 in),  $C_5 = 8.0$  cm (3.1 in),  $C_6 = 0$  cm. The height of the maximum lateral crush was 47.0 cm

**Figure 5.** Right side damage

(18.5 in) from the ground and was located at C4. The Door Sill Differential (DSD) was 8.0 cm (3.1 in). The Collision Deformation Classification (CDC) for the impact with the Camry was 02RPEW2.

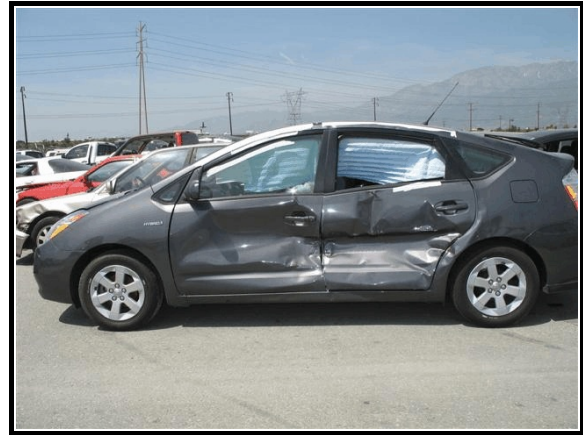
The Prius sustained moderate left side plane damage from the impact with the Journey (**Figure 6**). The direct damage began 28.0 cm (11.0 in) forward of the rear axle and extended 199.0 cm (78.3 in) forward along the left side plane. The combined direct and induced damage began 9.0 cm (3.5 in) forward of the rear axle and extended 219.0 cm (86.2 in) forward along the left side plane. Six crush measurements were documented at the mid-door level as follows:  $C_1 = 0$  cm,  $C_2 = 14.0$  cm (5.5 in),  $C_3 = 19.0$  cm (7.4 in),  $C_4 = 17.0$  cm (6.7 in),  $C_5 = 9.0$  cm (3.5 in),  $C_6 = 0$  cm. The height of the maximum lateral crush was 60.0 cm (23.6 in) from the ground and was located 119.0 cm (46.8 in) forward of the rear axle at the B-pillar. The DSD was 12.0 cm (4.7 in). The CDC for the impact with the Journey was 09LPEW2.

**Figure 6.** Left side damage

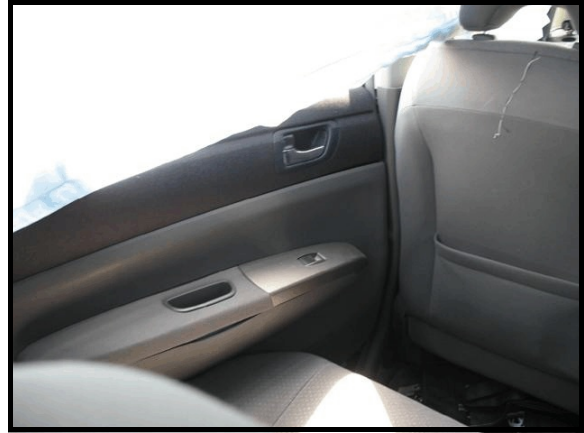
The Prius sustained minor interior damage as a result of passenger compartment intrusion (**Figure 7**). The left front and rear doors and B-pillar sustained lateral intrusion. The specific intrusions were as follows:

<b>Row</b>	<b>Position</b>	<b>Intruded Component</b>	<b>Magnitude of Intrusion</b>	<b>Direction</b>
1	Left	B-pillar	9.0 cm (3.5 in)	Lateral
1	Left	Door, rear upper quadrant	8.0 cm (3.1 in)	Lateral
2	Left	Door, forward upper quadrant	7.0 cm (2.8 in)	Lateral
1	Left	Seat back	1.0 cm (0.4 in)	Lateral

**Figure 7.** Left interior intrusion

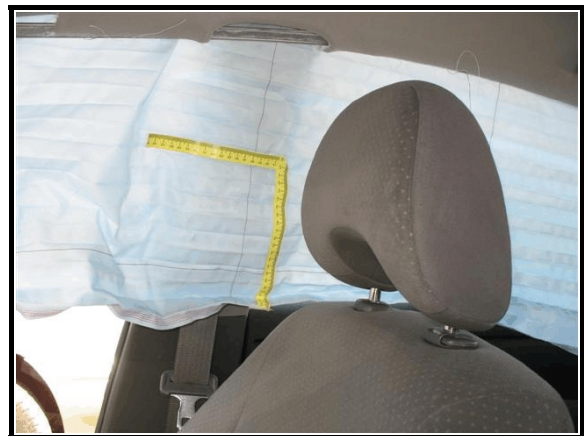
The right IC air bag deployed during the impact with the Camry (**Figure 8**). The right seat-mounted side air bag did not deploy. This was probably because the damage was located primarily near the C-pillar sensor. The right IC air bag deployed vertically from roof cladding. The curtain measured 172.0 cm (67.7 in) in length and 45.0 cm (17.7 in) in height. It provided coverage for both the first and second row of the vehicle and extended vertically 4.0 cm (1.6 in) below the side glass. The curtain was attached to the left A-pillar by a 27.0 cm (10.6 in) sail. There was a smear, which was suspected to be a hair oil transfer, that measured 16.0 cm (6.3 in) in width and 20.0 cm (7.9 in) in

**Figure 8.** Right side curtain air bag

height; the transfer was located at the B-pillar and extended down to the bottom edge of the air bag. A 6.0 cm (2.4 in) longitudinal transfer was located 49.0 cm (19.2 in) aft of the front aspect of the air bag and 4.0 cm (1.6 in) below the roof cladding.

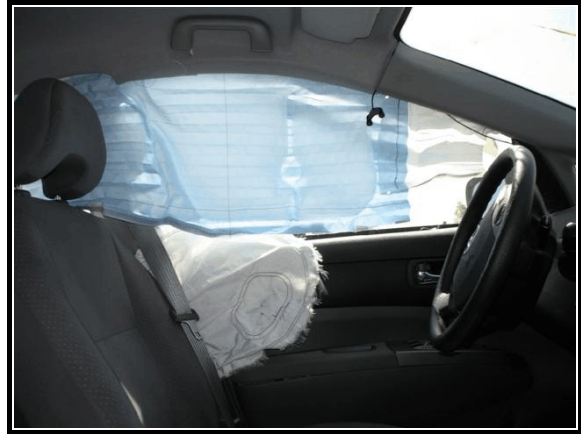
The left IC air bag and the left seat-mounted side air bag deployed during the impact with the Journey (**Figure 9**). The left IC air bag deployed vertically from the roof cladding and was of the same dimensions as the right IC air bag. There were no indications of damage or contact to the curtain. The side air bag deployed longitudinally from the driver's seat back. The air bag extended 40.0 cm (15.7 in) in length and 40.0 cm (15.7 in) in height. Three vent ports were located at the forward aspect of the air bag. A 2.0 x 4.0 cm (0.8 x 1.6 in) scuff was located 7.0 cm (2.8 in) aft of the forward aspect of the air bag.

**Figure 9.** Left IC air bag and side air bag

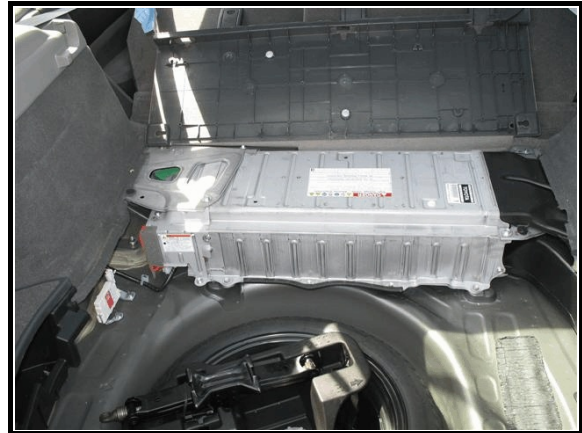
**Figure 10.** Traction battery

The battery system was a 201-volt Nickel Metal-Hydrate (NiMH) battery that was mounted in the rear cargo floor, aft of the second row seat (**Figure 10**). This high-voltage (HV) battery system was mounted lateral to lateral in the vehicle and was concealed and protected by an aluminum cover that was bolted to the rear floor of the vehicle. Orange color power cables carry high voltage direct current between the HV battery pack and the inverter/converter.

- There were no indications of electrolyte spillage from the propulsion battery.
- There was no movement of the battery module.
- The isolation test was not conducted; there was no power to the vehicle or to the traction battery.
- There were no indications of any arcing, fire or component meltdown.

This moderate severity crash was isolated to the left and right sides of the vehicle. There was no damage to the battery pack area and the battery had not moved. The engine compartment was not damaged. There was no evidence of damage by the first responders to the crash site.
