CRASH DATA RESEARCH CENTER
Calspan Corporation
Buffalo, NY 14225

CALSPAN ON-SITE ROLLOVER CRASH INVESTIGATION
SCI CASE NO: CA09018

VEHICLE: 2008 FORD TAURUS X
LOCATION: PENNSYLVANIA
CRASH DATE: JANUARY, 2009

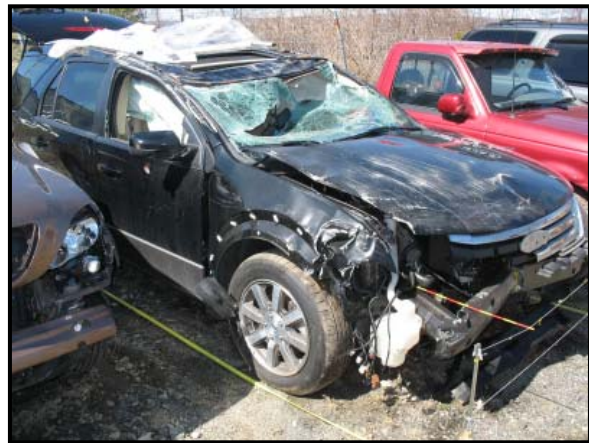
Figure 1: Front right oblique view of the Ford Taurus X.

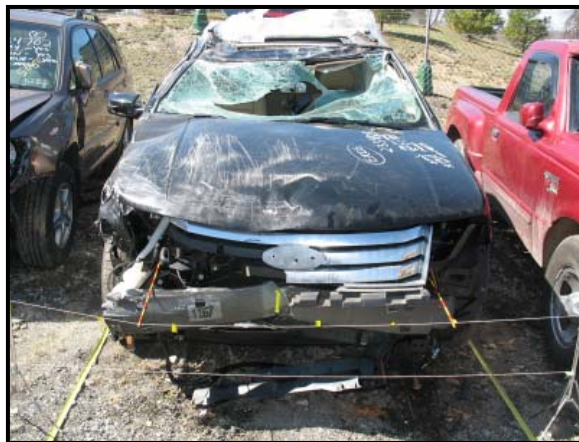
The front plane of the Ford sustained moderate severity damage from the impact with the Saturn (Event 1). The direct contact damage was biased to the front right aspect of the vehicle beginning at the centerline and extended 79 cm (31.1 in) to the right bumper corner. The damage consisted of longitudinal deformation to the frontal structure. The maximum crush was located at C4, 51 cm (20.0 in) inboard of the right bumper beam corner and was 24 cm (9.4 in) in depth. The deformation from this impact was captured by documenting a crush profile across the 127 cm (50.0 in) wide bumper beam and was follows: C1 = 0 cm, C2 = 16 cm (6.3

Figure 4: Front view of the Ford.

in), C3 = 24 cm (9.4 in), C4 = 24 cm (9.4 in), C5 = 21 cm (8.3 in), C6 = 6 cm (2.4 in). In addition to the longitudinal crush, there was slight lateral displacement of the frame rails from the 11 o'clock direction of force. The left frame rail was displaced to the right 4 cm (1.7 in) and the right frame rail was displaced 7 cm (2.7 in) to the right. The Collision Deformation Classification (CDC) for this impact was 11-FZEW1.

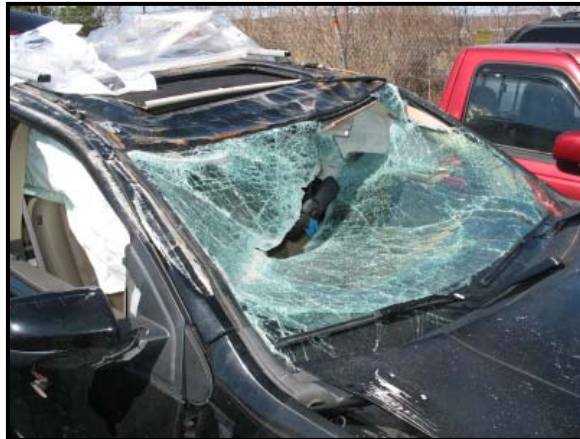
The Ford rotated CW as it separated from the Saturn, tripped, and rolled over two-quarter turns onto its roof (Event 2). This event resulted in moderate damage to the left and top planes of the vehicle that consisted of abrasions and vertical crush to the right A-pillar, windshield header and front roof areas. The surface abrasions were noted on the side rails, roof, and the hood. The maximum vertical crush measured 11 cm (4.5 in) located at the junction of the right A-pillar and windshield header. The maximum lateral crush was located at the right A-pillar/header junction and was an estimated 3 cm (1 in). The CDC for this event was 00-TDDO2.

Figure 5: Ford roof deformation as a result of the rollover.

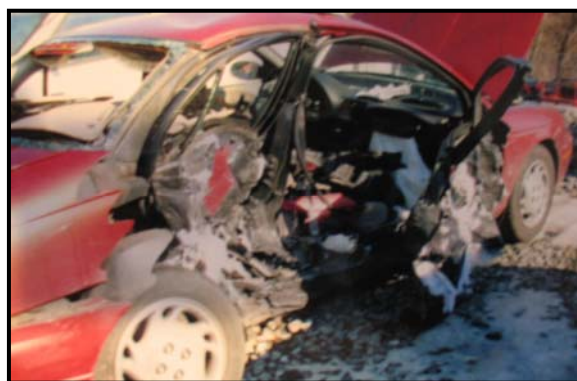
The damage assessment for the Saturn was derived from the single image that was provided by the Ford driver to the SCI investigator. Refer to **Figure 6**. The right side of the Saturn exhibited severe damage from the impact with the Ford. The damage was centralized within the passenger compartment area of the vehicle. The side panels of the Saturn were constructed of a composite material and had fractured. The composite panels over of the doors were fractured and separated from the vehicle. Severe crush was noted to the lower aspect of the right B-pillar and was estimated to be 51 cm (20 in). The right side door also exhibited lateral crush; however, the right front door appeared to have been pried open post-crash. The estimated CDC for this impact was 02-RDAW4.

Figure 6: Right oblique view of the Saturn supplied by the driver of the Ford.

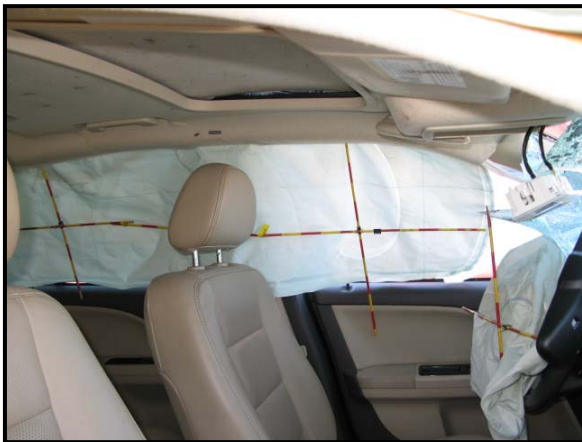
The Ford was equipped with rollover sensing IC air bags that were mounted in the roof side rails and provided coverage to the six outboard seat positions. As a result of the rollover event, both IC air bags deployed from the respective roof side rails. **Figures 7 and 8** are interior images depicting the deployed curtain air bags.

Figure 7: Deployed left curtain air bag.

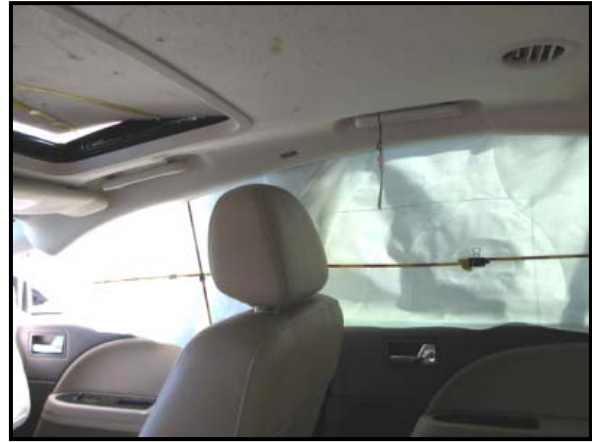
Figure 8: Deployed right curtain air bag.

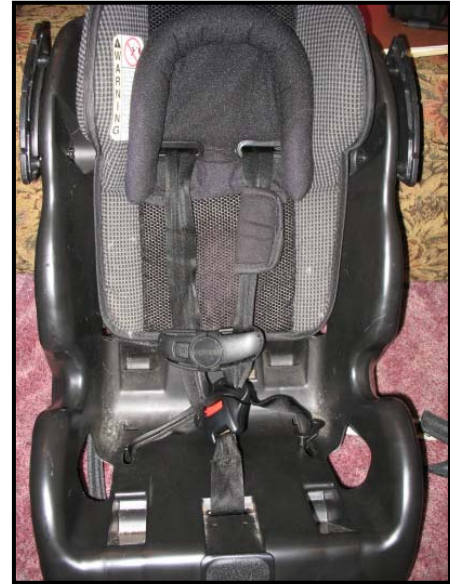
Figure 9: Cosco Alpha Omega CSS.

The CSS was inspected at the driver's residence and had been disassembled prior to SCI involvement in the investigation. Reportedly, it had been disassembled by the family after the crash, as they looked for the serial and model numbers to give to their insurance company. The SCI examination of the CSS was unremarkable for damage. No stress marks were identified on the shell. Subtle abrasions were observed at the forward facing belt path from interaction with

the safety belts. The internal harness strap was twisted and roped in the left buckle clip. There were no indications of stress or damage to the internal harness. The buckle and harness retainer clip were operational.

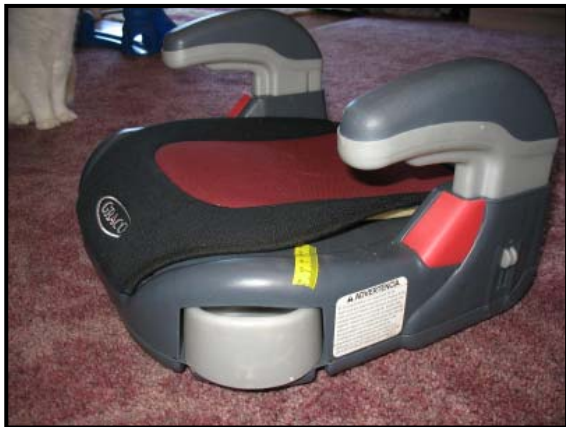
Figure 10: Graco booster CSS.

Examination of the booster seat was unremarkable for crash related damage. A minor 3 cm (1 in) stress mark to the seat was observed on its left aspect forward of the belt path. This stress mark did not appear to be crash related due to its forward location.
