ON-SITE SIDE IMPACT INFLATABLE OCCUPANT PROTECTION INVESTIGATION

CASE NUMBER - IN09020

VEHICLE - 2008 CADILLAC STS

CRASH DATE - June 2009

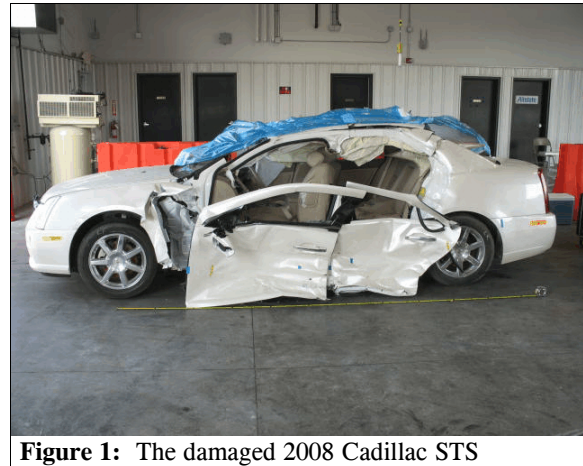
Figure 1: The damaged 2008 Cadillac STS

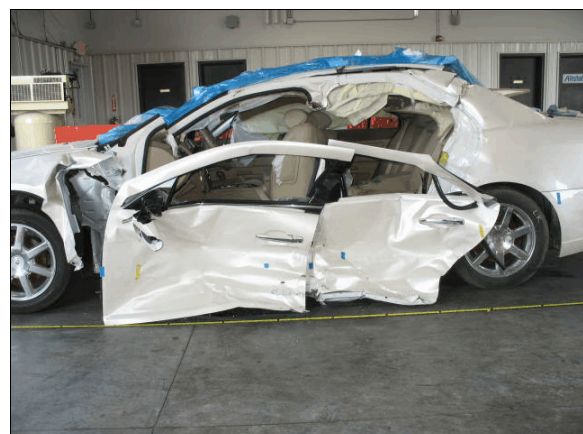
Crash: The front plane of the Dodge impacted the left side plane of the Cadillac (**Figure 4**). The force direction on the Cadillac was within the 10 o'clock sector and the impact force was sufficient to trigger the deployment of the driver's seat-mounted side impact air bag and the IC air bag. The right IC air bag also deployed. The impact caused the Cadillac to rotate counterclockwise 100 degrees as it traversed 13 m (42.6 ft) in a northeast direction to its final rest position in the median heading west (**Figure 5**). The Dodge rotated counterclockwise approximately 15 degrees as it traversed 14 m (45.9 ft) in a northeast direction to its final rest position partially on the inside shoulder and inside eastbound lane heading northeast (**Figure 5**).

Figure 4: Damage to the left side plane of the Cadillac from the impact with the front of the Dodge

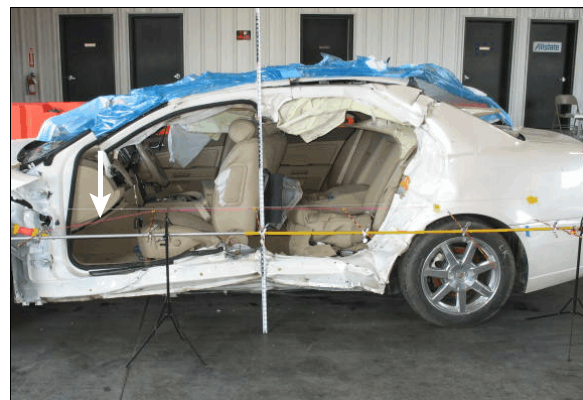
Exterior Damage: The impact with the Dodge involved the left side plane of the Cadillac. The left front and left rear doors were directly damaged. The direct damage began 74 cm (29.1 in) rear of the left front axle and extended 199 cm (78.3 in) along the left side. The crush profile (Figures 6 and 7) was based on measurements taken on the removed left front and left rear doors as well as comparison measurements taken on the vehicle's undamaged right side. The maximum residual crush was determined to be 32 cm (12.6 in) occurring at C₃. The height of the maximum door crush was 71 cm (28 in) and the Door Sill Differential was 25 cm (9.8 in). The Cadillac's left wheelbase was reduced 5 cm (2 in) while the right wheelbase was extended 1 cm (0.4 in). The induced damage involved the left A-pillar, left roof side rail, sill, and the left quarter panel. The left fender was deformed during the removal of the left side doors. Rescue personnel also cut the left and right A-, B-, and C-pillars. The table below shows the vehicle's right side crush profile.

Figure 6: Arrow shows the string representing the crush on the Cadillac's left front and left rear doors

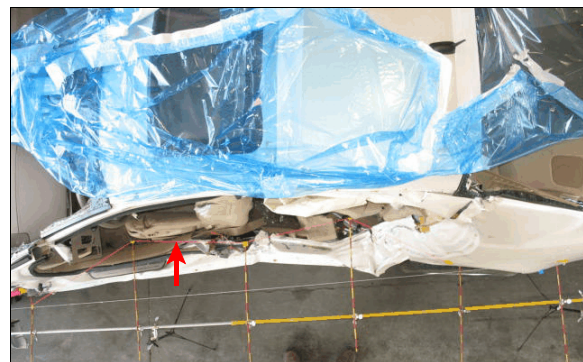
Figure 7: Top view of the Cadillac's left side crush profile represented by the string (arrow)

Damage Classification: The Collision Deformation Classification was **10-LPAW-3 (290 degrees)** for the left side impact. The Missing Vehicle algorithm of the WinSMASH program calculated the Cadillac's total Delta V as 25 km/h (16 mph). The longitudinal and lateral velocity changes were -8.6 km/h (-5.3 mph) and 23.5 km/h (14.6 mph), respectively. The results were based only on the Cadillac's crush profile and should be considered as a borderline reconstruction of the vehicle's Delta V. The Cadillac's EDR recorded the maximum longitudinal and lateral Delta Vs as 5.46 km/h (3.39 mph) and 27.28 km/h (16.95 mph), respectively.

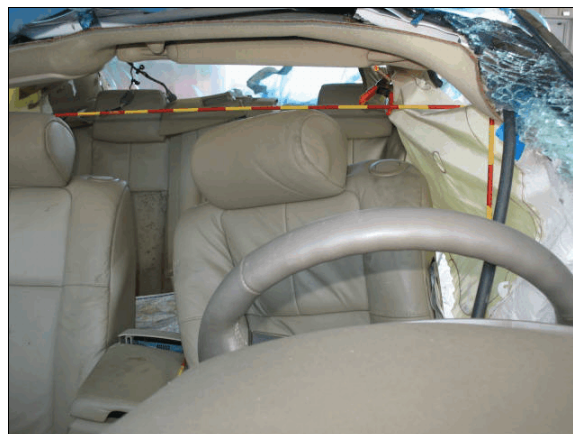
The passenger compartment sustained 15 intrusions. The most severe intrusions into the driver's occupant space involved the forward lower quadrant of the left front door, the left B-pillar, and the driver's seat back (Figures 8 and 9). These components intruded laterally 18 cm (7.1 in), 16 cm (6.3 in), and 16 cm (6.3 in), respectively. Due to the removal of the left front door and B-pillar, the intrusion values of these two components were estimated from measurements taken on the removed components and the undamaged right side.

Figure 8: Lateral displacement of the driver's seat back

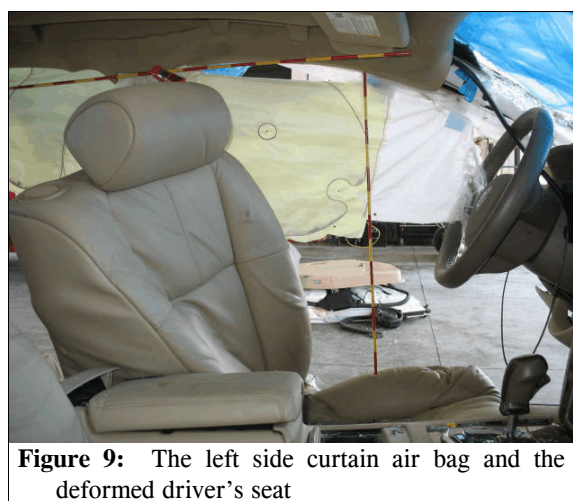
Figure 9: The left side curtain air bag and the deformed driver's seat

The left IC air bag (**Figure 9**) was located along the left roof side rail inside the headliner and extended from the A- to the C-pillar. The IC air bag was designed with inflation chambers adjacent to the driver and second row left seat positions. There were no visible external vent ports. The deployed IC air bag was 140 cm (55.1 in) in width and 40 cm (15.7 in) in height. A triangular fabric panel 37 cm (14.6 in) in width and 33 cm (13 in) in height was present at the front of the air bag and closed the gap between the air bag and the A-pillar. The front and back portions of both the left and right IC air bags had been cut and damaged during rescue operations. The fold creases on the air bag indicated that it had been folded in accordion fashion within the headliner. The right IC air bag (**Figure 10**) had the same dimensions and features as the left IC air bag. Inspection of the deployed left and right IC air bags revealed no discernable evidence of occupant contact or crash related damage.

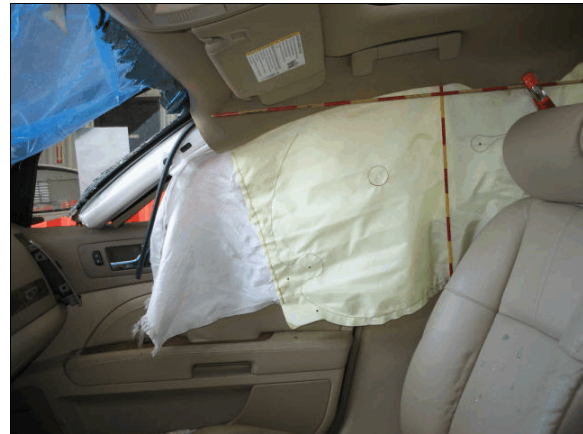
Figure 10: The right side curtain air bag

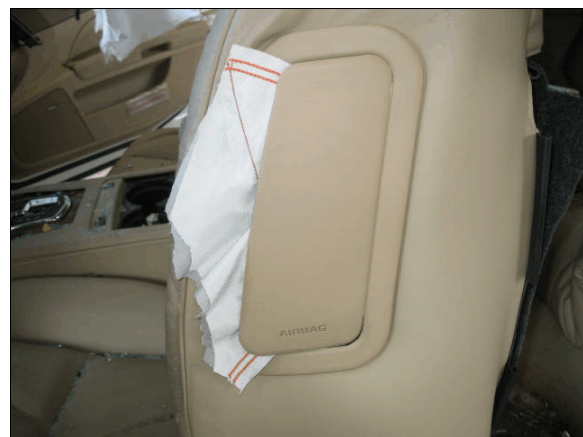
Figure 11: The driver's seat back-mounted side impact air bag was cut out of the vehicle

The seat-mounted side impact air bags were located within the outboard side of the front seat backs (**Figure 11**). The driver's seat-mounted side impact air bag deployed in this crash. It had been cut out of the vehicle prior to the inspection.

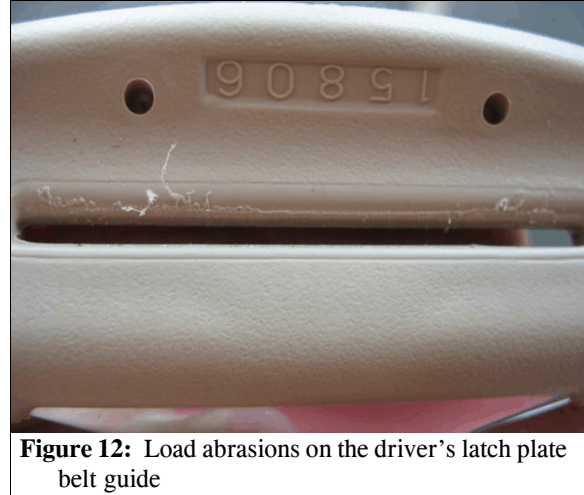
The inspection of the driver's safety belt assembly revealed that the belt webbing had been cut by rescue personnel, and the latch plate was found latched in the buckle. A light load abrasion was present on the safety belt webbing located 41 cm (16.1 in) above the stop button. Load abrasions were also present on the latch plate belt guide (**Figure 12**), and the EDR recorded the driver's safety belt switch circuit as buckled. The buckle stalk was shortened approximately 3 cm (1.2 in) due to pretensioner actuation. These findings confirmed that the driver was restrained at the time of the crash.

Figure 12: Load abrasions on the driver's latch plate belt guide
