**CALSPAN ON-SITE SIDE IMPACT INFLATABLE OCCUPANT  
PROTECTION SYSTEM CRASH INVESTIGATION**

**SCI CASE NO: CA09021**

**VEHICLE: 2007 HONDA CIVIC**

**CRASH DATE: MARCH 2009**

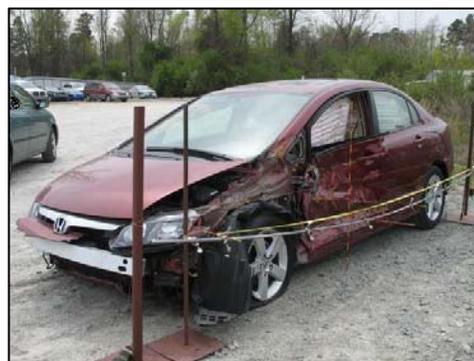
The exterior of the Honda sustained moderate severity damage to the left plane and right wheels as a result of this multiple impact crash. The left plane sustained sideswipe-type impact damage from contact with the front plane of the Chevrolet (Event 1). The direct damage began 55 cm (21.7 in) aft of the left rear axle position and extended forward 370 cm (145.7 in). The maximum crush measured 10 cm (3.9 in) in depth and was located at C4, 167 cm (65.7 in) forward of the left rear axle. The height of the maximum crush was 40 cm (15.7 in) above ground level. The height of the sill under the maximum crush location was 25 cm (9.8 in) and the resulting Door Sill Differential (DSD) was 10 cm (3.9 in). The direct contact damage extended 12 cm (4.7 in) above the belt line onto the A-pillar. The crush profile for the resultant damage of the initial impact was as follows: C1 = 0 cm, C2 = 0 cm, C3 = 2 cm (0.8 in), C4 = 10 cm (3.9 in), C5 = 4 cm (1.6 in), C6 = 0 cm. The Collision Deformation Classification (CDC) assigned for this impact was 12-LDAS-2. **Figure 3** depicts the left side damage sustained by the Honda.

**Figure 3: Front left view of the left side damage to the Honda.**

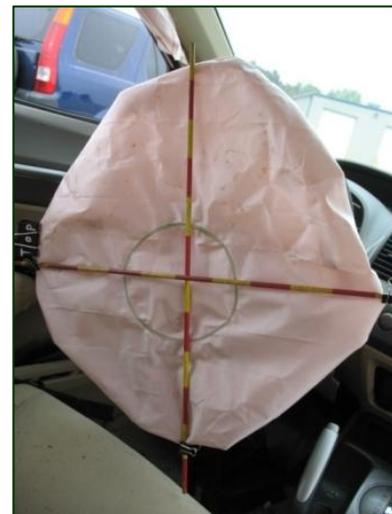
The Honda was equipped with a Certified Advanced 208-Compliant (CAC) frontal air bag system. The driver's air bag was concealed within the center hub of a 3-spoke steering wheel by a tri-flap design. The upper flap was 13 cm (5.1 in) in width at the horizontal tear seam and 7 cm (2.8 in) in height. The two lower flaps were symmetrical with the upper aspects measuring 7 cm (2.8 in) in width at the horizontal tear seam. The outboard sides measured 7 cm (2.8 in) in height and the lower aspects measured 3 cm (1.2 in) horizontally. The air bag (**Figure 4**) measured 60 cm (23.6 in) in diameter in its deflated state. The air bag was vented by two vent ports located at the 11 and 1 o'clock positions. The air bag was tethered by two tethers located at the 12 and 6 o'clock positions on a 16 cm (6.3 in) circular seam sewn to the center of the face of the air bag. There were no occupant contact points on the air bag; however, multiple drops of spilled coffee were noted on the right half of the bag.

**Figure 4: Deployed driver's frontal air bag.**

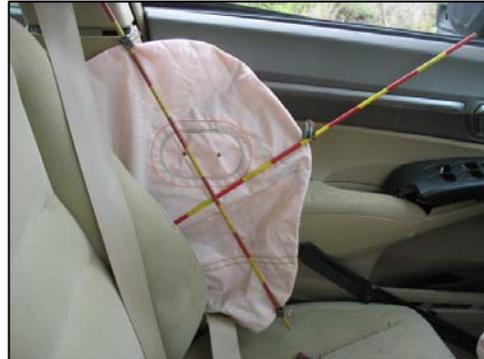
The left seat back-mounted side impact air bag deployed from the upper outboard aspect of the seat back. The air bag measured 52 cm (20.5 in) in height and 32 cm (12.6 in) in width. The air bag had one vent port on the outboard aspect at the four o'clock position. There was no contact evidence or damage on the air bag.

**Figure 5: Deployed left side impact air bag.**

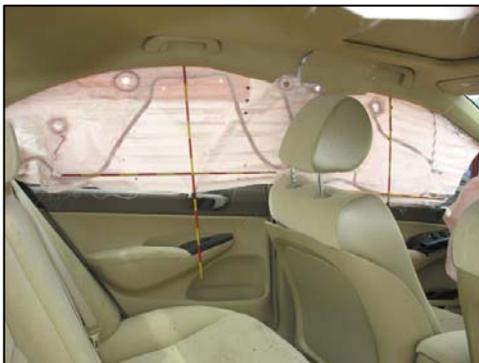
The IC air bags deployed from the roof side rails. The air bags measured 182 cm (71.7 in) in length. At the front seating positions, the IC measured 38 cm (15 in) in height and 35 cm (13.8 in) at the rear positions. The IC air bag provided coverage from the C-pillar to 22 cm (8.7 in) rear of the A-pillar. A triangular shaped void was present aft of the A-pillars. The vertical measurement of the void behind the A-pillars was 15 cm (5.9 in). Vertically, the IC air bags extended below the beltline at each outboard position. The left IC air bag was free of occupant contact points and contained multiple black deployment transfers that extended diagonally downward from right to left on the inboard aspects throughout the length of the air bag. The left roof side rail was torn at two locations. A 10 cm (3.9 in) vertical tear was located at the B-pillar, and a 5 cm (2 in) tear was present at the rear attachment point of the front left passenger grab handle. The right IC air bag was free of occupant contact points. A 14 cm (5.5 in) vertical tear was noted at the B-pillar. The IC air bags are depicted in **Figures 6 and 7**.

**Figure 6: Left side IC air bag.**

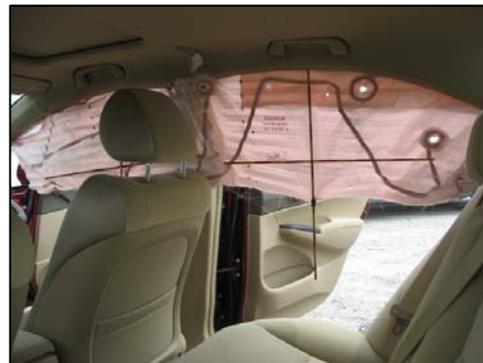
**Figure 7: Right side IC air bag.**
