CALSPAN ON-SITE CHILD RESTRAINT SYSTEM CRASH INVESTIGATION

SCI CASE NO: CA09023

VEHICLE: 2007 SATURN ION

CRASH DATE: APRIL 2009

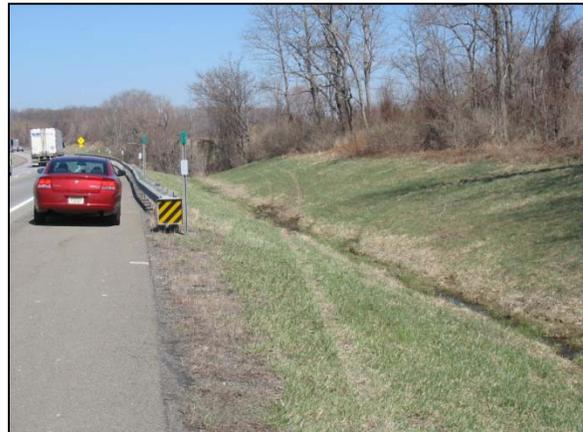
Figure 7: View of the Saturn's off-road impression's from the point of road departure.

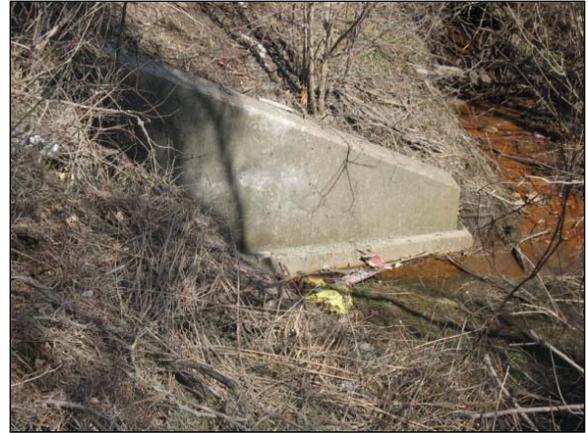
east concrete headwall of the culvert (Event 4) in a non-horizontal impact. **Figure 8** is a view of the culvert wall impacted by the Saturn. At the location of impact, the height of the angled wall measured 122 cm (48 in). The thickness of the wall measured 30 cm (12 in). The impact force resulted in the (probable) actuation of both front-row safety belt pretensioners and the deployment of the driver's air bag. The Saturn's front right passenger air bag was suppressed due to the unoccupied front right seat.

Figure 8: View of the concrete culvert wall impacted by the top plane of the Saturn.

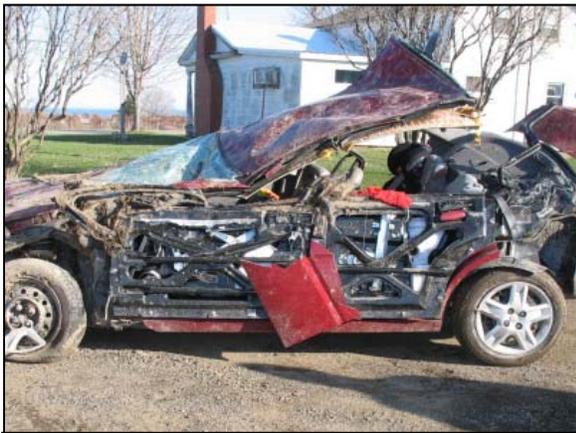
The Saturn's hood, windshield, and A-pillar area then impacted the wall (Event 4) which resulted in vertical crush to the pillars, windshield header and roof. **Figure 9** is a left side view of the damaged Saturn. The non-horizontal impact forces, from this event, produced a maximum residual vertical crush of 35 cm (13.8) to the top left A-pillar area of the roof (**Figure 10**). The maximum residual lateral crush to this same component measured 12 cm (4.7 in). The CDC of the culvert impact was 00TYDW5.

Figure 9: Left side view of the crush to the Saturn's roof area.

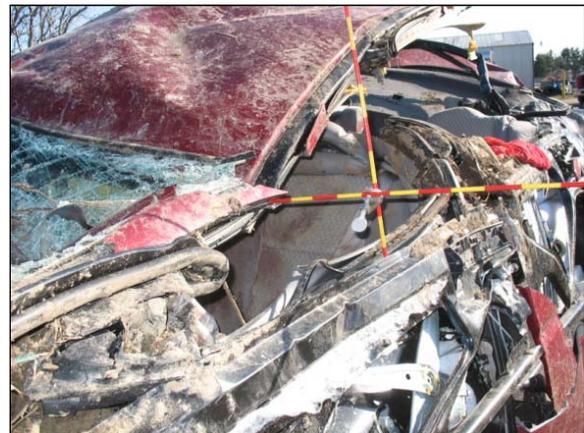
Figure 10: View of the maximum vertical and lateral crush at the Saturn's left A-pillar.

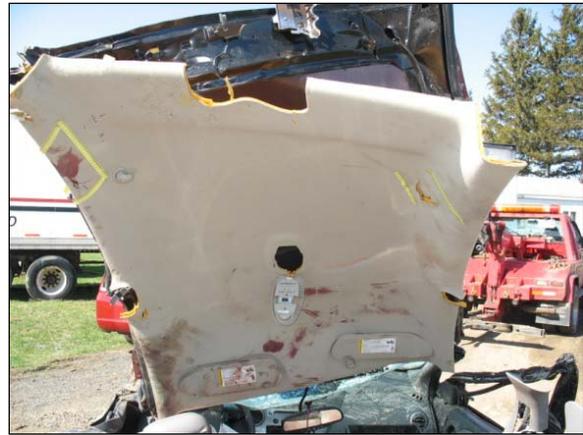
The interior damage to the Saturn consisted of deployment of the driver's frontal air bag, the actuation of the front row pretensioners, multiple vertical intrusions of the greenhouse components and occupant contact points. The occupant contacts (**Figure 11**) consisted of compression type blood transfers and scuff marks to the front row headliner, the second row left roof side rail and the second row right headliner. The contact to the second row left roof side rail also contained embedded hair strands.

Figure 11: Interior view of the Saturn's headliner and the occupant contacts.

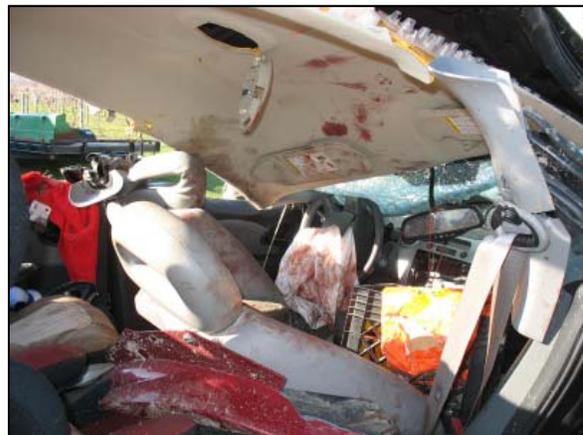
Figure 12 is a view of the front interior. The driver seat was located in the mid-to-forward track position and the seatback was reclined 30 degrees aft of vertical with the head restraint located in the full-down position. The head restraint was deformed 10 cm (4 in) from vertical intrusion of the roof. The 4-spoke tilt steering wheel was located in the full-down position. There was no deformation of the steering wheel rim and no displacement of the shear capsules. The driver's head contacted the roof headliner as evidenced by a 5 cm (2.8 in) diameter blood transfer mark and deformation of this component. No contact evidence was identified on the driver's deployed frontal air bag due to the magnitude of dripped blood from the driver's injuries.

Figure 12: View of the Saturn's interior front row.

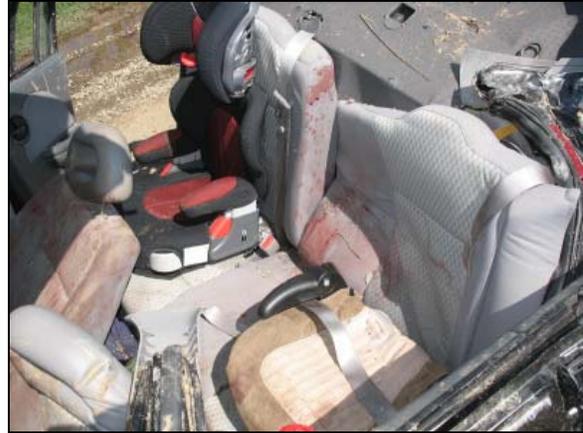
The left and center second row seatbacks were deformed and compressed 13 cm (5.1 in) downward from vertical and lateral passenger compartment intrusions of the interior roof components (**Figure 13**). The second row left occupant's head contacted the left roof side rail as evidenced by a 12 cm (4.7 in) diameter blood transfer mark and deformation of this component which contained embedded hair. The upper aspect of the second row right CRS and the head of the occupant contacted the right roof area, as evidenced by a 10 cm (3.9 in) diameter deformation of this component, and contained a 24 cm (9.4 in) scuff mark. Refer to the CRS section below for additional detail regarding the damage to the CRS.

Figure 13: Left lateral view of the Saturn's second row.

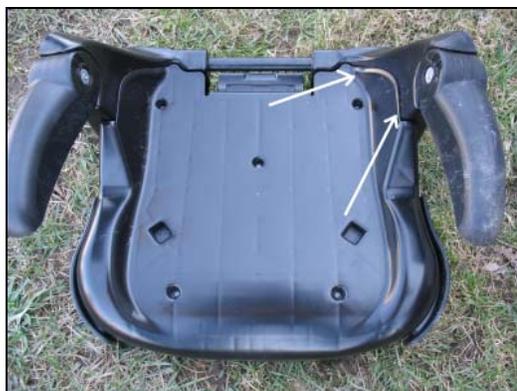
The Eddie Bower backless CRS (**Figure 15**) was manufactured on June 21, 2007 and consisted of a single black plastic shell base with adjustable plastic armrests. The CRS was labeled for use by children over 1 year of age with a height of 109 to 145 cm (43 to 57 in) and weight of 18 to 45 kg (40 to 100 lb) and were to utilize the vehicle's 3-point lap and shoulder belt. The base was covered with a quilted brown and tan fabric cover, which was held in place with two posterior mounted bilateral elastic bands. The seat cover contained dirt and blood stains to its forward aspect. The left plastic armrest was also soiled with dirt and exhibited scuff marks. The CRS appeared to be structurally intact while maintaining its symmetrical shape; however, once the seat cover was removed the left armrest was found to be slightly deformed and separated from the plastic base (**Figure 16**), which indicated that the occupant loaded the CRS during the crash sequence.

Figure 16: Overhead view of the CRS depicting the loading evidence to the left arm rest.

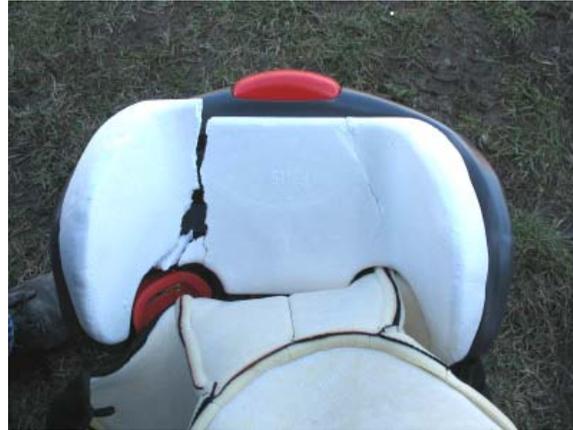
The CRS appeared to be structurally undamaged at initial inspection. The seat cover and padded armrests of the CRS contained dirt and blood stains. However, once the fabric coverings were removed the styro-foam insert in the upper aspect of the high-back exhibited bilateral vertical cracks (**Figure 18**), which separated this component into three separate pieces. Additionally, light discolorations in the upper plastic shell were observed, which indicated that the plastic material had been subjected to loading. Further, it was determined that the hinge system connecting the back support to the base was deformed and disjointed from the same impact

forces. A scuff mark to the fabric covering at the outboard wing of the back support was also identified. The damage to the CRS was directly associated to the vertical intrusion of the roof and right side rail during the crash.

Figure 18: View of the damaged styro-foam insert within the upper back of the Graco CRS.

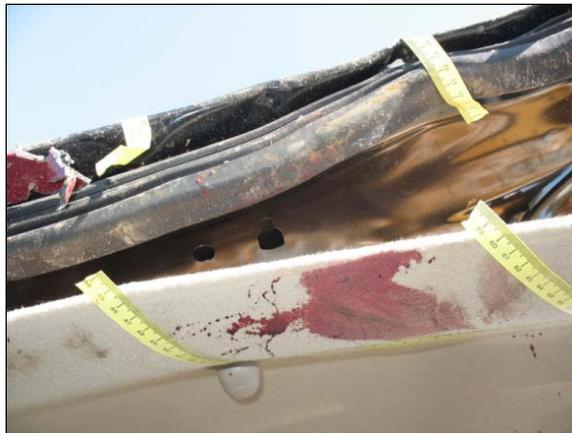
During the SCI vehicle inspection, a compression type transfer mark consisting of blood and underlining scuffs were identified to the left rear headliner, which covered the metal and rubber gasket portion of the left roof side rail. A semi-circle deformation of the metal roof side rail was located directly above the blood transfer mark (**Figure 19**). Multiple long hair strands were found to be embedded in the second row left roof side rail. Additional long hair strands were discovered on the left C-pillar and left side of the backlight shelf.

Figure 19: Depicts the headliner and roof side rail contact points associated with the second row left side occupant

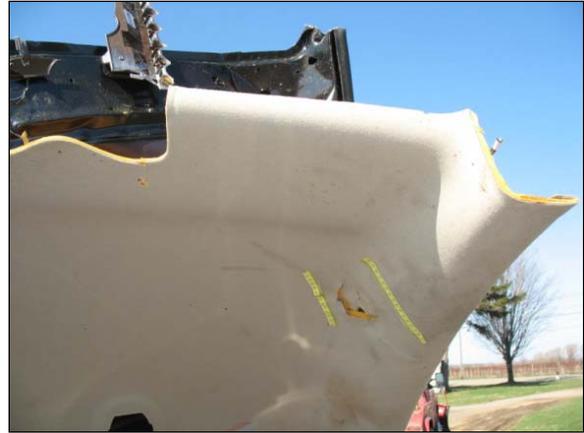
During the SCI vehicle inspection, multiple scuff marks were identified to the right rear headliner (**Figure 20**). CRS damage consisting plastic stress marks and fractures in the styro-foam insert were attributed to a combination of vertical loading of the CRS by the intruding roof in conjunction with loading contact from this occupant. It was also concluded that the open radius and ulna fractures of the left forearm were most likely attributed to the intruding roof structure. As the roof intruded into the greenhouse area, this occupant may have raised his hands in a bracing motion. The downward force of the intrusion may have loaded this occupant's left

Figure 20: Depicts the headliner contact points associated with the second row right side occupant
