OFFICE OF DEFECTS INVESTIGATION
CALSPAN ON-SITE AIR BAG NON-DEPLOYMENT CRASH INVESTIGATION

SCI CASE NO: CA09026

VEHICLE: 2008 NISSAN TITAN
LOCATION: PENNSYLVANIA
CRASH DATE: MARCH, 2009

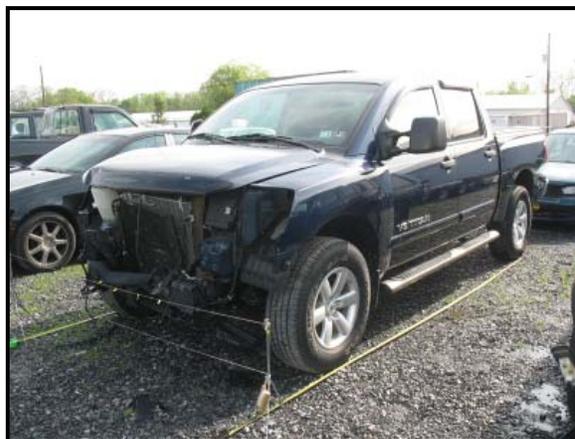
Figure 1: Front right view of the Nissan.

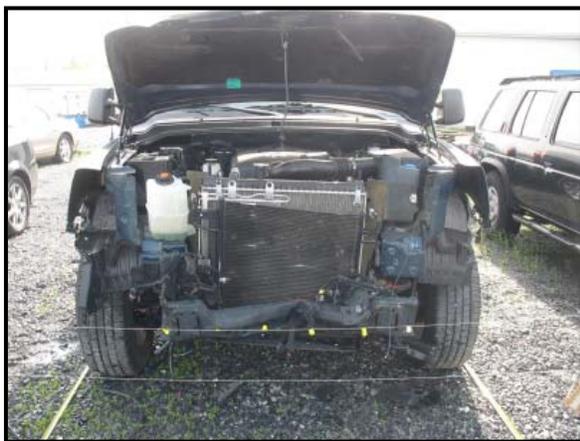
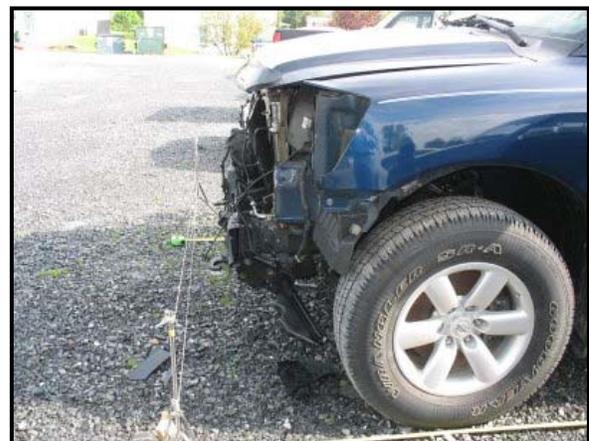
The Nissan Titan sustained damage across the full frontal plane as a result of the impact (**Figures 4 and 5**). At the time of the SCI inspection, the Nissan had been partially disassembled to facilitate an insurance damage estimate. The damaged components included: the front bumper, bumper reinforcement, the head lamp assemblies, the center grille, the upper radiator support, radiator, condenser and associated components. These components had been discarded prior the SCI inspection. The left fender was shifted rearward. The residual crush measured along the bumper reinforcement bar was as follows: C1 = 5 cm (2 in), C2 = 15 cm (5.9 in), C3 = 24 cm (9.4 in), C4 = 19 cm (7.5 in), C5 = 15 cm (5.9 in), C6 = 8 cm (3.1 in). The maximum residual crush was located 9 cm (3.7 in) left of center and measured 24 cm (9.4 in). The dynamic crush of the frontal components resulted in contact between the back side of the radiator and the cooling fan. This contact was evidenced by damage to the radiators fins and a fractured fan blade. There was no change in the wheelbase dimensions. All the doors remained closed during the crash and were operational at the time of the SCI inspection. There was no damage to the windshield and all the window glazing was intact.

Figure 4: Frontal view of the damaged Nissan.

Figure 5: Left lateral view at the front plane.

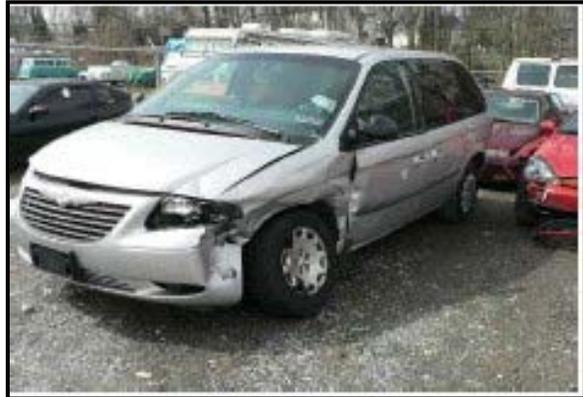
Insurance carrier photographs of the Chrysler were obtained and used to assess the damage to the Chrysler. **Figure 6** is a left front view of the Chrysler. The direct contact damage to the Chrysler began at the left corner and extended an estimated 127 cm (50 in) along the left side plane to the forward aspect of the left front door. The lateral crush at the left corner was an estimated 38 cm (15 in). The force of the impact deformed the left front suspension inboard and damaged the wheel assembly. The redesigned frontal air bags in the Voyager deployed. The estimated CDC was 10-LYAW3.

Figure 6: Left front oblique view of the Chrysler. This image was provided by the insurance carrier.

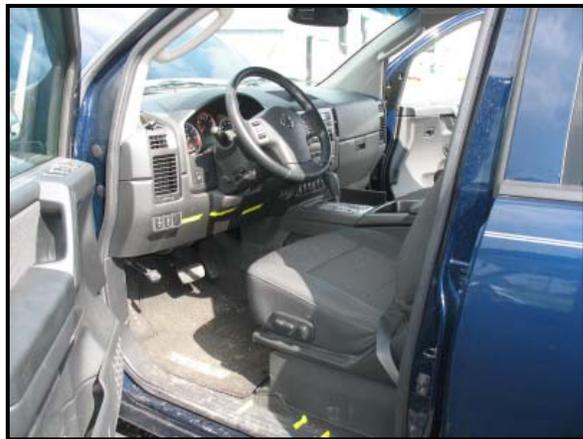
There was no damage to the interior of the Nissan as a result of the exterior crash force. **Figure 7** is a left view of the front interior.

The driver seat was located in a mid-track position 9 cm (3.5 in) forward of full-rear. The total seat track travel was 25 cm (10 in). The seat back was reclined 25 degrees aft of vertical. The horizontal distance from the seat back to the driver air bag module measured 61 cm (24 in). There was no deformation to the three-spoke steering wheel rim. There was no shear capsule separation. Three minor occupant contact points to the left knee bolster were identified. A 3 cm (1 in) diameter scuff was located 20 cm (7.7 in) left of the steering column center line. A 5 cm (2 in) diameter scuff was located 8 cm (3 in) left of the steering column. A 3 cm (1 in) diameter scuff was located 14 cm (5.7 in) right of the steering column. These scuffs were all located approximately 48 cm (19 in) above the floor. These contact points were attributed to contact from the lower extremities of the driver.

Figure 7: Left interior view.

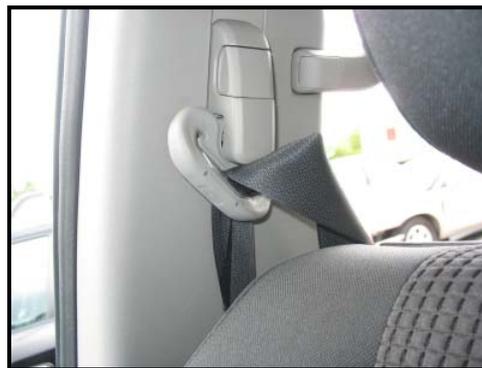
The front right passenger's restraint consisted of a continuous loop webbing, sliding latch plate, a switchable Automatic Locking Retractor/ELR (ALR/ELR) and an adjustable D-ring. This restraint was not buckled (not in use) at the time of the crash. The front right retractor pretensioner actuated during the crash with the webbing in the stowed position. The webbing was gathered in the D-ring and the retractor was not operational. The webbing on the back side of the D-ring was abraded from contact with the D-ring surface as the pretensioner actuated. The diagnostic routine of the vehicle's Air bag Control Module (ACM) stored a Diagnostic Trouble Code (DTC) that confirmed the pretensioner actuation. The cause of the pretensioner actuation in an unoccupied seat position could not be determined.

Figure 8: Front right D-ring and gathered webbing.

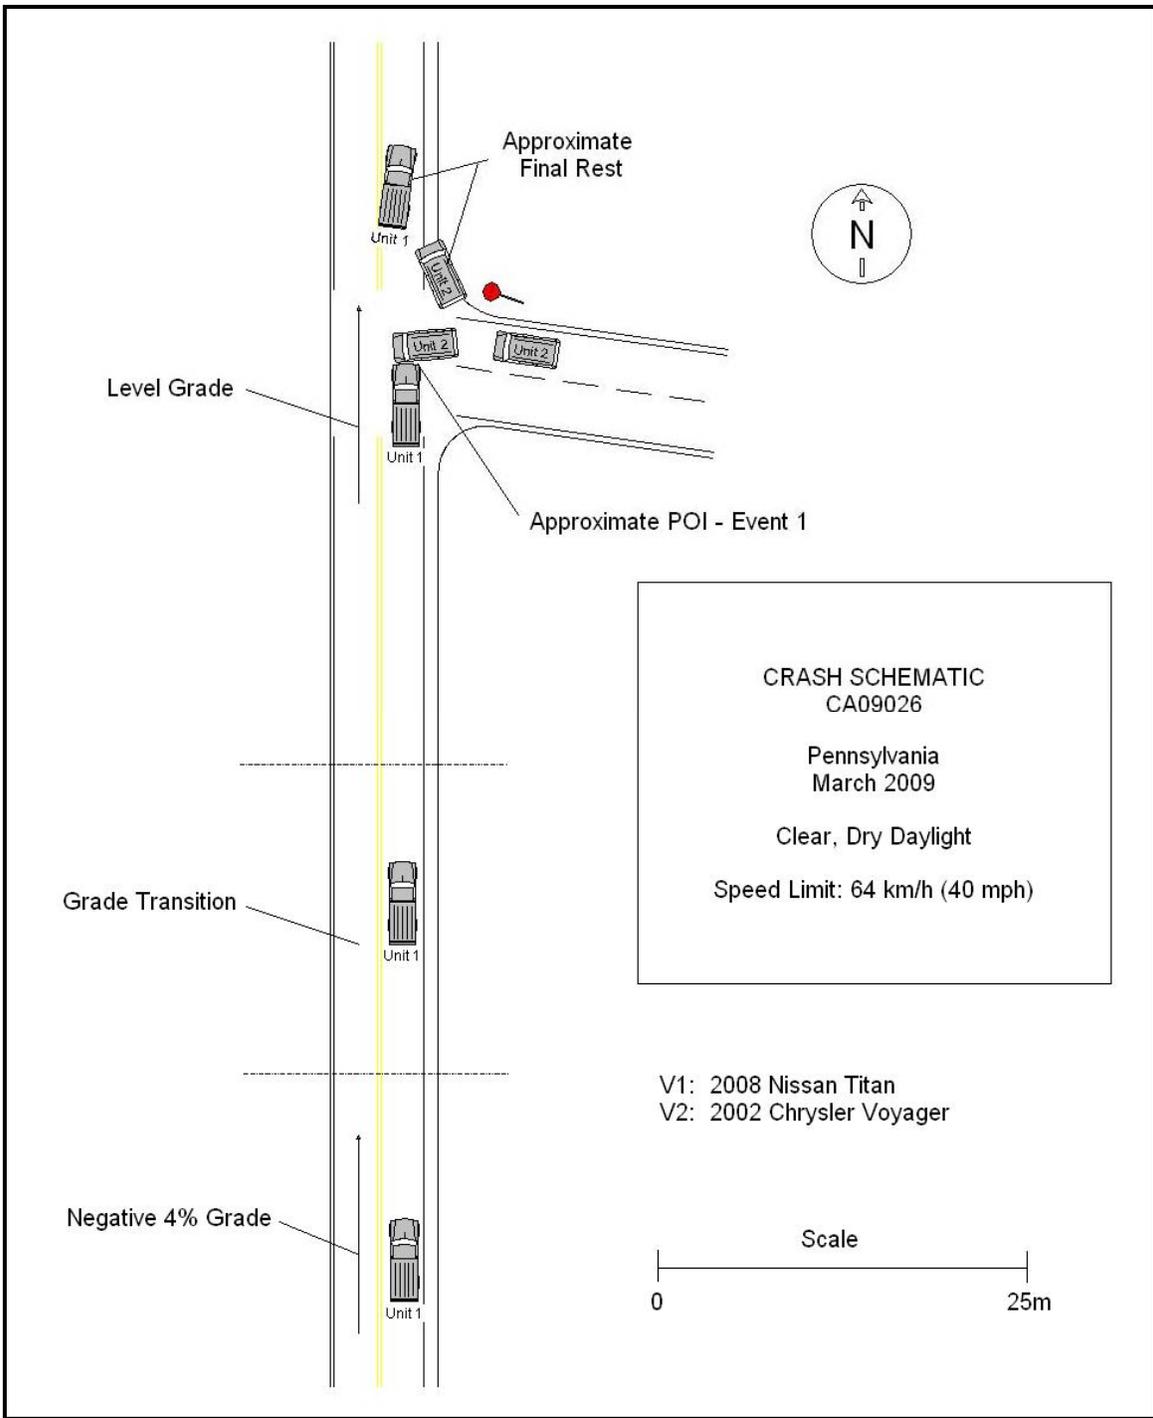
Figure 9: Crash Schematic.

The 2002 Chrysler Voyager was driven by a 55-year-old restrained male. The Chrysler was stopped at the three-leg intersection and it was the driver's intention to turn left and travel south. The 2008 Nissan Titan was northbound driven by 35-year-old restrained female. The Nissan was traveling an EDR recorded speed of 64 km/h (40 mph) seven seconds (7 sec) prior to the crash. The Chrysler Voyager accelerated forward from the stop sign and into the path of the Nissan. The Nissan's EDR data indicated that the driver applied the brakes two seconds (2 sec) prior to the crash in an attempt to avoid the Chrysler. A schematic of the crash is included at the end of this report as **Figure 9**.
