On-Site Child Restraint System Investigation  
Dynamic Science, Inc. (DSI), Case Number DS09027  
1998 Ford F-150  
California  
July 2009

1. Report No. DS09027	2. Government Accession No.	3. Recipient Catalog No.	
4. Title and Subtitle Child Restraint System Investigation		5. Report Date March 25, 2010

**Dynamic Science, Inc.**  
**Crash Investigation**  
**Case Number: DS09027**

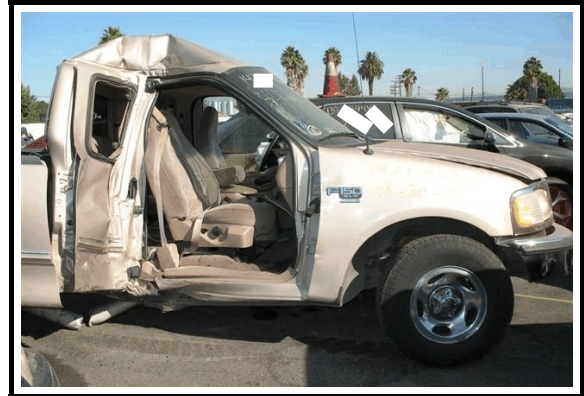
**Figure 1.** Subject vehicle, 1998 Ford F-150

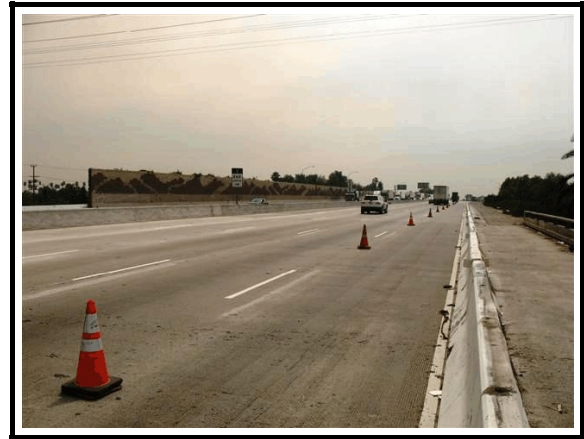
The crash site was a five-lane southbound interstate highway that was bordered on the left by a raised concrete divider and on the right by a paved shoulder. (Figure 2). Outboard of the paved shoulder were unpaved ground and shrubbery. The travel lanes each measured 3.7 m (12.0 ft) in width and were separated by dashed white stripes; the outboard lane was bordered on the right by a solid white fog line. The paved shoulder measured 4.3 m (14.0 ft) in width and the unpaved ground measured between 0 - 1.8 m (0 - 6.0 ft) in width from the shoulder to the shrubbery.

**Figure 2.** Southbound approach, subject vehicle

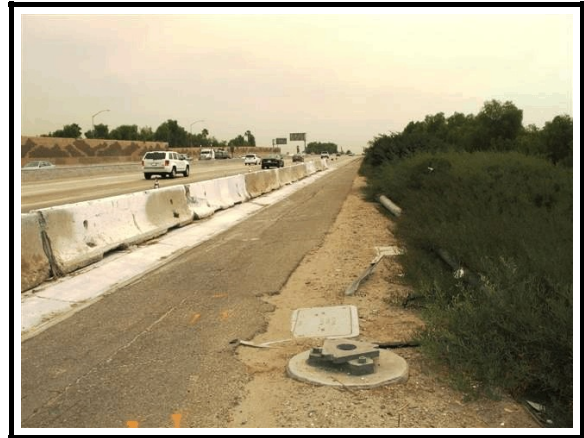
The pole was designed to breakaway and was mounted to a triangular slip base plate seated on a concrete base and connected by three bolts. The base plate measured 3.0 cm (1.2 in) in height. The base end of the pole measured 23.0 cm (9.0 in) in diameter and the top end measured 10.0 cm (4.0 in) in diameter. The pole measured 10.7 m (35.0 ft) in length and had a 5.5 m (18.0 ft) long

extension attached near the top that extended laterally and contained the light fixture. The extension was also metal and measured 10.0 cm (3.9 in) in diameter. The triangular slip plate measured 43.0 cm (17.0 in) at its median and was 10.0 cm (3.9 in) in height above the concrete base. The concrete base was 76.0 cm (30.0 in) in diameter and was 5.0 cm (2.0 in) above grade. The direct damage to the pole began at the base and extended upward 180.0 cm (70.9 in). The damage extended laterally to approximately one half of its circumference. The pole was deformed inward at 42.0 cm (16.5 in) from the base where it was contacted by the vehicle's right sill. During the crash, the pole was displaced into the roadway and was later moved onto the shoulder.

**Figure 3.** Point of impact with streetlight pole, base in foreground

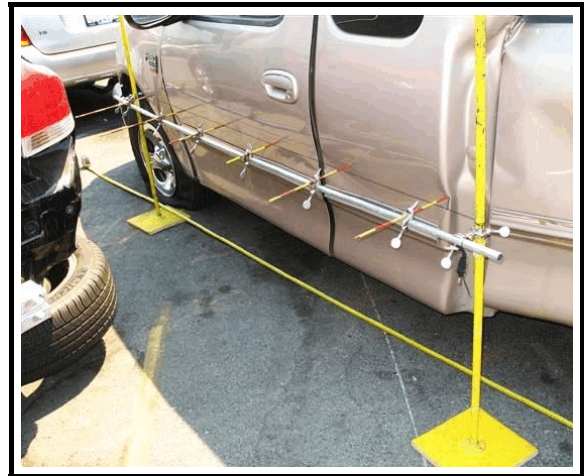
**Figure 5.** Left side crush profile, Event 4

The Ford was redirected to the left and it reentered the roadway traveling southeast. The vehicle crossed the paved median and first two travel lanes, entered the third lane and traveled into the path of the Freightliner. The left side of the Ford impacted the right side of the Freightliner. The direct damage to the Ford began 117 cm (46.1 in) forward of the left rear axle and extended forward 199.0 cm (78.3 in); the Field L included the same location (**Figure 5**). Six crush measurements were taken at mid-door as follows:  $C_1 = 2.0$  cm (0.8 in),  $C_2 = 0$  cm,  $C_3 = 0$  cm,  $C_4 = 0$  cm,  $C_5 = 0$  cm,  $C_6 = 2.0$  cm (0.8 in). Maximum vertical crush was located 117.0 cm (46.1 in) forward of the left rear axle and measured 2.0 cm (0.8 in). The CDC for Event 4 was 07LYES1.

The Ford sustained crush damage to the left front door due to vehicle-to-vehicle contact. The height of maximum door crush measured 66.0 cm (26.0 in), the sill height measured 37.0 cm (14.6 in), and the Door Sill Differential (DSD) measured 7.0 cm (2.8 in).

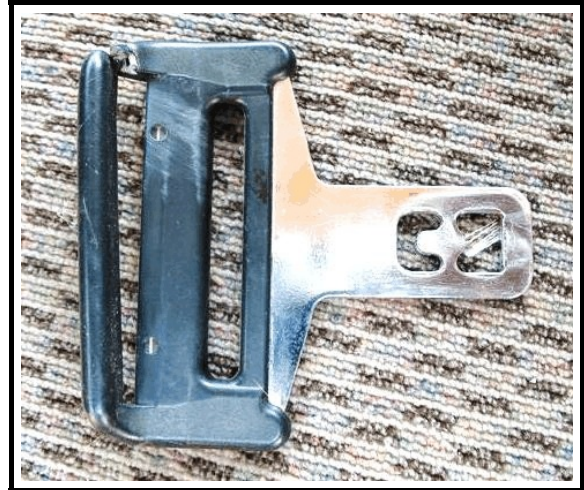
The latch plate was found separated from the webbing and in the buckled position. The metal tang was scratched indicating historical usage. The plastic cover was scuffed and fractured as a result of occupant loading during the pole impact (**Figure 6**). The fracture measured less than 1 cm (0.4 in) in diameter and was located where the belt webbing was routed through the latch plate. The abrasions were located on both sides of the latch plate and were deposited by the safety belt webbing. Based on evidence of occupant loading, post-crash extrication activities, and occupant kinematics, it was determined the driver's safety belt was used during the crash.

**Figure 6.** Driver's safety belt latch plate showing scuffs and fracture

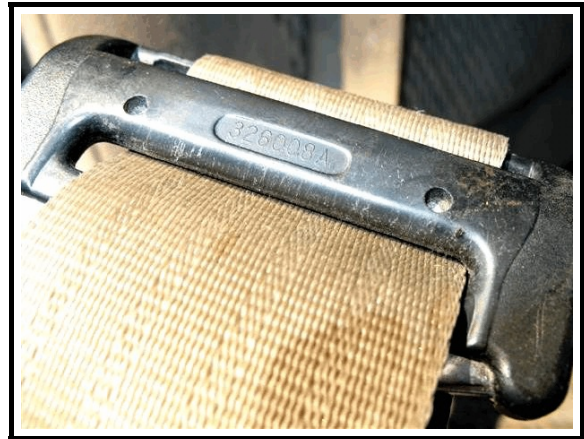
**Figure 7.** Front right occupant's latch plate showing loading marks

The latch plate (**Figure 7**), safety belt webbing, and D-ring showed evidence of occupant loading. The latch plate was scratched indicating historical usage and was abraded where the webbing was routed through it. The D-ring was abraded where the webbing was routed through it. An area of scuff marks on the safety belt webbing began at the D-ring and extended 13.0 cm (5.1 in) toward the stop button. A second area of loading damage began 35.0 cm (13.8 in) from the D-ring and extended 6.0 cm (2.4 in) toward the stop button. This area of webbing contained scuff marks, frayed fibers and body fluid deposits from the occupant. Based on the post-impact position of the safety belt webbing, evidence of occupant loading, and occupant kinematics, it was determined that the safety belt was in use at the time of the crash.

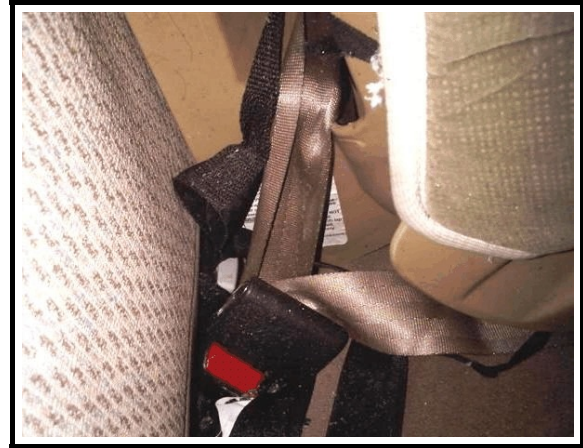
seat position was occupied by the 3-year-old female seated in a Cosco Ventura combination CRS (**Figure 8**). The safety belt latch plate was scratched indicating historical usage and the webbing showed wear marks. The latch plate was otherwise unremarkable. On-scene police photographs show the belt routed through the CRS and the latch plate fully engaged in the buckled position. The police report stated there was some slack in the belt that allowed the CRS to move away from the seat. During the vehicle inspection, the latch plate was inserted into the buckle and would not properly engage. The buckle was examined and although no deformation was observed, glass kernels or other debris in the buckle prevented the latch plate from properly engaging.

**Figure 8.** Second row center lap belt routed through CRS and buckled (Police photo)

The locking latch plate was adjusted on the webbing 52.0 cm (20.5 in) from the seat bight. The safety belt webbing exhibited two areas of occupant loading evidence. The first was a 3.0 cm (1.2 in) stretch mark that was located 52.0 cm (20.5 in) from the seat bight where the cinching latch plate had been positioned. The second was an area of abrasion 11.0 cm (4.3 in) from the seat bight where transfers from the CRS were deposited in the safety belt webbing. The deposits were on the side of the belt that, if properly installed, had been in contact with the CRS shell.

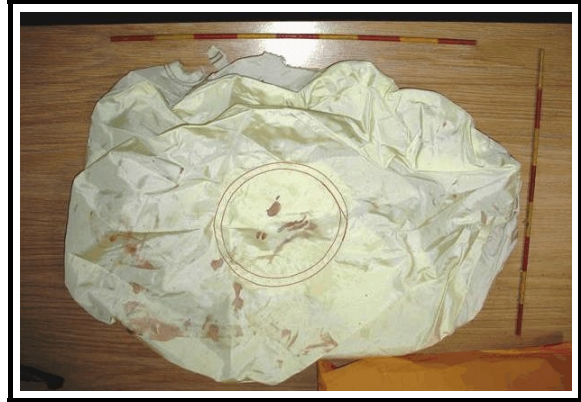
The driver's air bag module was located in the steering wheel hub and the air bag deployed through two H-configured cover flaps that opened at the tear points and were not damaged. The air bag was circular in shape and measured 60.0 cm (23.6 in) in diameter in its deflated state (**Figure 9**). It had one internal tether that terminated at the center of the front panel; it had two vent ports measuring 3.0 cm (1.2 in) in diameter that were located at the 11 and 1 o'clock positions on the air bag's back panel.

**Figure 9.** Driver's frontal air bag

The air bag showed several blood deposits that were concentrated in the center and lower left quadrant of the front panel. The driver's medical records did not reveal blood loss related to her injuries, and the interviewee stated that the driver did not sustain blood loss as a result of her injuries. Based on the medical records and interview, the blood deposits were determined to be from sources other than the driver. The air bag did not show additional evidence of occupant loading was otherwise unremarkable.

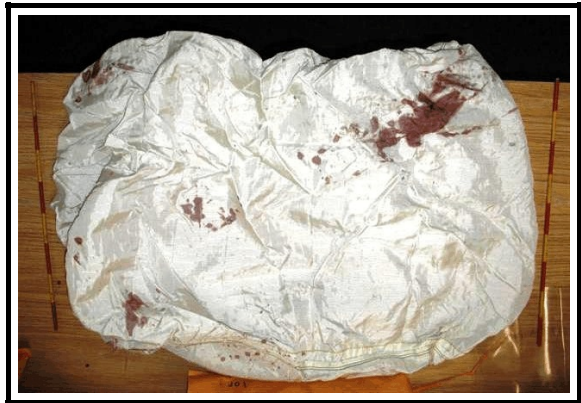
**Figure 10.** Front right occupant's frontal air bag

The right passenger's frontal air bag deployed from the right middle instrument panel (**Figure 10**) through a single rectangular cover flap that opened at the tear points and was undamaged. The air bag was rectangular in shape and measured 55.0 cm (21.7 in) in height and 76.0 cm (29.9 in) in width in its deflated state. It was configured with two vent ports and a single internal tether.

The air bag showed several blood deposits that were concentrated in the upper right quadrant but also present in the upper and lower left quadrants of the front panel. The front right occupant sustained a right arm laceration resulting from a door panel contact. It is probable the blood deposits to the air bag resulted during post-crash occupant activity. The air bag revealed eight small holes that probably resulted from contact with flying glass. The holes were less than 1.0 cm (0.4 in) in diameter and were scattered within the upper right quadrant of the front panel. The air bag showed no additional evidence of occupant loading and was otherwise unremarkable.

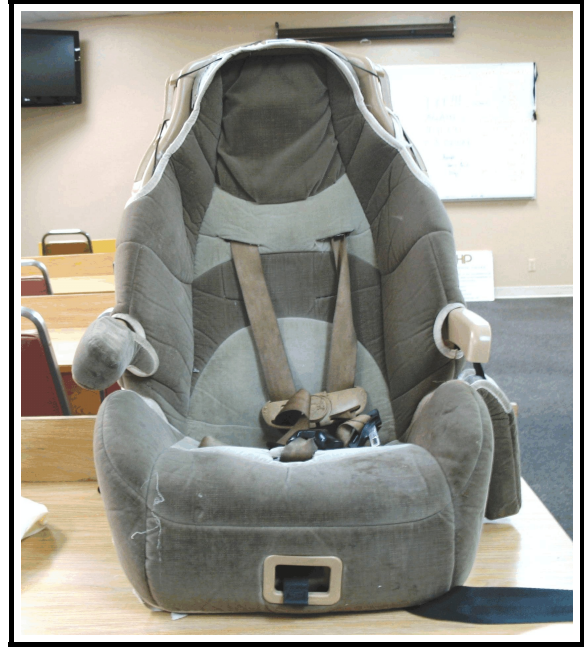
The second row center occupant was a 3-year-old female who was seated in a Cosco Ventura CRS (**Figure 11**). The CSS model number was 22-248-WAL and the date of manufacture was 6/29/2006. The Ventura was equipped with a 5-point harness system with a chest retainer clip and buckle, padded seat cushion, non-detachable base, locking clip, and LATCH hardware. The CRS was a

**Figure 11.** Cosco Ventura CRS

According to the autopsy report, the 3-year-old occupant was 109.0 cm (43.0 in) in height and 25.0 kg (55.0 lb) in weight. Based on the child's weight it was determined that the child did not meet the usage requirements for the CRS when using the 5-point harness system. She exceeded the weight limit by 6.8 kg (15.0 lb).

twisted and the retainer clip was positioned low on the harness. The harness straps did not sustain any deformation due to loading and the retainer clip functioned properly. The occupant's safety belt webbing exhibited loading evidence, and there was evidence of loading to the CRS at the left slot where the safety belt webbing was routed through the shell. Scuffs were documented at the lower aspect of the slot that corresponded to scuffs on the vehicle's lap belt.

The CRS did not show any fractures, deformities or transfers that suggested contact with components in the vehicle such as the intruded right B-pillar, or door panel, or front right seat-back. It was therefore determined that while the police report stated there was lateral movement of the CRS due to slack in the lap belt, the CRS was not displaced from the center seat position during the crash. No further damage to the CRS was documented.
