On-Site Side Air Bag Investigation
Dynamic Science, Inc. (DSI), Case Number DS09029
2007 Dodge Nitro
Arizona
July 2009

**Dynamic Science, Inc.
Crash Investigation
Case Number: DS09029**

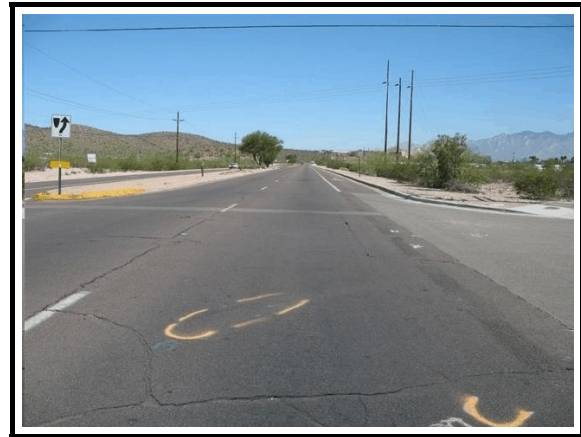
The crash sequence included four events: Events 1 and 2 were vehicle-to-vehicle impacts and Events 3 and 4 were vehicle-to-object impacts. Initially, the front plane of the Buick impacted the left side of the Dodge (Event 1). The point of impact in the northbound outboard lane was identified by a patch of scrape marks on the roadway measuring 1.2 m (4.0 ft) in length and 0.3 m (1.0 ft) in width (**Figure 3**).

Figure 3. Point of impact, Event 1

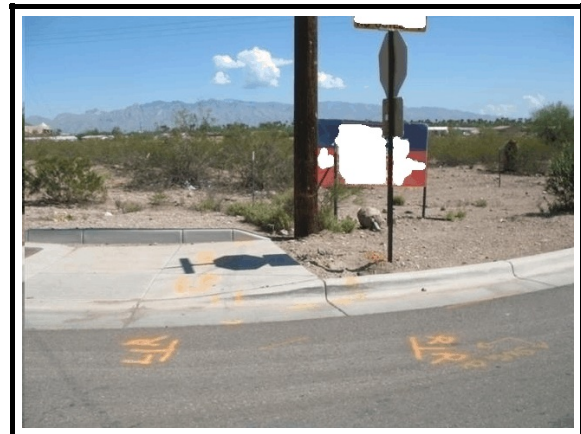
Following the second impact, the Dodge traveled to the northeast corner of the intersection and its front plane impacted a wooden utility pole (Event 3). The Buick then departed the northbound roadway on the right side and impacted a barbed wire fence with its front end (Event 4).

Prior to the pole impact, the Dodge's left front tire deposited a skid mark measuring 3.3 m (10.8 ft) in length on the concrete gutter and sidewalk. The vehicle came to rest with its front tires off the roadway and its rear tires on the roadway (**Figure 4**). The distance traveled from the first vehicle-to-vehicle impact (Event 1) to final rest was 17.4 m (57.1 ft).

Figure 4. Point of impact, Event 4, and final rest location of subject vehicle

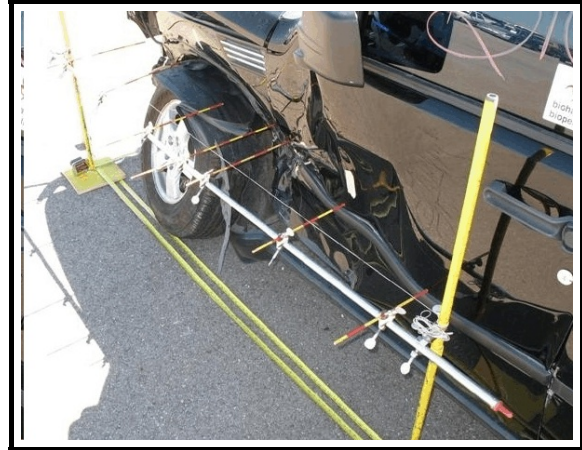
For Event 1, direct damage was located on the left side beginning at the front axle and extending 109.0 cm (42.9 in) rearward. The Field L began at the front left bumper corner and extended 188.0 cm (74.0 in) rearward (**Figure 5**). Six crush measurements were taken at mid-door level as follows: $C_1 = 0$ cm, $C_2 = 8.0$ cm (3.1), $C_3 = 20.0$ cm (7.8 in), $C_4 = 16.0$ cm (6.3 in), $C_5 = 13.0$ cm (5.1 in), $C_6 = 19.0$ (7.5 in). Maximum crush was located 99.0 cm (39.0 in) aft of the front left bumper corner between C_3 and C_4 and measured 23.0 cm (9.1 in). The Collision Deformation Classification (CDC) for the first impact was 10LYEW2.

Figure 5. Dodge Nitro crush measurements, Event 1

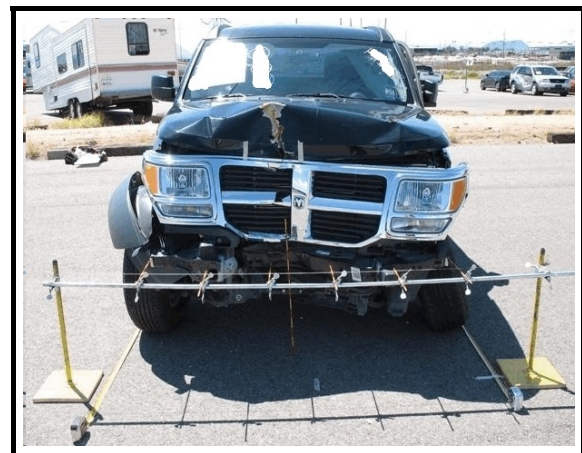
Figure 6. Dodge Nitro crush measurements, Event 3

For Event 3, direct damage was located on the front end beginning 71.0 cm (28.0 in) right of the left edge of the bumper bar and extending 24.0 cm (9.5 in) to the right. The Field L measured 140.0 cm (55.1 in) and was distributed across the entire front end (**Figure 6**). Six crush measurements were taken at bumper level as follows: $C_1 = 1.0$ cm (0.4 in), $C_2 = 0$ cm, $C_3 = 16.0$ cm (6.3 in), $C_4 = 35.0$ cm (13.8 in), $C_5 = 0$ cm, $C_6 = 0$ cm. Maximum lateral crush was located at C_4 . The Collision Deformation Classification (CDC) for the pole impact was 12FCEN2.

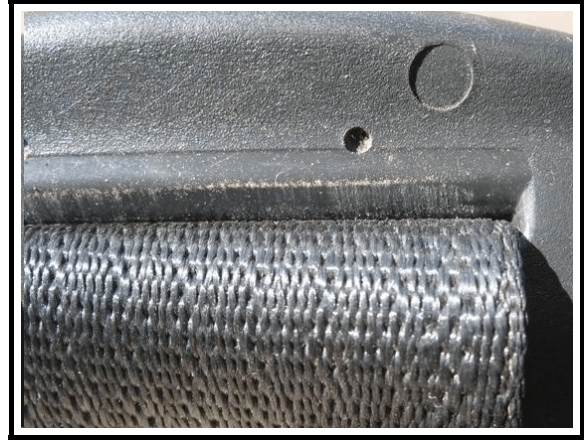
The driver's safety belt D-ring was in the full-up position and the latch plate exhibited scratches indicating historical usage. The pretensioners had actuated during the crash and the belt was locked in the used position. The buckle stalk was compressed 3.0 cm (1.2 in) from its original length. The latch plate cover was scuffed on the plastic cover where the belt webbing was routed through (**Figure 7**) and the safety belt webbing was stretched beginning at the stop button and extending upward 25.0 cm (9.8 in). The safety belt webbing was frayed at 115.0 cm (45.3 in) above the stop button where it was routed through the D-ring. Based on the inspection it was determined that the safety belt was used to restrain the driver during the crash.

Figure 7. Evidence of occupant loading, driver's safety belt latch plate

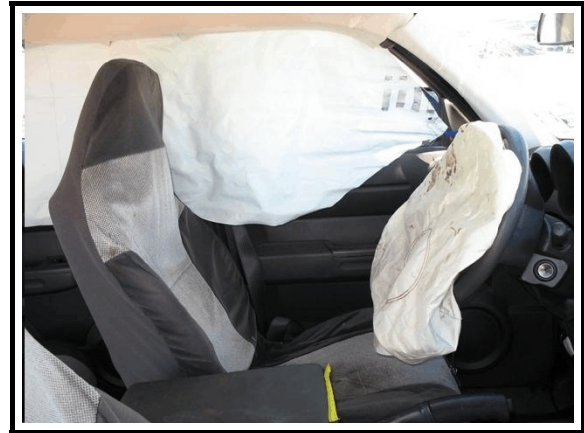
Figure 8. Deployed left frontal and IC air bags

The left IC air bag deployed from the roof side rail and extended from the A-pillar to the C-pillar. It measured 180.0 cm (70.9 in) in width and 45.0 cm (17.7 in) in height and covered the front and second row windows. A 20.0 cm (7.9 in) tether connected the leading edge of the air bag to the A-pillar. The inboard panel revealed a make-up and skin oil transfer deposited by the driver at impact. The transfers each measured 1.0 cm (0.4 in) in size and were 6.0 cm (2.3 in) apart. They were located 14.0 cm (5.5 in) below the top of the air bag and began 26.0 cm (10.2 in) from its leading edge.

The transfers each measured 1.0 cm (0.4 in) in size and were 6.0 cm (2.3 in) apart. They were located 14.0 cm (5.5 in) below the top of the air bag and began 26.0 cm (10.2 in) from its leading edge.

The driver's frontal air bag deployed through two I-configured cover flaps in the steering wheel hub. The flaps opened at their tear points and were not damaged. The air bag was circular in shape and measured 50.0 cm (19.7 in) in diameter. It had two internal tethers that terminated at the center of the front panel. Two vent ports measuring 3.0 cm (1.2 in) in diameter were located at the 11 and 1 o'clock positions on the back panel.

The frontal air bag deployed at impact with the utility pole and the driver loaded the air bag as she was displaced forward. The air bag revealed a make-up transfer measuring 3.0 x 3.0 cm (1.2 x 1.2 in) in size that was located 10.0 cm (3.9 in) from the center of the front panel in the upper right quadrant. The lower left and right quadrants and the upper right quadrant of the front panel showed dried blood deposits. During the interview the driver did not clarify the source of the blood deposits. The driver and front right occupant each sustained scalp lacerations and the blood was possibly deposited by both occupants.

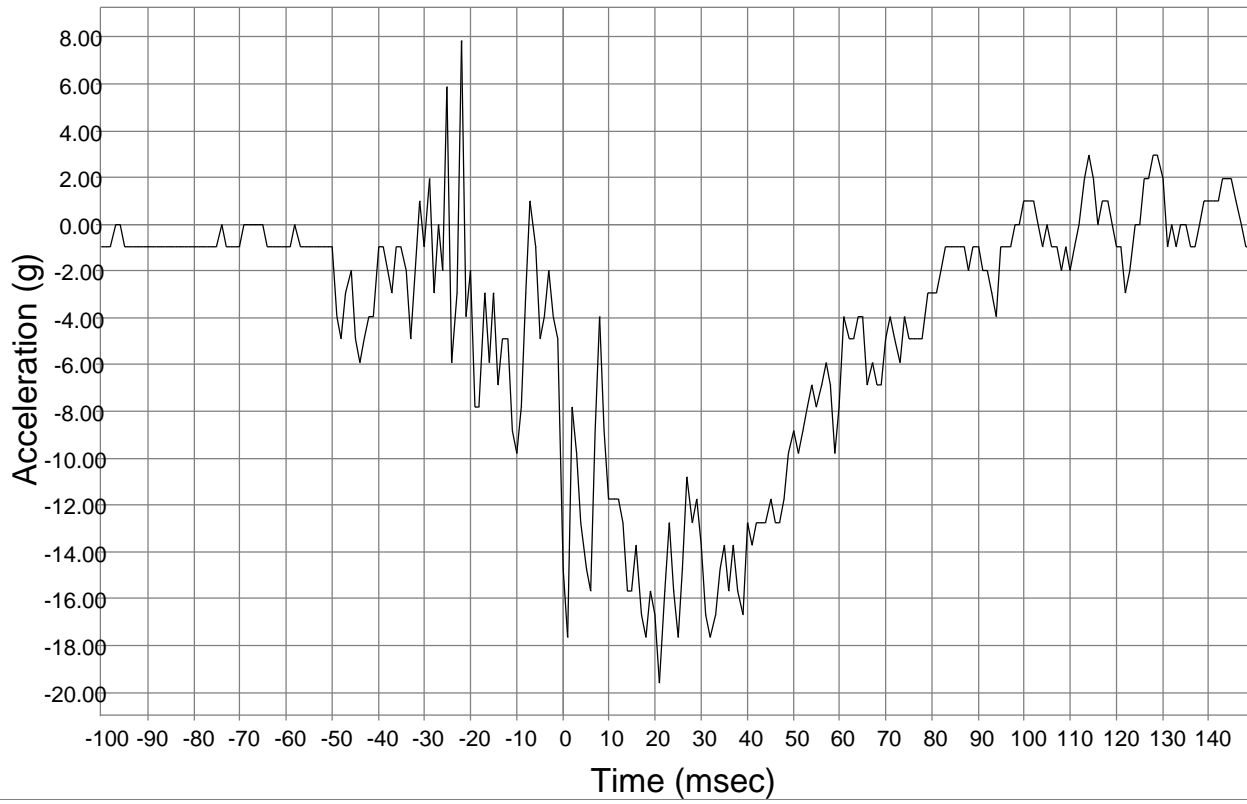
Longitudinal Crash Pulse (Most Recent Event)

The EDR recorded 250 ms of Longitudinal Crash Pulse data indicating the vehicle's longitudinal acceleration. The maximum recorded longitudinal acceleration was -19.61 (g) at 21 ms.
