CALSPAN ON-SITE HYBRID VEHICLE CRASH INVESTIGATION

SCI CASE NO.:CA09031

VEHICLE: 2006 FORD ESCAPE HYBRID

CRASH DATE: MARCH 2009

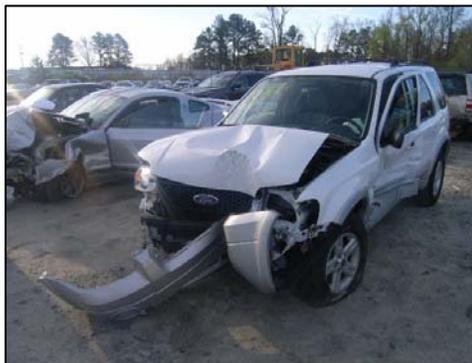
Figure 1: 2006 Ford Escape Hybrid case vehicle.

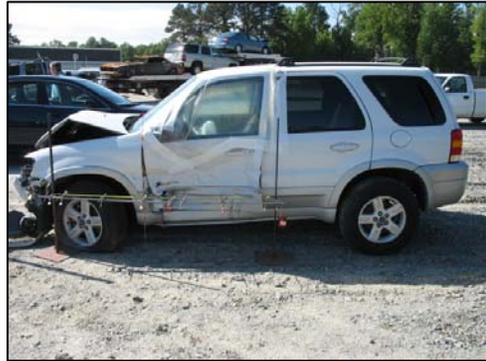
The left and front planes of the Ford Escape were damaged in this multiple impact crash. The initial impact involved moderate severity damage to the left front side area of the Ford (**Figure 2**). The direct contact damage began 108 cm (42.5 in) forward of the left rear axle and extended 169 cm (66.5 in) forward to the left front wheel area. Lateral crush was present to the left front door, A-pillar and fender. A crush profile capturing the residual crush from the impact with the Scion was documented along the left side, forward of the B-pillar. The combined direct and induced damage (Field L) began 108 cm (42.5 in) forward of the left rear axle and extended forward 169 cm (66.5 in). The residual crush profile was measured at the lower door elevation and was as follows: C1 = 0 cm, C2 = 10 cm (3.9 in), C3 = 18 cm (7.1 in), C4 = 6 cm (2.4 in), C5 = 2 cm (0.8 in), C6 = 0 cm. The maximum crush was located on the left front door, 199 cm (78.3 in) forward of the left rear axle and measured 20 cm (7.9 in). The elevation of the maximum crush was 45 cm (17.7 in), consistent with the front bumper height of the Scion that was 39 cm (15.4 in) above ground level. The Door Sill Differential (DSD) was 13 cm (5.1 in). The Collision Deformation Classification (CDC) of this impact was 11-LYEW-2.

Figure 2: Initial and sideslap impact damage to Ford Escape.

The left front and left rear door hinges were intact and remained attached to the A- and B-pillars, respectively. Both left side door latches remained engaged and both left side doors remained closed during the crash. The left front door was jammed closed as a result of damage. The left rear and right side doors remained operational. The front left tire and wheel were engaged by the Scion; however, the suspension components remained attached to the Ford.

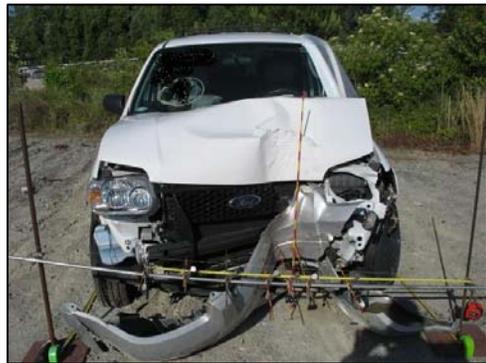
The left and center aspects of the frontal plane sustained moderate severity damage as a result of the impact with the tree (**Figure 3**). The direct contact damage began 19 cm (7.5 in) left of the vehicle's centerline and extended left 37 cm (14.6 in). A crush profile was documented along the full frontal width of the bumper beam. The crush profile was as follows: C1 = 13 cm (5.1 in), C2 = 35 cm (13.8 in), C3 = 28 cm (11 in), C4 = 18 cm (7.1 in), C5 = 8 cm (3.1 in), C6 = 0 cm. The maximum crush for this impact was located 21 cm (8.3 in) left of the centerline of the vehicle and was 36 cm (14.2 in). The CDC for this impact was 12-FYEN-2. This impact actuated the driver's pretensioners and deployed the driver's frontal CAC air bag.

Figure 3: Overall view of the frontal damage to the Ford Escape.

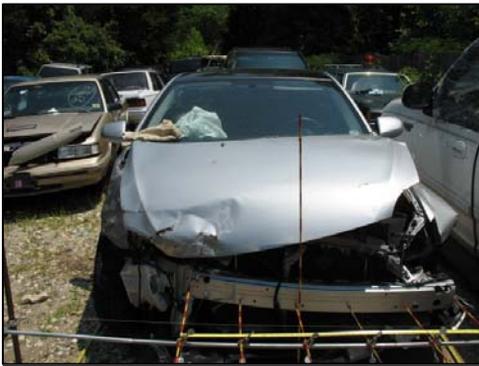
The front and right side planes of the Scion were damaged in this multiple impact crash. The initial impact involved moderate severity damage to the front of the Scion (**Figure 4**). The direct contact damage began 20 cm (7.9 in) left of the centerline of the vehicle and extended 90 cm (35.4 in) to the front right bumper corner. Longitudinal crush was present to the bumper beam. The lateral component of the 2 o'clock impact force displaced the frame rails to the left 27 cm (10.6 in). The bumper fascia was separated from the vehicle. **Figure 5** depicts the separated bumper fascia, with a rubber transfer from direct contact with the left front tire of the Ford. A crush profile was documented along the full-width of the bumper beam and was as follows: C1 = 5 cm (2 in), C2 = 16 cm (6.3 in), C3 = 15 cm (5.9 in), C4 = 16 cm (6.3 in), C5 = 18 cm (7.1 in), C6 = 9 cm (3.5 in). The maximum crush was located 1 cm (0.4") right of the centerline and was 18 cm (7.1 in) in depth. The CDC assigned for this impact was 82-FZEW-1 with a shift increment value of 80.

Figure 4: Overall view of frontal damage to the Scion.

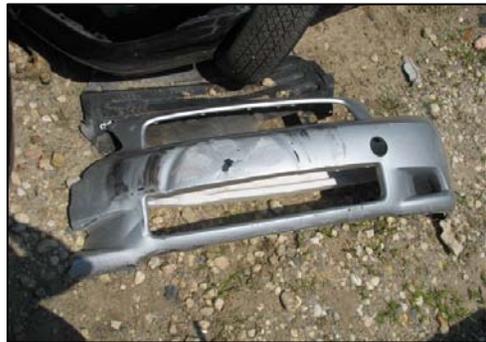
Figure 5: Damaged front bumper fascia of the Scion.

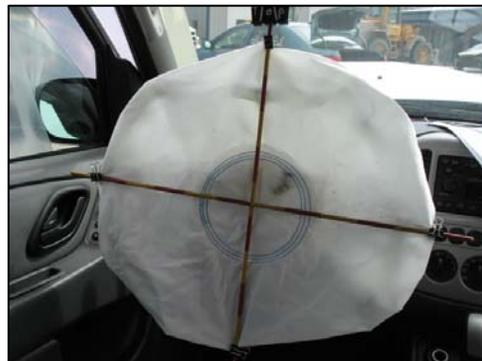
The driver's air bag was concealed within the center hub of the four-spoke steering wheel by two asymmetrical cover flaps. The upper flap measured 15 cm (5.9 in) in width at the horizontal tear seam and 7 cm (2.8 in) in height. The lower flap measured 14 cm (5.5 in) in width at the horizontal tear seam and 5 cm (2.0 in) in height. The air bag (**Figure 6**) measured 60 cm (23.6 in) in diameter in its deflated state. The air bag was vented by two vent ports located at the 3 and 9 o'clock positions on the rear aspect of the air bag. The air bag was tethered by two tethers located at

Figure 6: Deployed driver's frontal air bag of the Ford Escape.

the 12 and 6 o'clock positions on a 9 cm (3.5 in) diameter circular seam sewn to the center face of the air bag. There were no occupant contacts to the driver's frontal airbag.

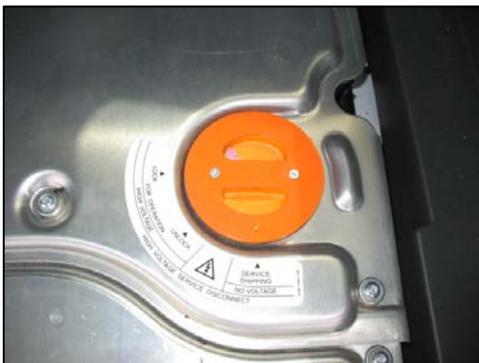
Figure 7: Hybrid battery disconnect switch in the Ford Escape.

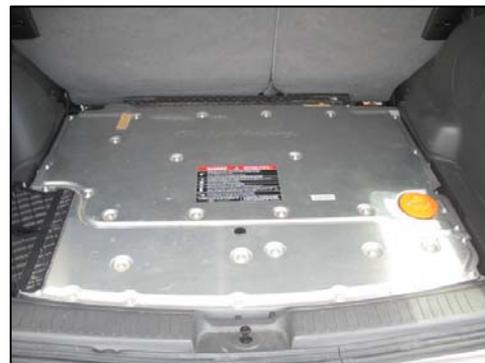
Figure 8: Hybrid battery centered over rear axle and behind rear seat of the Ford Escape.

There was no intrusion rearward of the left B-pillar to the vehicle. The Hybrid battery was not damaged. The individual cells were covered by aluminum covers at the forward and rear aspects. The battery was examined with the covers in place for leakage of fluid or corrosion. No damage to the battery was found.

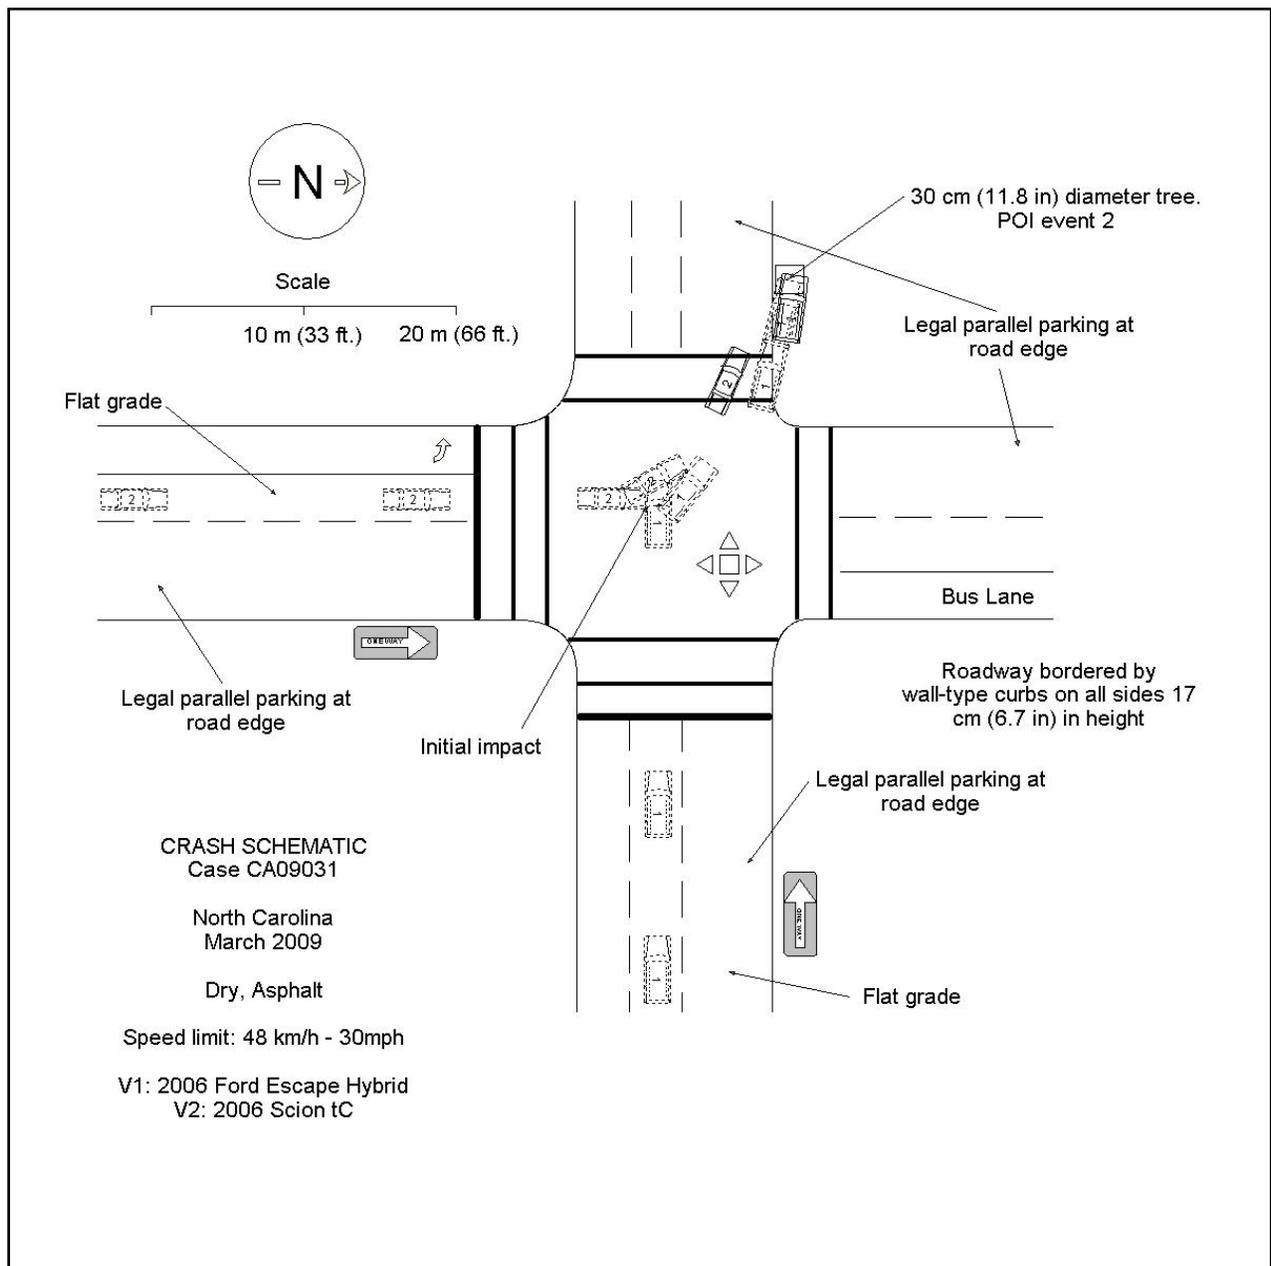
Figure 9: Crash Schematic

This crash occurred during the evening hours of March 2009 in the signalized intersection of two one-way urban roadways. Both roadways consisted of three travel lanes that were 3.3 m (10.8 ft) in width with parallel parking permitted along the curb line at the right side. The roadways were surfaced with asphalt. The roadsides were bordered by concrete barrier curbs that were 17 cm (6.7 in) in height. The police reported conditions at the time of the crash were clear, dry, and dusk. The southwest corner of the intersection was an active construction work zone at the time of the crash. Beyond the curbline at the northwest corner of the intersection, the sidewalk was surfaced in brick, with trees planted in brick lined planters north of the roadway. Beyond the curb lines at the northeast and southeast corners of the intersection were narrow strips of grass followed by concrete sidewalks, with trees planted north and south of the roadway. The posted speed limit on both roadways was 48 km/h (30 mph). The Crash Schematic is included as **Figure 9** of this report.
