On-Site Rollover Investigation
Dynamic Science, Inc. (DSI), Case Number DS09031
2008 Ford Escape
Washington
September 2009

1. Report No. DS09031	2. Government Accession No.		3. Recipient Catalog No.	
4. Title and Subtitle On-Site Rollover Investigation		5. Report Date May 11, 2010

Dynamic Science, Inc.
Crash Investigation
Case Number: DS09031

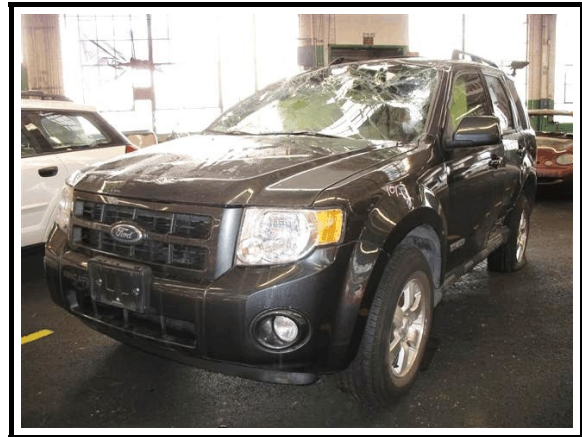
Figure 1. Subject vehicle, 2008 Ford Escape

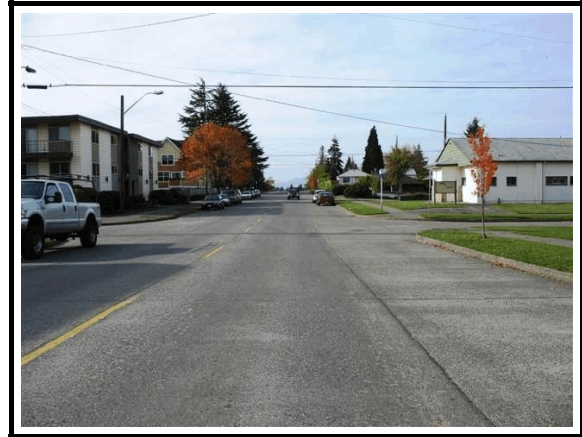
The crash site was a four-leg intersection consisting of an undivided east/west roadway and an undivided north/south roadway. (**Figure 2**). The east/west roadway was configured with one lane for each direction; each lane measured 6.5 m (21.2 ft) in width. The lanes were separated by a dashed yellow painted stripe. The roadway was bordered on each side by raised concrete curbs

Figure 2. Crash site, looking west

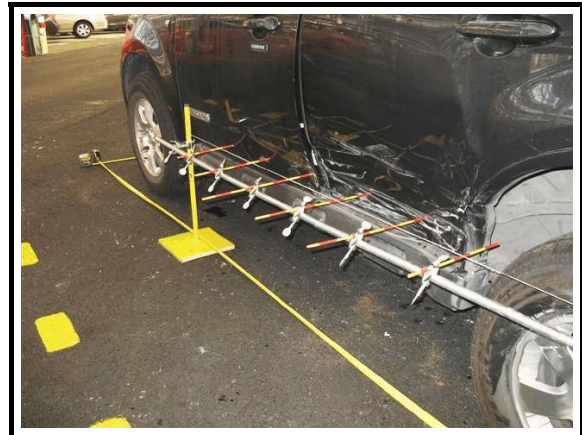
The Ford sustained direct and induced damage to the left side resulting from the vehicle-to-vehicle impact (Event 1) and direct and induced damage to the right side and top resulting from the rollover (Event 2). Direct damage to the left side began at the left rear axle, extended 160.0 cm (63.0 in) forward, and ended 101.0 cm (39.8 in) aft of the left front axle. The Field L began 34.0 cm (13.4 in) forward of the left rear axle, extended 126.0 cm (49.6 in) forward, and ended 101.0 cm (39.8 in) aft of the right front axle (**Figure 3**). Six crush measurements were taken at lower-door level as follows: $C_1 = 5.0$ cm (2.0 in), $C_2 = 7.0$ cm (2.8 in), $C_3 = 8.0$ cm (3.2 in), $C_4 = 4.0$ cm (1.6 in), $C_5 = 3.0$ cm (1.2 in), $C_6 = 0$ cm. Maximum crush was located 84.0 cm (33.1 in) forward of the right rear axle at C_3 . The Collision Deformation Classification (CDC) for Event 1 was 10LZEW1.

The vehicle-to-vehicle impact resulted in direct damage to the Ford's left B-pillar, left C-pillar, and left side doors. At the second row left side door, the height of maximum door crush measured 48.0 cm (18.9 in), the sill height measured 41.0 cm (16.1 in), and the Door Sill Differential (DSD) was 6.0 cm (2.4 in).

Figure 3. Left side crush profile, 2008 Ford Escape

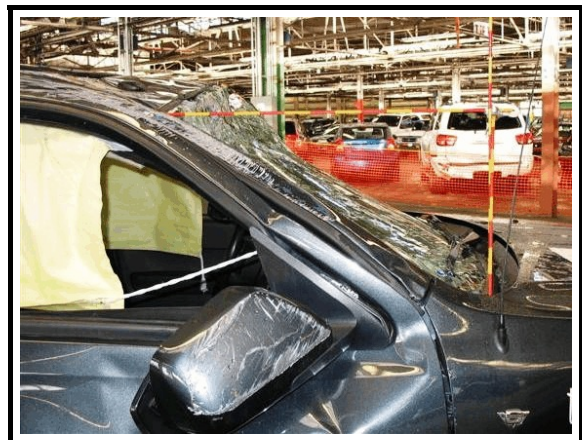
Figure 4. Maximum vertical crush measurement, 2008 Ford Escape

began at the D-pillar, 65.0 cm (25.6 in) aft of the right rear axle; the damage extended 372.0 cm (146.5 in) forward to the right front fender. Vertically, the damage began at the sill and extended upward 177.0 cm (46.1 in) to the roof side rail. The direct damage to the top plane began on the forward aspect of the hood, extended rearward 371.0 cm (146.1 in), and ended on the rearward aspect of the roof. Laterally, the damage was distributed 126.0 cm (49.6 in) from roof side rail to roof side rail. Maximum lateral crush to the right roof side rail was located 157.0 cm (61.8 in) forward of the right rear axle and measured 16.0 cm (6.3 in). Maximum vertical crush to the left windshield header was located 8.0 cm (3.2 in) right of the left roof side rail and measured 12.0 cm (4.7 in) (**Figure 4**). The CDC for the rollover was 00TDDO2.

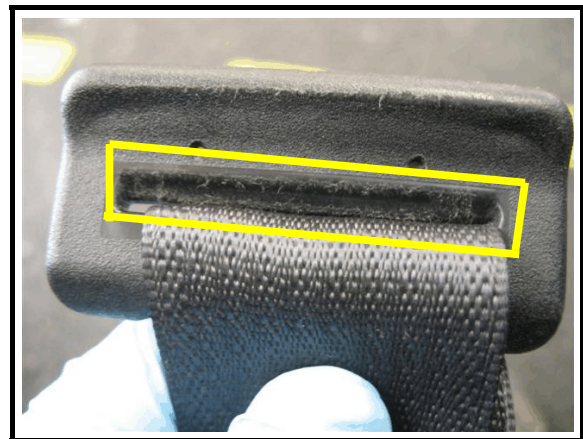
The driver's safety belt D-ring was in the full-up position and the latch plate was scratched indicating historical usage. The safety belt retractor pretensioner had actuated during the crash and the safety belt webbing was locked in the used position. The buckle pretensioner also actuated and the buckle stalk measured 23.0 cm (9.0 in) in length, resulting in of pretensioner distance of 1.0 cm (0.4 in). The safety belt latch plate was scuffed where the webbing was routed as a result of occupant loading (**Figure 5**). The scuff to the back side measured 4.0 cm (1.6 in) in width. The safety belt webbing exhibited three scuff marks resulting from occupant loading: the first scuff was located 38.0 cm (15.0 in) above the stop button at the latch plate, the second scuff was located 50.0 cm (19.7 in) above the stop button at the driver's

Figure 5. Driver's safety belt latch plate, 2008 Ford Escape

abdomen, and the third scuff was located 110.0 cm (43.3 in) above the stop button at the D-ring. A load mark at the D-ring measured 1.0 x 4.0 cm (0.4 x 1.6 in). Based on the vehicle inspection, the front row left safety belt was determined to have been used to restrain the driver during the crash.

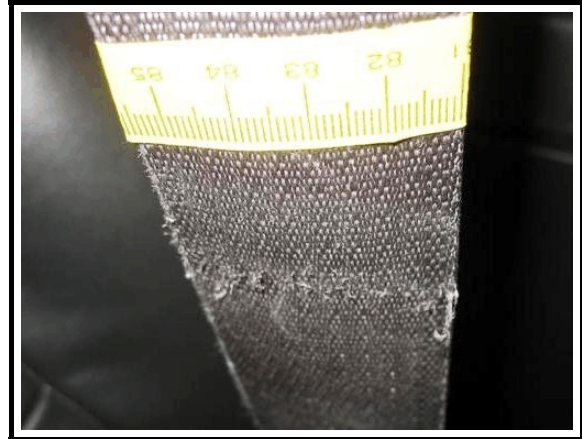
The front row right passenger's safety belt D-ring was set to the middle position and the latch plate was scratched indicating historical usage. The safety belt retractor pretensioner had actuated during the crash and the safety belt webbing was locked in the used position. The buckle pretensioner also actuated and the stalk measured 20.0 cm (7.9 in) in length, resulting in a pretensioner distance of 4.0 cm (1.2 in). The safety belt latch plate exhibited load marks on both sides where the webbing was routed. The scuffs on the latch plate measured 4.0 cm (1.6 in) in width and was equal to the width of the webbing. The safety belt webbing yielded load marks in three areas: the first was located 24.0 cm (9.4 in) above the stop button at the latch plate (**Figure 6**); the second was located 53.0 cm (20.9 in) above the stop button at the occupant's right shoulder; the third was located 92.0 cm (36.2 in) above the stop button at the D-ring. A scuff to the D-ring measured 1.0 x 4.0 cm (0.4 x 1.6 in). Based on the vehicle inspection, the front row right safety belt was determined to have been used to restrain the front right occupant during the crash.

Figure 6. Front right occupant's safety belt webbing, 2008 Ford Escape

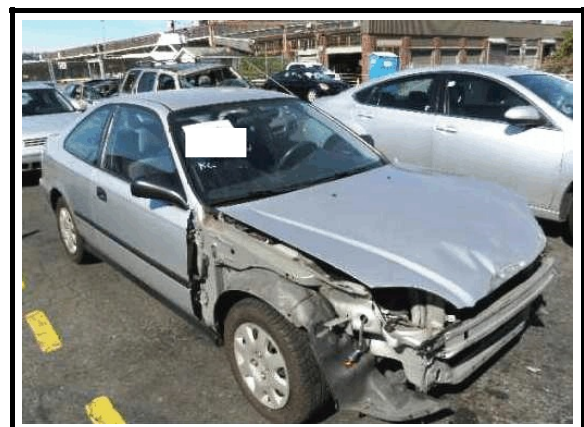
The Honda Civic (**Figure 7**) was identified by VIN: 1HGEJ6179YL8xxxxx. The vehicle was a 2-door coupe was equipped with a 1.6-liter, 4-cylinder engine. The vehicle was manufactured in the U.S.A. for the Canadian market. The odometer reading was 99,131 km (61,598 mi). The vehicle was sold at an insurance auction facility and photographs obtained from the facility show that partial tear-down of the vehicle's damaged sheet

Figure 7. Other vehicle, 2000 Honda Civic

metal had taken place before the sale. The missing components included the grille, front bumper fascia, and left and right front fenders. The hood was buckled and exhibited induced minor damage distributed laterally across the front.
