On-Site Side Air Bag Investigation
Dynamic Science, Inc. (DSI), Case Number DS09032
2007 Honda Accord
Washington
September 2009

1. Report No. DS09032	2. Government Accession No.		3. Recipient Catalog No.	
4. Title and Subtitle On-Site Side Air Bag Investigation		5. Report Date August 27, 2010

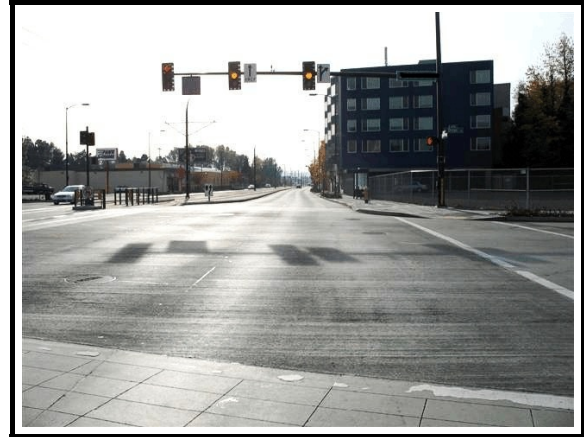
The crash consisted of a single event. The front end of the Toyota impacted the left side of the Honda between its B-pillar and rear axle, aft of its longitudinal center of gravity. The Honda then initiated a post-impact counterclockwise rotation and was displaced to the right. It came to rest facing north in the outboard southbound lane (**Figure 3**) approximately 8.0 m (26.0 ft) from the point of impact.

Figure 3. Area of impact and path to final rest for subject vehicle, looking south

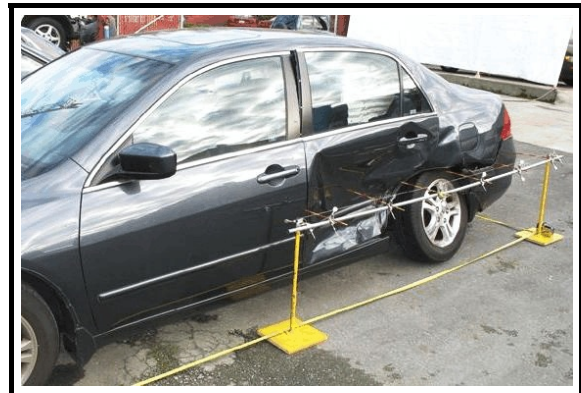
The Honda sustained direct and induced damage to the left side. Direct damage began 38.0 cm (15.0 in) forward of the left rear bumper corner, extended forward 194.0 cm (76.4 in), and ended 140.0 cm (55.1 in) aft of the front axle. The Field L began at the left rear bumper corner, extended forward 210.0 cm (82.7 in), and ended 162.0 cm (63.8 in) aft of the front axle (**Figure 4**). Vertically, the direct damage began at the sill, extended upward 59.0 cm (23.2 in), and ended above mid-door level. Six crush measurements were taken at mid-door level as follows: $C_1 = 0$, $C_2 = 0$, $C_3 = 11.0$ cm (4.3 in), $C_4 = 19.0$ cm (7.5 in), $C_5 = 13.0$ cm (5.1 in), $C_6 = 0$. Maximum crush was located at C_4 and measured 19.0 cm (7.5 in). The Collision Deformation Classification (CDC) for Event 1 was 10LZEW2.

Figure 4. Subject vehicle showing left side crush profile measurement

The Honda sustained direct damage to the left rear door panel. The vehicle's sill height measured 29.0 cm (11.4 in), the height of maximum door crush measured 57.0 cm (22.4 in), and the Door Sill Differential (DSD) measured 8.0 cm (3.1 in). Additionally, the vehicle's left rear tire was restricted and the rim was deformed to a 15 degree inboard cant.

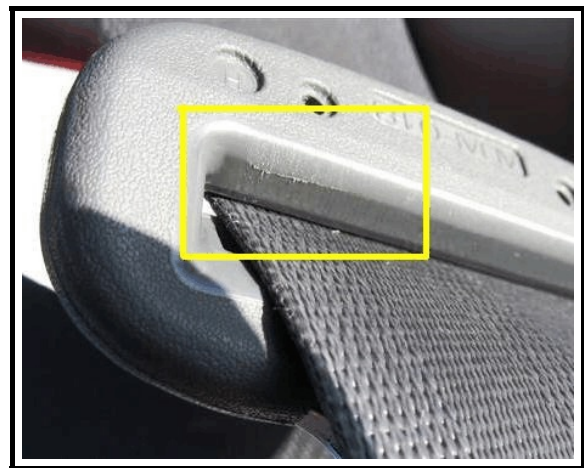
The driver's safety belt D-ring anchorage was in the full-up position. The latch plate was scratched and the shoulder belt webbing revealed wear marks indicating historical usage. The safety belt retractor pretensioner had actuated during the crash and the safety belt webbing was locked in the used position. The safety belt latch plate was scuffed indicating occupant loading where the webbing was routed through the latch plate (**Figure 5**). Two scuffs measuring less than 1.0 cm (0.4 in) each were located 11.0 cm (4.3 in) above the stop button, and an abraded section measuring 9.0 cm (3.5 in) in length began 3.0 cm (1.2 in) below the stop button and extended downward. Based on the vehicle inspection, the driver's safety belt was determined to have been used to restrain the driver during the crash.

Figure 5. Scuff to safety belt latch plate resulting from occupant loading

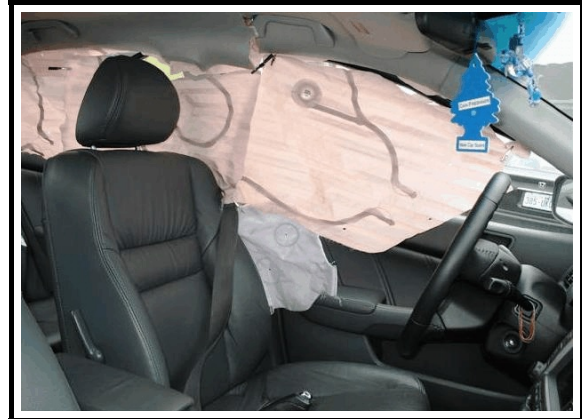
The vehicle's Supplemental Restraint System (SRS) included an air bag control module (ACM), driver and passenger frontal air bags, front seat-mounted side air bags, side impact IC air bags, and safety belt retractor pretensioners for the front row. During the crash, the left seat-mounted side air bag and the left IC air bag deployed (**Figure 6**) and the driver's safety belt retractor pretensioner actuated.

The left seat-mounted side air bag deployed from the outboard aspect of the left seat-back. The air bag was hexagonal in shape with a rectangular tab at the leading edge. It measured 35.0 cm (13.8 in) in height, 30.0 cm (11.0 in) in width, and covered the upper rear quadrant of the left door panel. The air bag's lower edge was level with the bottom of the arm rest and the upper edge extended to the side glass. The air bag was configured with two vent ports and did not have internal tethers.

The seat-mounted side air bag exhibited evidence of occupant loading on the outboard panel. The outboard panel revealed a 2.0 cm (0.8 in) scuff located near the leading edge resulting from occupant loading which in turn caused the air bag to load the left door panel. A scuff measuring 5.0 x 5.0 cm (2.0 x 2.0 in) on the door panel's rear upper quadrant was consistent with the evidence on the air bag.

Figure 6. Deployed seat-mounted side air bag and IC air bag

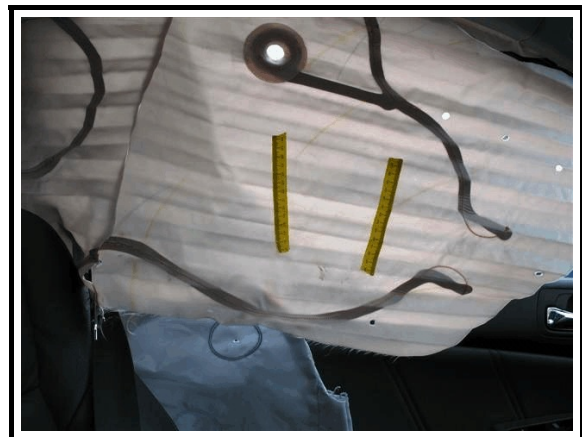
The left IC air bag deployed from the left roof side rail above the front and second rows. The IC air bag measured 184.0 cm (72.4 in) in length x 40.0 cm (15.7 in) in height. The air bag was configured with 20 folded pleats that were oriented horizontally. The IC air bag was configured with three 2.0 cm (0.8 in) vent ports and several smaller vent ports. Two sections of the IC air bag had been cut out by the repair facility to allow easier access to the vehicle's interior. The displaced sections were located in the vehicle during the inspection. The DSI investigator reattached the sections to their original positions and the inboard panel revealed a hair and skin oil transfer measuring 8.0 x 8.0 cm (3.1 x 3.1 in). The transfer was located near the vertical center of the inboard panel and approximately 32.0 cm (12.6 in) from the leading edge of the panel (**Figure 7**). Based on the

Figure 7. Location of hair and skin oil transfer on the left IC air bag

driver's kinematics and injuries, her head and hair were determined to be the source of the transfer.

The driver's head and possibly her left face loaded the IC air bag, depositing a hair and skin oil transfer to the inboard panel and resulting in post-impact dizziness and disorientation. The window opening allowed the IC air bag some space in which to move laterally when it was loaded by the driver. The driver did not sustain a facial injury but possibly sustained a minor closed head injury after loading the IC air bag.

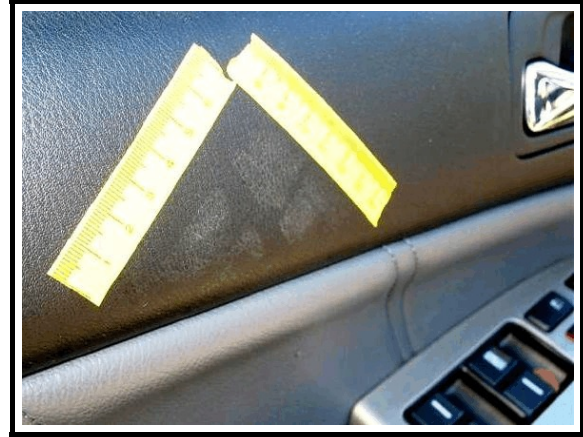
contacted the seat back in the lower left quadrant depositing scuffs to the leather. The driver's left shoulder and flank loaded the seat-mounted side air bag, depositing scuffs and transfers to the rear upper door panel just below the bottom of the side glass (**Figure 8**). Her left hip loaded the rear lower quadrant of the left door panel and sustained a contusion.

Figure 8. Scuff to door panel resulting from occupant loading
