On-Site Child Restraint System Investigation
Dynamic Science, Inc. (DSI), Case Number DS09036
2002 Nissan Xterra
Oregon
November 2009

| 16. Abstract This on-site child restraint system (CRS) investigation focused on the occupants and Infant Safety Seat (ISS) in a 2002 Nissan Xterra sport utility vehicle that was involved in a side impact crash. The vehicle was being driven by a restrained 21-year-old female. The front right seat of the Nissan was occupied by a restrained 55-year-old female and the second row left seat was occupied by a restrained 28-year-old female. The second row right seat was occupied by a 1-month-old female who was seated in the rear-facing ISS. The other vehicle was a 1979 GMC pickup that was being driven by a 75-year-old male. The crash occurred in the northbound lane of a state highway. The Nissan was traveling southbound and the GMC was traveling northbound. The driver of the Nissan lost control of the vehicle, initiated a counterclockwise rotation, and entered the northbound travel lane. The front of the GMC impacted the right side of the Nissan. The driver of the Nissan sustained moderate injuries and was transported to a local hospital where she was tre

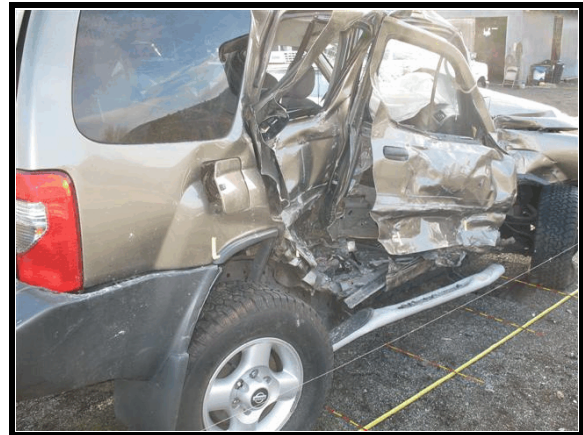
The Nissan sustained moderate right side damage due to the impact with the front of the GMC (**Figure 4**). The direct damage began 31.0 cm (12.2 in) forward of the rear axle and extended forward 240.0 cm (94.4 in). The Field L began 13.0 cm (5.1 in) aft of the rear axle and extended forward 314.0 cm (123.6 in). Six crush measurements were documented at the mid-door level: $C_1 = 0$ cm, $C_2 = 32.0$ cm (12.6 in), $C_3 = 46.0$ cm (18.1 in), $C_4 = 32.0$ cm (12.6 in), $C_5 = 40.0$ cm (15.7 in), $C_6 = 0$ cm. The maximum crush was located 85.0 cm (33.4 in) forward of the rear axle and measured 69.0 cm (27.1 in). The height of the maximum crush was 74.0 cm (29.1 in) and the Door Sill Differential (DSD) was 26.0 cm (10.2 in). The Collision Deformation Classification (CDC) for the right side impact was 02RZAW3.

Figure 4. Right side damage, subject vehicle

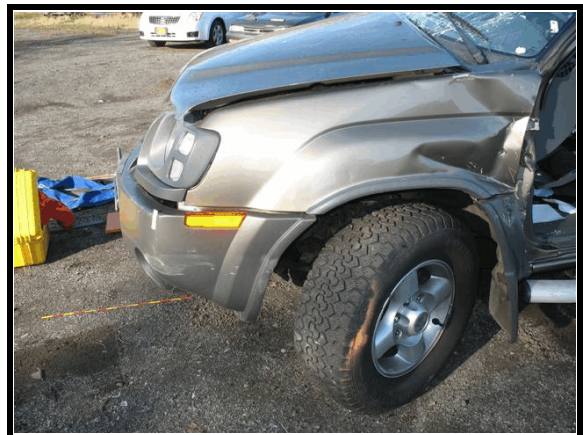
The vehicle sustained minor left side damage due to the impact with the guardrail (**Figure 5**). The direct damage began at the front left bumper corner and extended rearward 84.0 cm (33.0 in) along the bumper fascia and including light contact to the wheel hub. The maximum crush was located at the left bumper corner and measured 3.0 cm (1.2 in). The CDC for the guardrail impact was 07LFES1. There was also damage to the side panel near the left A-pillar that was probably a result of extrication efforts.

Figure 5. Left front damage

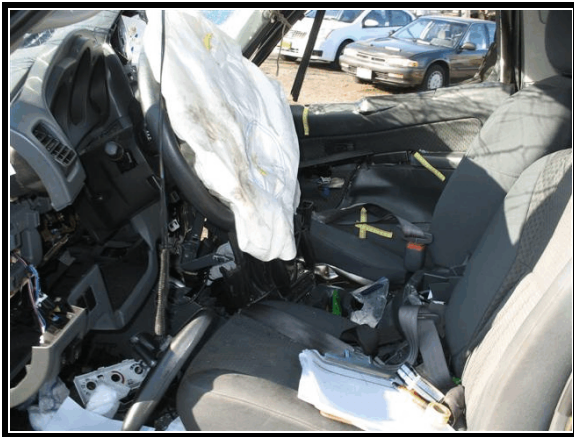
The Nissan sustained moderate interior damage from intrusion and occupant contacts (**Figures 6-7**). Contacts and loading were documented to front row right door, center console, second row right door, driver's seat belt webbing, and the right instrument panel. There was lateral intrusion of the right doors, right A-pillar, right sill, right B-pillar, center console, right roof rail, front seat back, and right C-pillar; there was longitudinal intrusion of the right and center instrument panel. Both right side doors were jammed shut. The left front door was reported by the police to have been jammed shut; it was removed from the vehicle during extrication efforts.

Figure 6. Front row contacts and intrusion

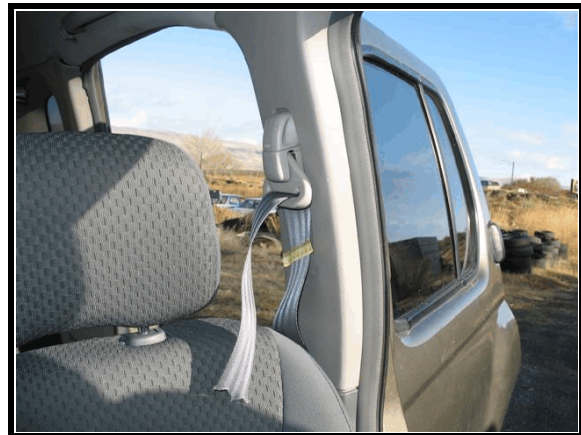
The Nissan was configured with 3-point manual lap and shoulder belts for the four outboard seat positions and a lap belt for the second row middle seat position. The vehicle was equipped with driver and front passenger safety belt retractor pretensioners that actuated as a result of the crash. The front seats were equipped with seat belt anchorages that were in the full-up position. The driver's safety belt was configured with a sliding latch plate and an Emergency Locking Retractor (ELR); it was being used at the time of the crash. There were abrasions observed at the latch plate and at the anchorage consistent with driver loading (**Figure 8**). The belt webbing had been cut by emergency personnel at a point 18.0 cm (7.0 in) from the stop button.

Figure 8. Driver seat belt loading

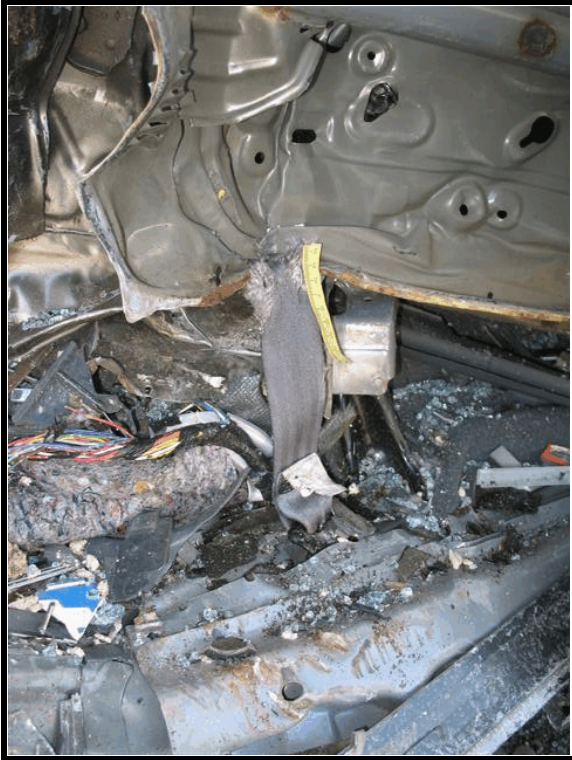
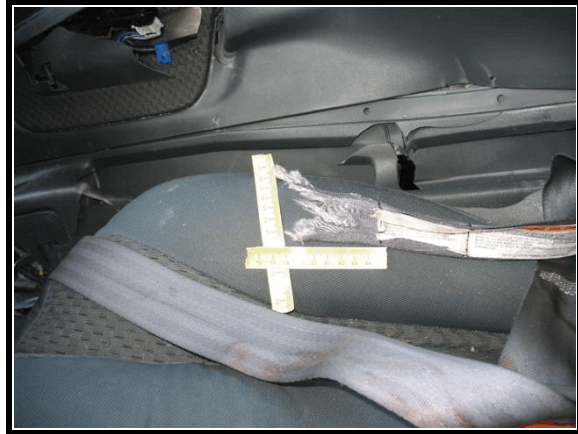
The front right passenger safety belt was configured with a sliding latch plate and a switchable ELR/Automatic Locking Retractor (ALR); it was being used at the time of the crash. There was blood observed along the lap portion of the belt and the belt had been cut by emergency personnel. The belt was torn and damaged from vehicle damage at a point 16.0 cm (6.3 in) from the anchor (**Figures 9 and 10**).

Figure 9. Front right seat belt (at anchor)

Figure 10. Front right seat belt (in vehicle)

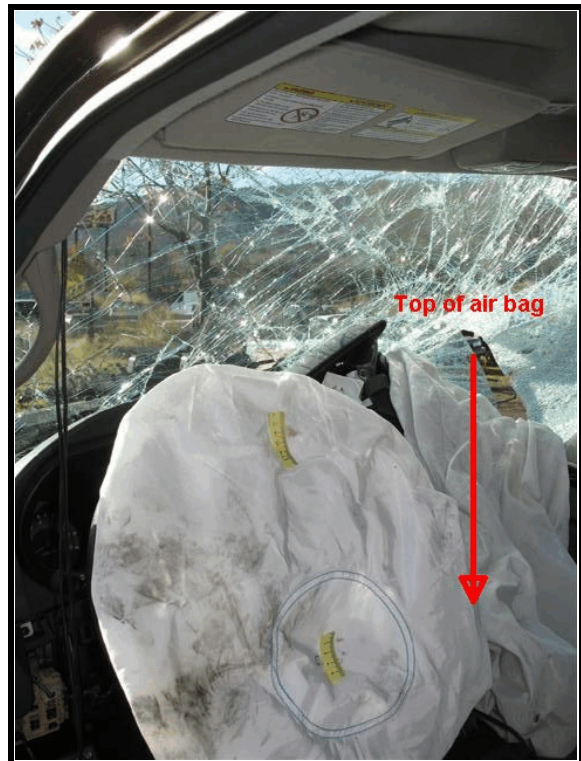
Figure 11. Driver air bag

The driver air bag module was located in the center hub of the steering wheel. The module cover flaps were designed in a tri-fold pattern. The upper flap measured 14.0 x 4.0 cm (5.5 x 1.6 in), width by height. The symmetrical lower flaps measured 8.0 x 6.0 cm (3.1 x 2.4 in), width by height. There was no damage or occupant contact to the flaps. The driver air bag measured 62.0 cm (24.4 in) in diameter in its deflated state. The bag was tethered by a single strap and vented by two ports located on the back side of the bag in the 11/1 o'clock sectors. The right side of the face of the air bag was dirt and grease covered; a small blood drop was located at the bottom of the bag (**Figure 11**). The front right passenger air bag was located in the right aspect of the instrument panel. The air bag deployed from a top-mount

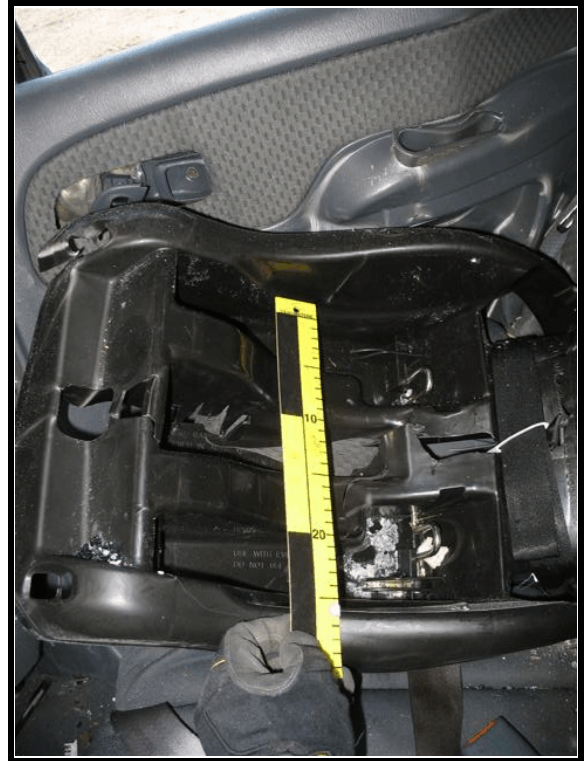
The 1-month-old female child was seated in a Evenflo Embrace ISS (**Figure 12**). The seat was identified by the Model No. 4851928A and was manufactured on 4-15-2009. The seat was designed to be used in the rear-facing orientation only and was to be used for children weighing between 2.3-10.0 kg (5.0-22.0 lbs) and whose height was between 48.2-73.6 cm (19.0-29.0 in). The 1-month-old weighed approximately 5.0 kg (11.0 lbs) and was within the weight guideline; her height was 57.0 cm (22.5 in) and was within the height guideline. The seat was equipped with a 3-position handle that rotated from a vertical carry position, to a horizontal car position, to a 45 degree stand position. The handle was in the car position at the time of the crash. The seat was also equipped with a fabric cushioning shell, an attached pillow, and a canopy. The canopy was in the down position at the time of the crash. The seat was designed with a 5-point harness with 2 crotch strap buckle positions and 3 shoulder harness positions; at the time of the crash the crotch strap was in the rear-most position and the shoulder harness straps were routed through the middle slots. According to the interviewee, the retainer clip was at the chest/armpit level and the harness straps were tightly fastened. The seat was attached to a stay-in-car base that was anchored to the vehicle using the two ISS LATCH connector straps and the vehicle's lower anchors (**Figure 13**). The seat base was equipped with an adjustment foot that was used to adjust the level of the base. At the time of the vehicle inspection, the base indicator was green—meaning that the base was level.

Figure 12. Damaged ISS base

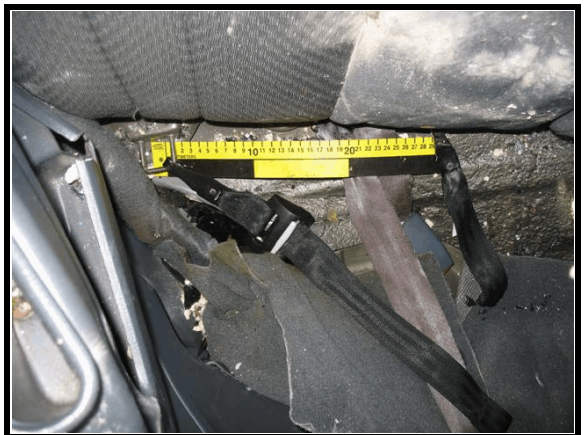
Figure 13. LATCH anchors and straps (looking toward rear of vehicle)

After the ISS carrier was removed from the vehicle, the seat base and its installation was observed with the base still anchored to the vehicle. The driver had been instructed in the installation procedures by a local law enforcement officer. To all appearances, the installation appeared correct and there was virtually no movement of the seat. It should be noted that the right rear door intruded into this seating area and seat was pinned into place by the door. Efforts were undertaken to remove the seat base by the investigating officer. When this could not be done by loosening the adjuster strap, the LATCH straps were cut and the base was removed from the vehicle. The distance from the anchor attachment to the buckle adjuster measured 32.0 cm (12.6 in).

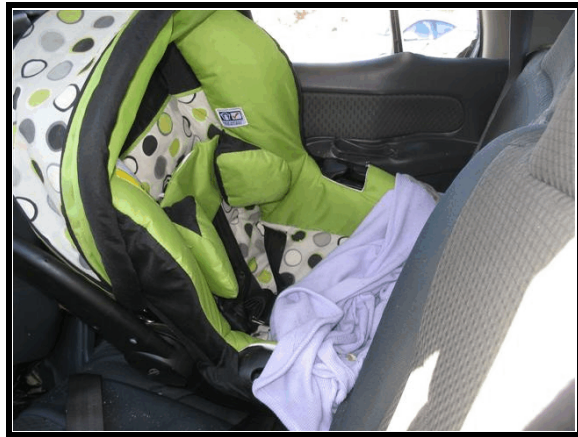
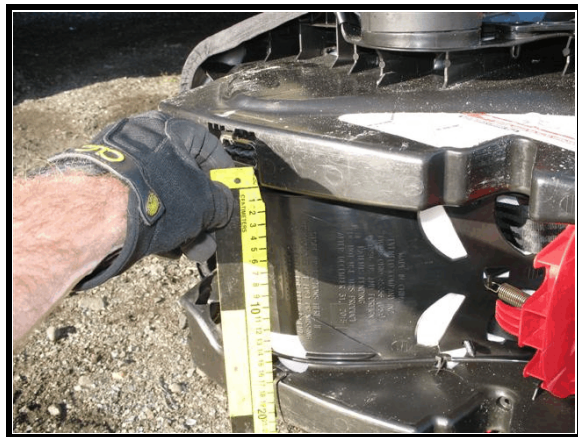
Figure 14. Evenflo Embrace ISS

Both the ISS carrier and the base were damaged during the crash due to the lateral intrusion of the second row right door (**Figures 14-15**). References to the damage to the rear-facing seat will be as viewed forward-facing in the vehicle. The seat base was deformed and fractured on the right side (side next to the door). There were several fractures in the center area and a 12.0 x 4.0 cm (4.7 x 1.6 in) section of plastic was fractured and displaced. At either end, there were hazed areas of plastic that was indicative of compression or bending. The carrier was fractured on the left side and the fracture extended to the bottom of the left base insertion area.

Figure 15. Damage to ISS carrier

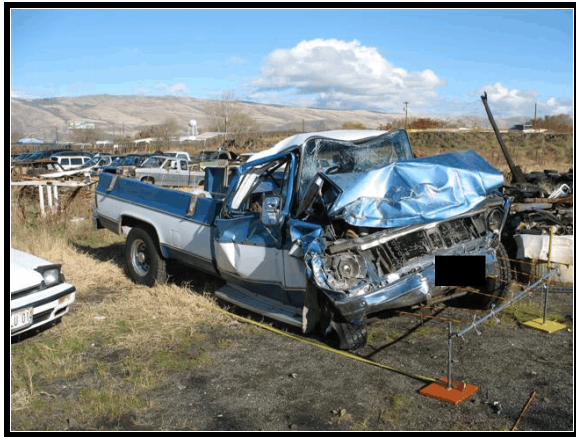
The GMC sustained moderate front end damage due to the impact with the right side of the Nissan (**Figure 16**). The direct damage began at the right front bumper corner and extended 182.0 cm (71.6 in) across the front of the vehicle. The Field L included the entire front end. Six crush measurements were documented at the bumper level: $C_1 = 33.0$ cm (12.9 in), $C_2 = 17.0$ cm (6.7 in), $C_3 = 26.0$ cm (10.2 in), $C_4 = 33.0$ cm (12.9 in), $C_5 = 44.0$ cm (17.3 in), $C_6 = 74.0$ cm (29.1 in). The CDC for the frontal impact was 12FDEW4.

Figure 16. Front right, 1979 GMC pickup

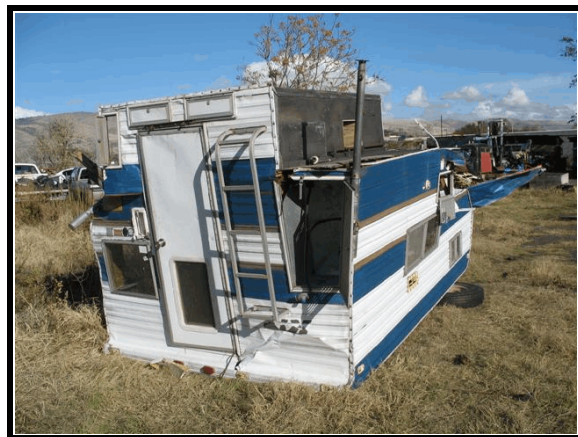
Figure 17. Kit Cabover Camper

During the impact, the Kit camper was displaced from the bed of the vehicle, rolled two quarter turns, and came to rest on its roof.
