**CRASH DATA RESEARCH CENTER**

**NOT-IN-TRAFFIC SURVEILLANCE  
CALSPAN ON-SITE FRONT OVER INVESTIGATION**

**SCI CASE NO: CA09039**

**VEHICLE: 2005 CHRYSLER PACIFICA  
LOCATION: CONNECTICUT  
INCIDENT DATE: JUNE, 2009**

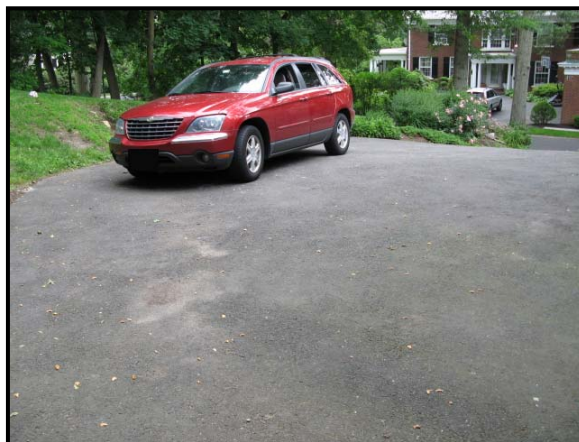
This on-site investigation focused on the circumstances surrounding the serious injuries sustained by an 11-year old female child who was injured during a front over incident in the driveway of her home. The child was struck by the front of a 2005 Chrysler Pacifica driven by her mother. The child was sitting in the driveway working on an arts and craft project at the time of the incident. The driver was returning home from a work related event and ascended the positive grade of the driveway toward a paved parking area located immediately outside of the garage. The center aspect of the Pacifica's front plane struck the non-motorist and knocked her to the ground. The forward undercarriage of the Pacifica then overrode the child as the vehicle came to a controlled stop. The driver stopped and exited the vehicle not knowing the front over incident had occurred (**Figure 1**).

**Figure 1: Approximate stopped position of the Chrysler reconstructed during the SCI inspection.**

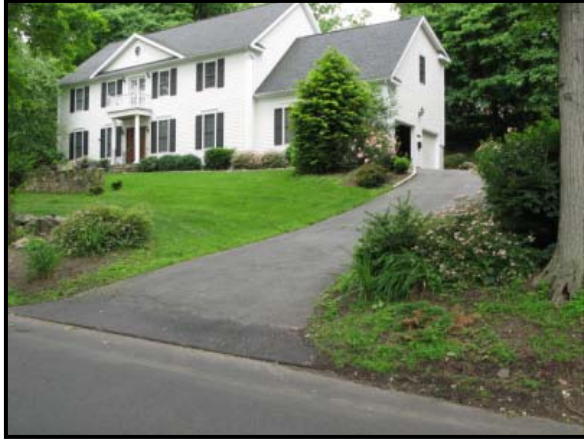
Figure 2: Southwest view toward the property.

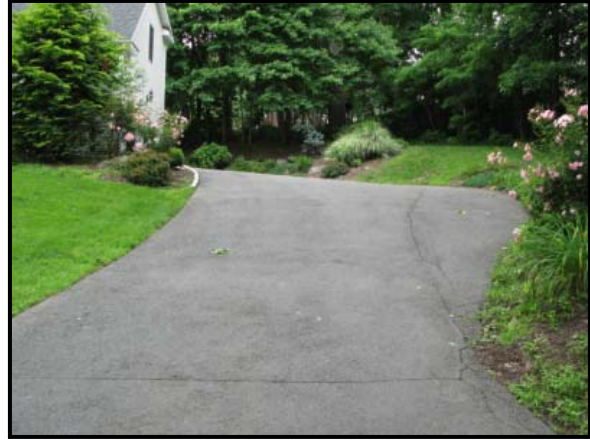
Figure 3: West view along the driveway.

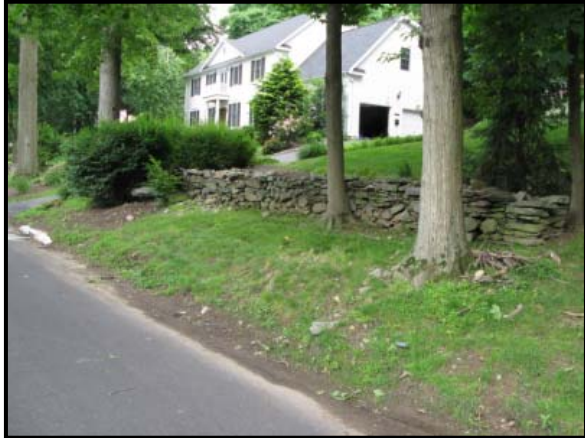
The visibility from the road to the parking area was partially obstructed by trees and landscaping along the vehicle's path of travel. **Figures 4 and 5** are views toward the driveway on the approach path. The driver turned right entered the driveway and began to ascend the grade. The driver estimated the speed of the vehicle was less than 8 km/h (5 mph). **Figure 6** is a view from the base of the driveway with the target placed at the approximate position of the non-motorist.

**Figure 4: View toward the residence from the approach path.**

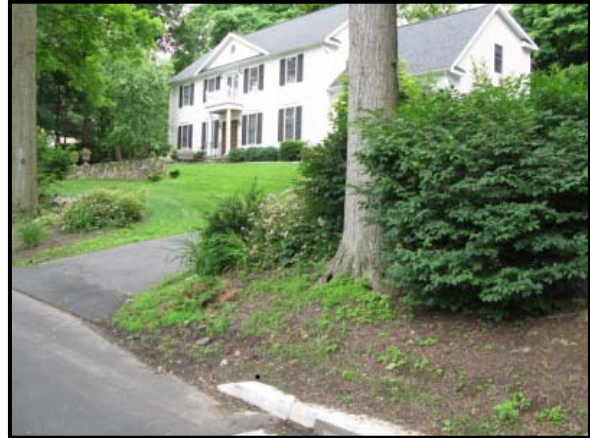
**Figure 5: View toward the driveway from the approach path.**

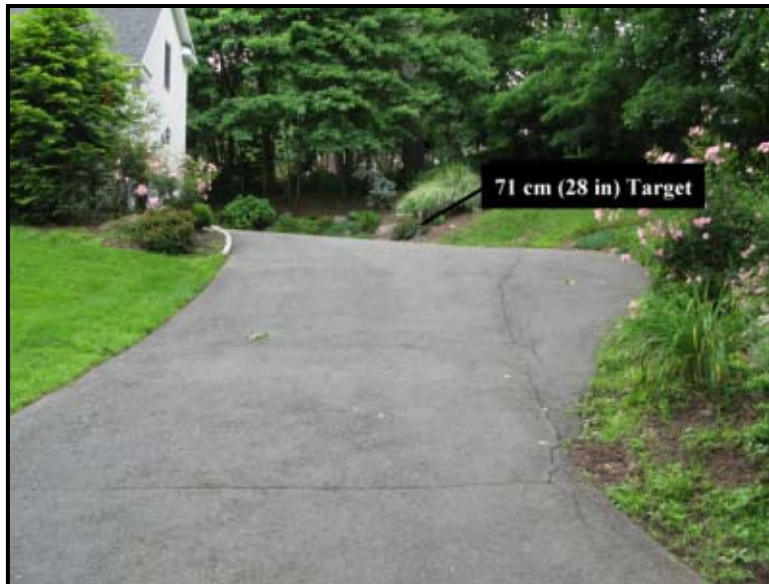
**Figure 6: View from the base of the driveway with the 71 cm (28 in) target at the non-motorist location.**

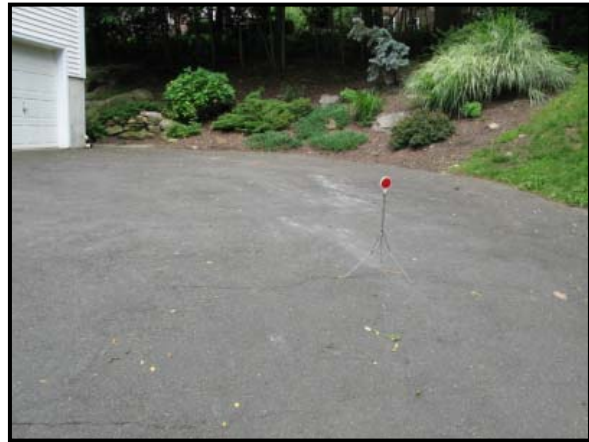
**Figure 7** is view of the area of dissolved soap taken from the perspective of the vehicle’s path of travel. The reflective target depicted the pre-incident location of the non-motorist.

**Figure 7: View of the dispersed, dissolved soap; the area of the incident.**

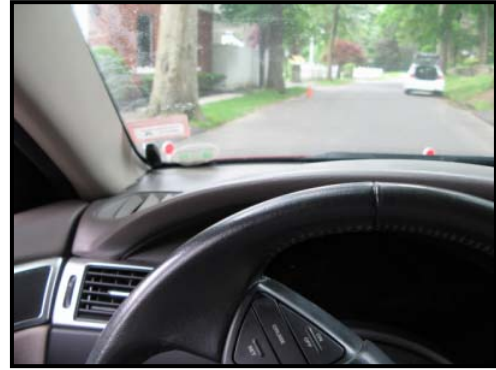
located outboard the left mirror, at the left front, forward centerline, at the right front and outboard the right mirror. The driver was asked when she could first identify the targets while seated in a normal driving position. Her seated eye height was 157 cm (52 in) above the ground. **Figure 8** is a driver view through the windshield to the centerline target. **Figures 9 and 10** are exterior views depicting the forward blind zone of the Pacifica on level ground. The target locations were then measured with respect to the vehicle. On level ground, the longitudinal distance from the front bumper fascia to the centerline target measured 145 cm (57.2 in).

**Figure 8: Driver view to the forward visibility targets.**

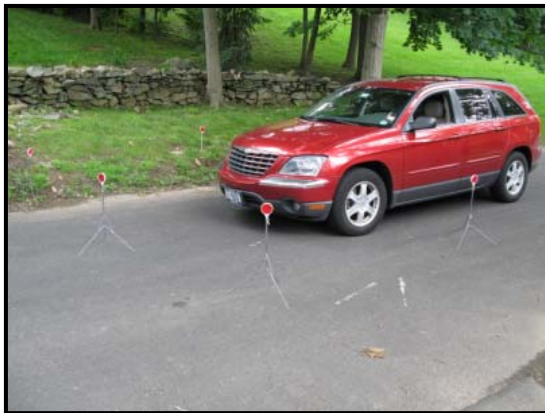
**Figure 9: Left front oblique view of the forward blind zone (level pavement).**

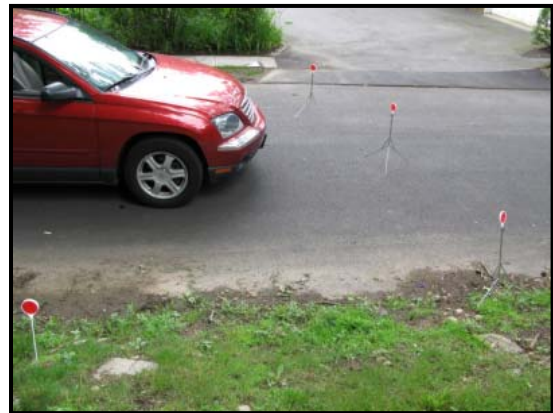
**Figure 10: Right exterior view of the forward blind zone (level pavement).**

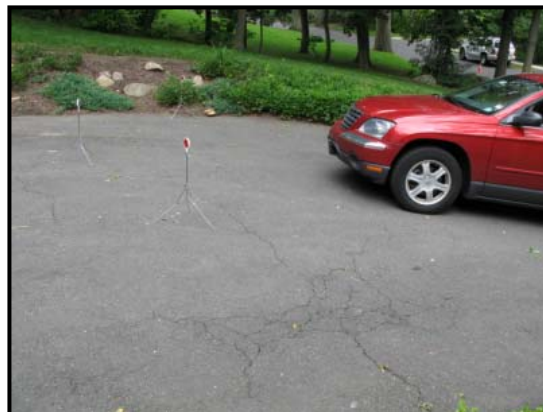
The Chrysler was then moved, parked near the crest of the driveway, and the measurements repeated. The front plane of the vehicle was located 14.6 m (48 ft) from the end of the driveway. **Figure 11** is an exterior view depicting the forward blind zone at the crest of the driveway. Parked on the sloped driveway, the bumper to centerline target distance measured 285 cm (112.2 in). **Figure 12** attached to the end of this report is a scaled overhead visibility schematic depicting the blind zone forward of the driver based in the measured target locations.

**Figure 11: Left exterior view of the forward blind zone at the driveway crest.**

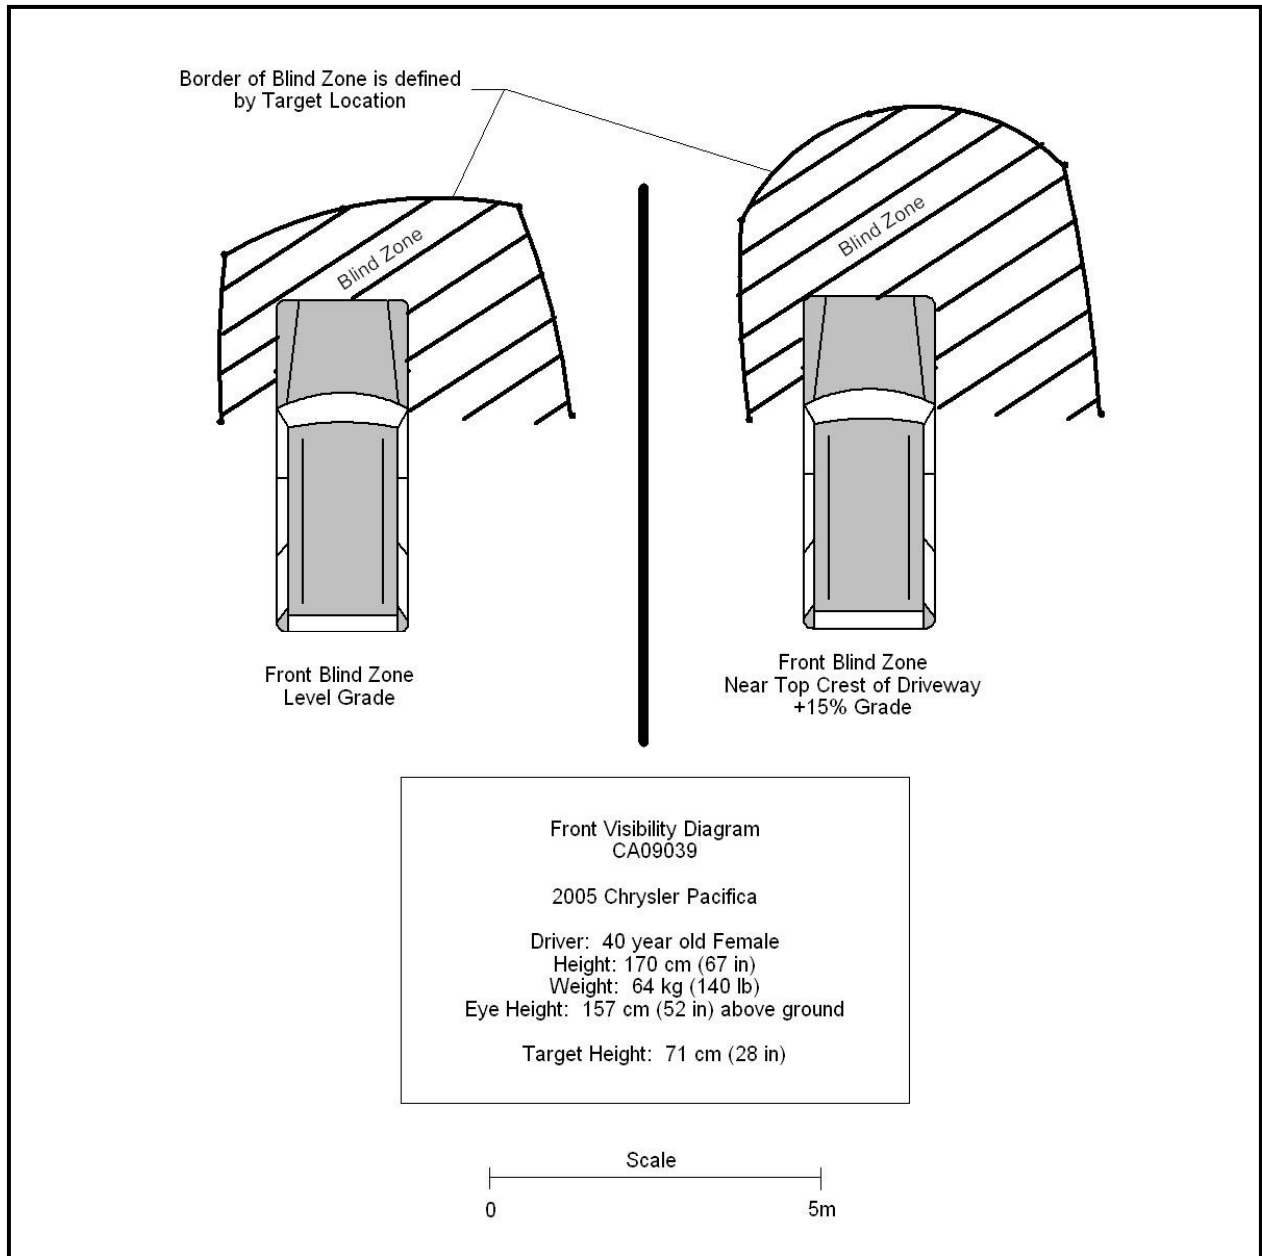
**Figure 12: Overhead front visibility diagram.**

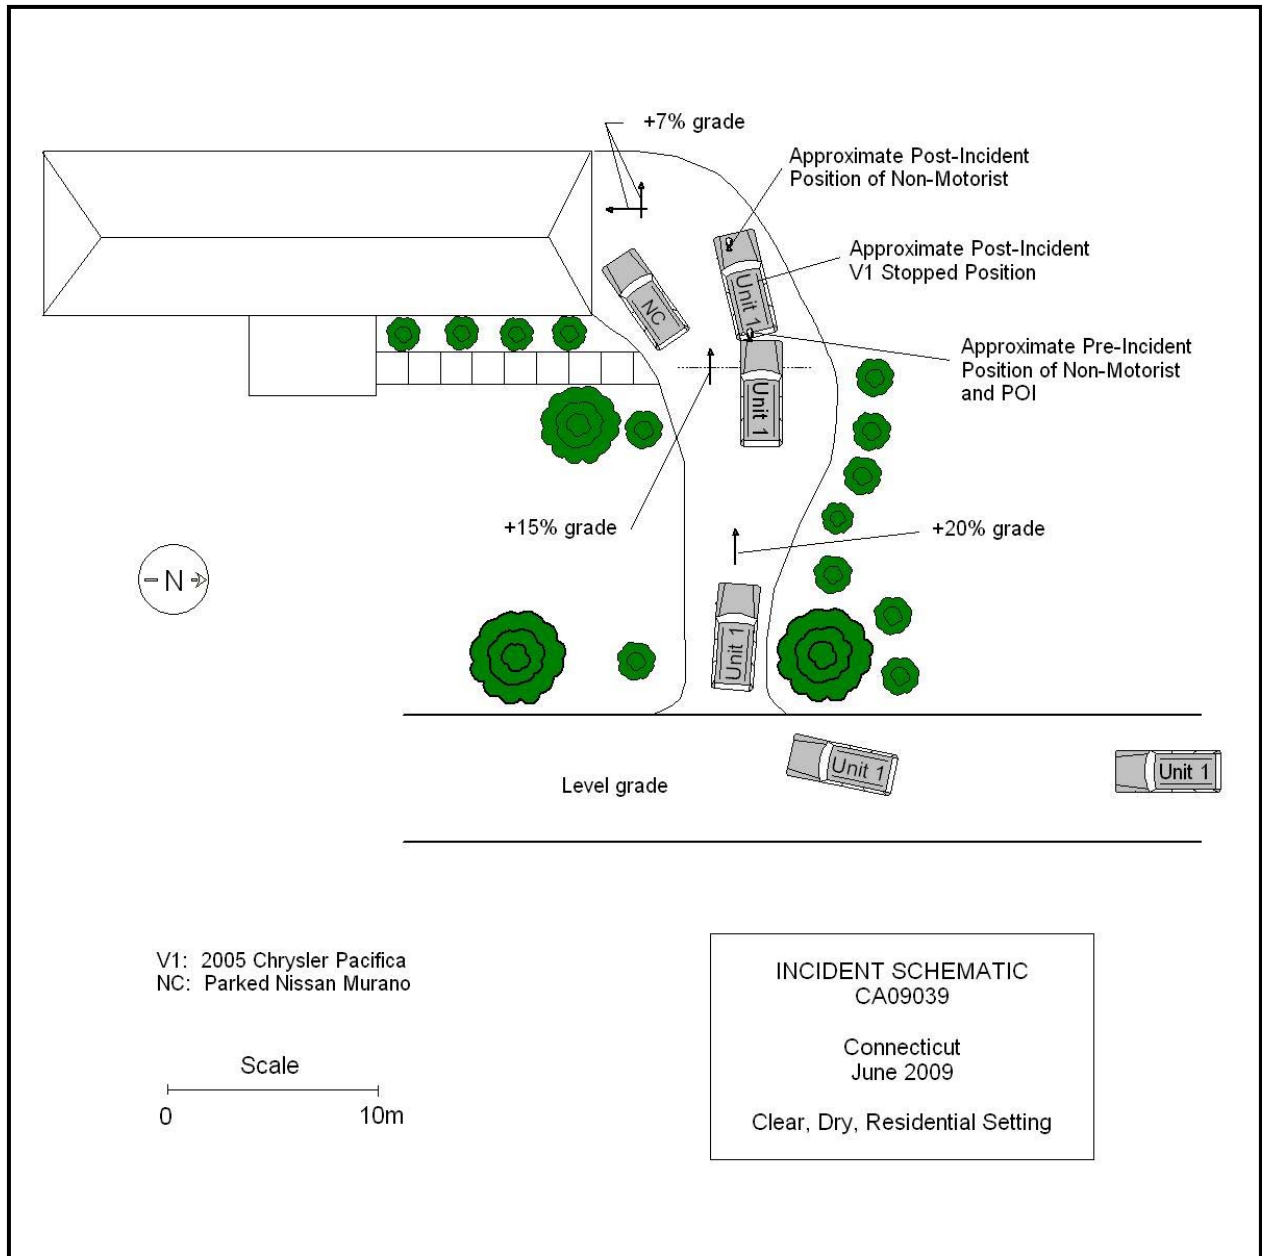
A schematic of the incident is attached to the end of this narrative report, **Figure 13**. The driver of the Chrysler approached the residence from the north, traveling south on the roadway. She indicated that this was her typical path of travel and never approached the driveway from the south. She was returning home from a work-related event and was not rushed or in a hurry. The non-motorist was sitting in the driveway approximately 18 m (60 ft) from the road edge. A non-contact vehicle was located on the left side of the parking area at the first garage bay.

Figure 13: Incident schematic.
