ON-SITE ROLLOVER INVESTIGATION

CASE NUMBER - IN09039

VEHICLE - 2006 KIA SORENTO LX

CRASH DATE - September 2009

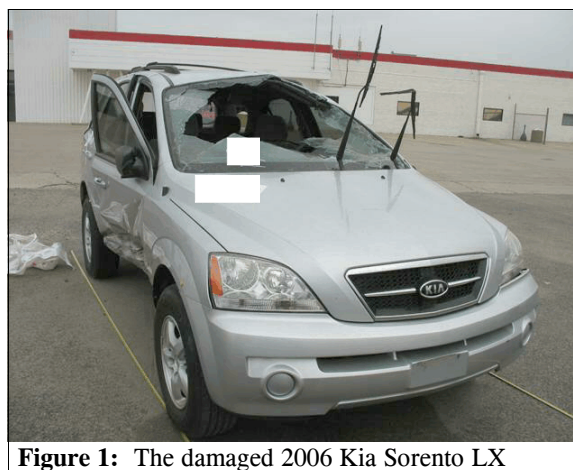
Figure 1: The damaged 2006 Kia Sorento LX

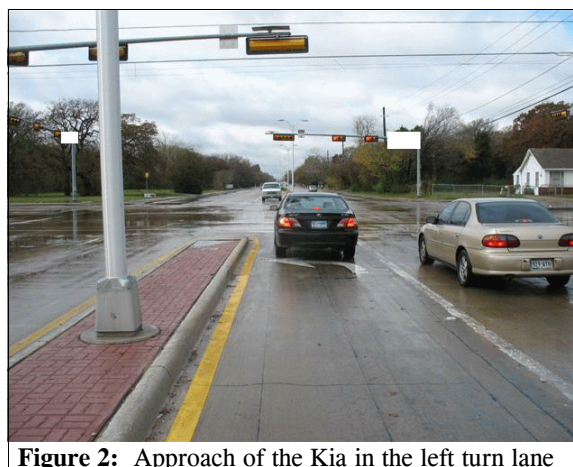
Figure 2: Approach of the Kia in the left turn lane

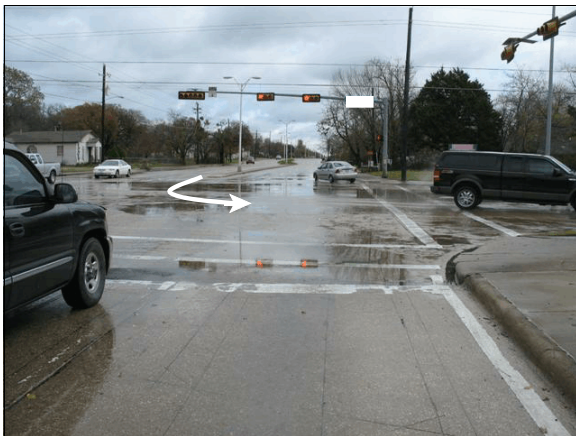
Figure 3: Approach of the Ford; arrow shows approach of the Kia

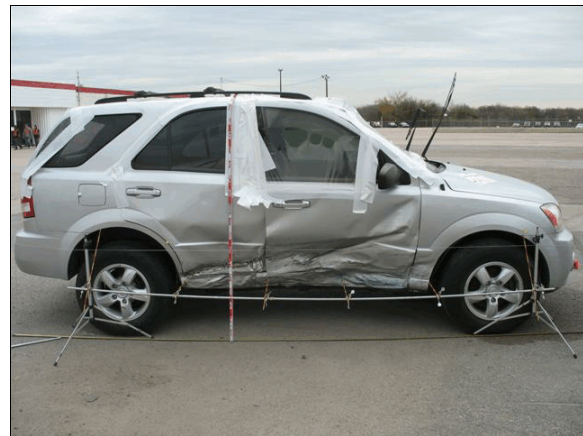
Crash: The right side plane of the Kia (Figure 4) was impacted by the front plane of the Ford (event 1). The direction of force on the Kia was within the 2 o'clock sector and the right side impact inflatable curtain (IC) air bag did not deploy. Following the impact, the Kia rotated clockwise and rolled over (event 2) left side leading one quarter-turn (Figure 5). The vehicle continued to rotate clockwise while on its left side and came to final rest in the inside lane of the southbound roadway heading east (Figure 6). The Ford came to final rest in the mouth of the southbound roadway heading southeast. None of the Kia's air bags deployed during the crash.

Figure 4: Damage on the right side plane of the Kia from impact with the front plane of the Ford

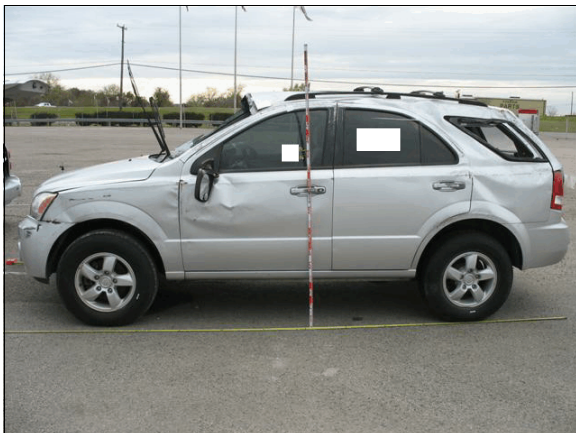
Figure 5: Damage on the left side plane of the Kia from the rollover

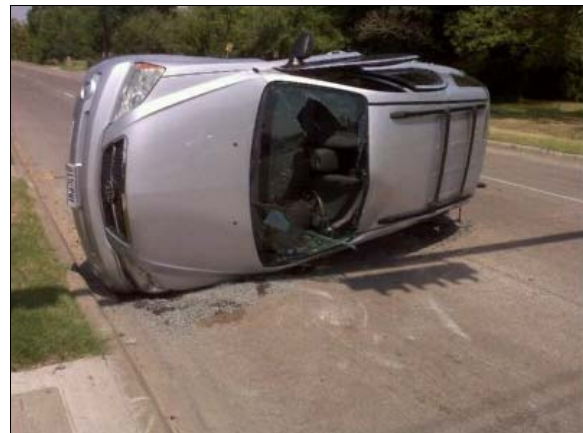
Figure 6: The final rest position of the Kia

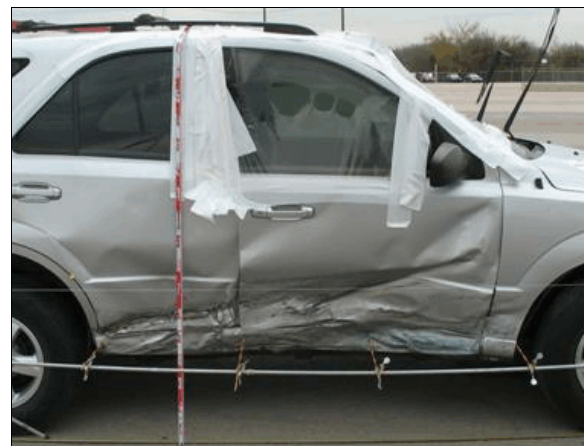
Exterior Damage: The impact by the front of the Ford involved the right side plane of the Kia. The fender, front door, B-pillar, and rear door were directly damaged (**Figure 7**). The direct damage began 20 cm (7.9in) forward of the right front

Figure 7: Damage on the right side plane of the Kia from the impact with the front plane of the Ford

axle and extended 252 cm (99.2 in) rearward along the right side. The crush measurements were taken at the sill level and the residual maximum crush was 24 cm (9.4 in) occurring at C₄. The vehicle’s sill height was 46 cm (18.1 in). The Door Sill Differential was 0 cm, since there was greater crush on the sill than on the door (Figure 8). The induced damage involved the right fender and both right side doors. The table below presents the right side crush profile.

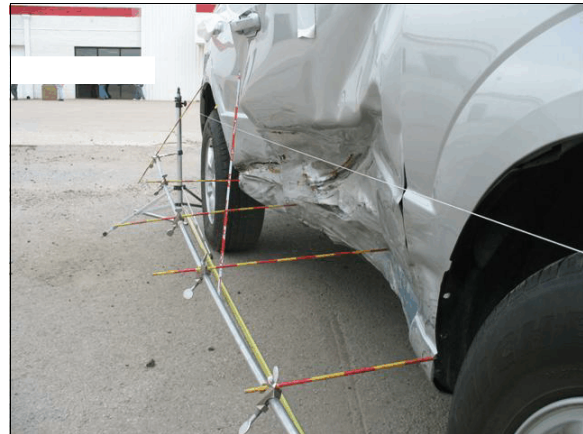
Figure 8: The maximum crush occurred on the sill

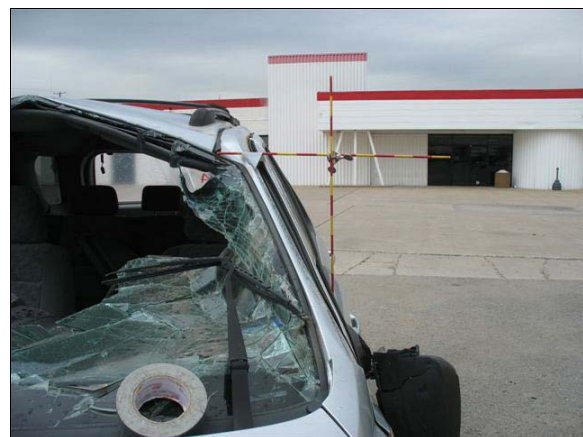
The rollover (event 2) involved the left side plane of the Kia. The direct damage on the left side plane extended the entire length of the vehicle. It began 59 cm (23.2 in) forward of the left front axle and extended 417 cm (164.2 in) rearward along the left side. The maximum residual lateral crush was 9 cm (3.5 in) and occurred at the top of the left A-pillar (Figure 9), 81 cm (31.9 in) rear of the left front axle. The maximum vertical crush was and 3 cm (1.2 in) and occurred at the left corner of the windshield header (Figure 9).

Figure 9 Max vertical crush
