CALSPAN ON-SITE HYBRID VEHICLE CRASH INVESTIGATION

SCI CASE NO.: CA09046

VEHICLE: 2007 HONDA CIVIC HYBRID

CRASH DATE: APRIL 2009

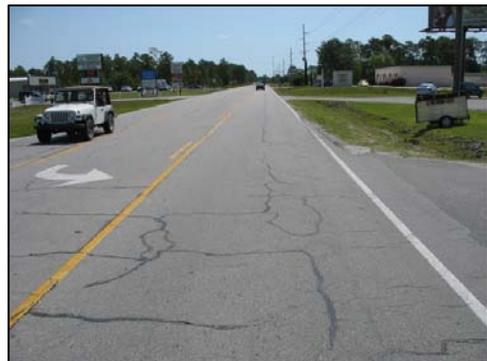
The front of the Ford impacted the rear of the Honda in the eastbound travel lane. **Figure 2** depicts the area in which the impact occurred. The directions of force were within the 6 o'clock

Figure 2: Area of impact.

sector for the Honda and 12 o'clock (estimated) for the Ford F-150. The Missing Vehicle algorithm of the WIMSMASH program was used to calculate a total delta-V of 39 km/h (24 mph) for the Honda and 22 km/h (14 mph) for the F-150. The longitudinal and lateral components of the Honda's delta-V were 39 km/h (24 mph) and 0 km/h, respectively. The longitudinal component of the Ford's delta-V was -22 km/h (-14 mph) with a lateral component of 0 km/h. No air bags in the Honda deployed during the rear-end crash event.

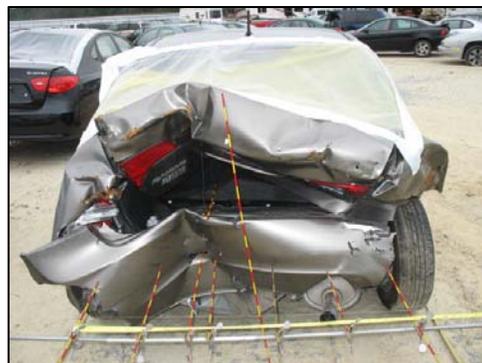
The rear of the Honda Civic sustained moderate severity damage to the rear bumper, trunk area and quarter panels of the Honda (**Figure 3**). The combined direct and induced (Field L) damage extended from bumper corner-to-bumper corner and was 112 cm (44.1 in.) in length. The bumper beam, trunk area, spare tire well and both quarter panels were crushed forward. There was a 9 cm (3.5 in) tear in the rear bumper fascia of the Honda located 20-29 cm (7.9-11.4 in) left of the centerline of the vehicle. This tear corresponded in height and width to the left front tow hook of an exemplar 2005 Ford F-150. The left tow hook

Figure 3: Damage to the rear of the Honda.

on the exemplar vehicle was located 34-44 cm (13.4-17.3 in) left of the centerline of the vehicle. The maximum crush was 66 cm (26 in) and was located on the bumper beam 23 cm (9.1 in) left of the vehicle's centerline.

The residual crush profile extended the full width of the damaged bumper beam and was as follows: C1 = 10 cm (3.9 in), C2 = 47 cm (18.5 in), C3 = 65 cm (25.6 in), C4 = 50 cm (19.7 in), C5 = 30 cm (11.8 in), C6 = 21 cm (8.3 in). The longitudinal distance from the maximum crush on the bumper beam to the rear of the hybrid battery compartment was 22 cm (8.7 in). This distance is depicted in **Figure 4**.

The Honda's backlight was disintegrated by the exterior deformation in this rear impact event. All side windows and the windshield were undamaged. The left front, right front and left rear doors remained closed during the crash and were operational post-crash. The right rear door remained closed during the crash and was jammed post-crash. The Collision Deformation Classification (CDC) assigned for this impact was 06-BDEW-6.

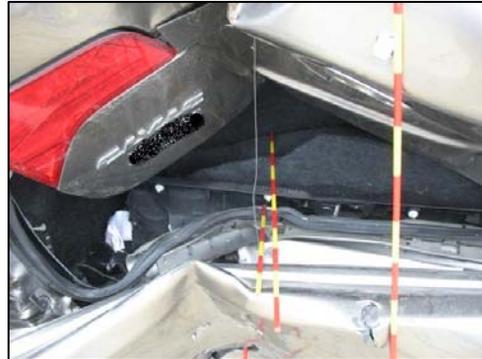
Figure 4: Distance remaining between maximum crush and the hybrid battery.

The battery pack was a Panasonic 158 volt, 5.5 Ah multiple-cell nickel-metal hydride battery. The battery was located behind the rear seat back, vertically mounted and centered slightly forward of the rear axle position. The rear crush to the trunk area resulted in forward displacement of the battery compartment and intrusion of the rear seat back and package tray into the passenger compartment. Due to the resultant damage and intrusion, a limited visual inspection of the battery area was performed. The battery compartment could not be accessed to conduct a voltage test for electrical isolation.

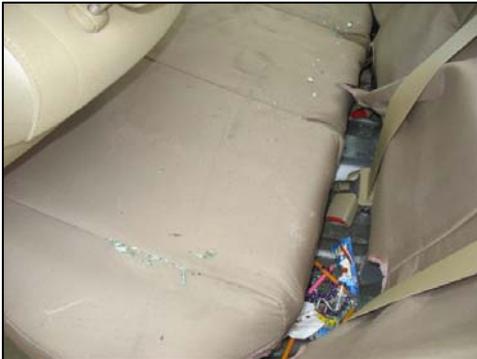
The lower second row seat area, under the seat cushion and the lower aspect of the front of the trunk did not display evidence of leakage from the battery (**Figures 5 and 6**). The area under the vehicle in the vicinity of the battery pack was inspected without visible evidence of leakage. The absence of warning lights and no indication of a reduced charge on the battery meter in the instrument panel pointed toward no damage occurring to the hybrid battery cells.

Figure 5: Area under the hybrid battery and rear seat cushion.

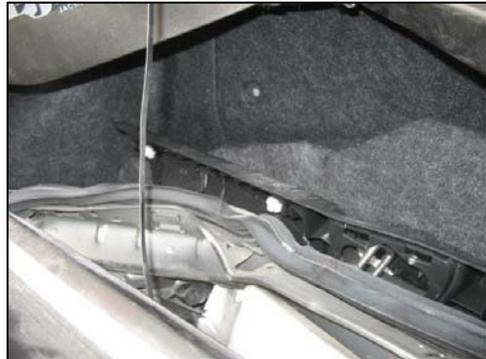
Figure 6: Area under the hybrid battery in the trunk of the Honda.

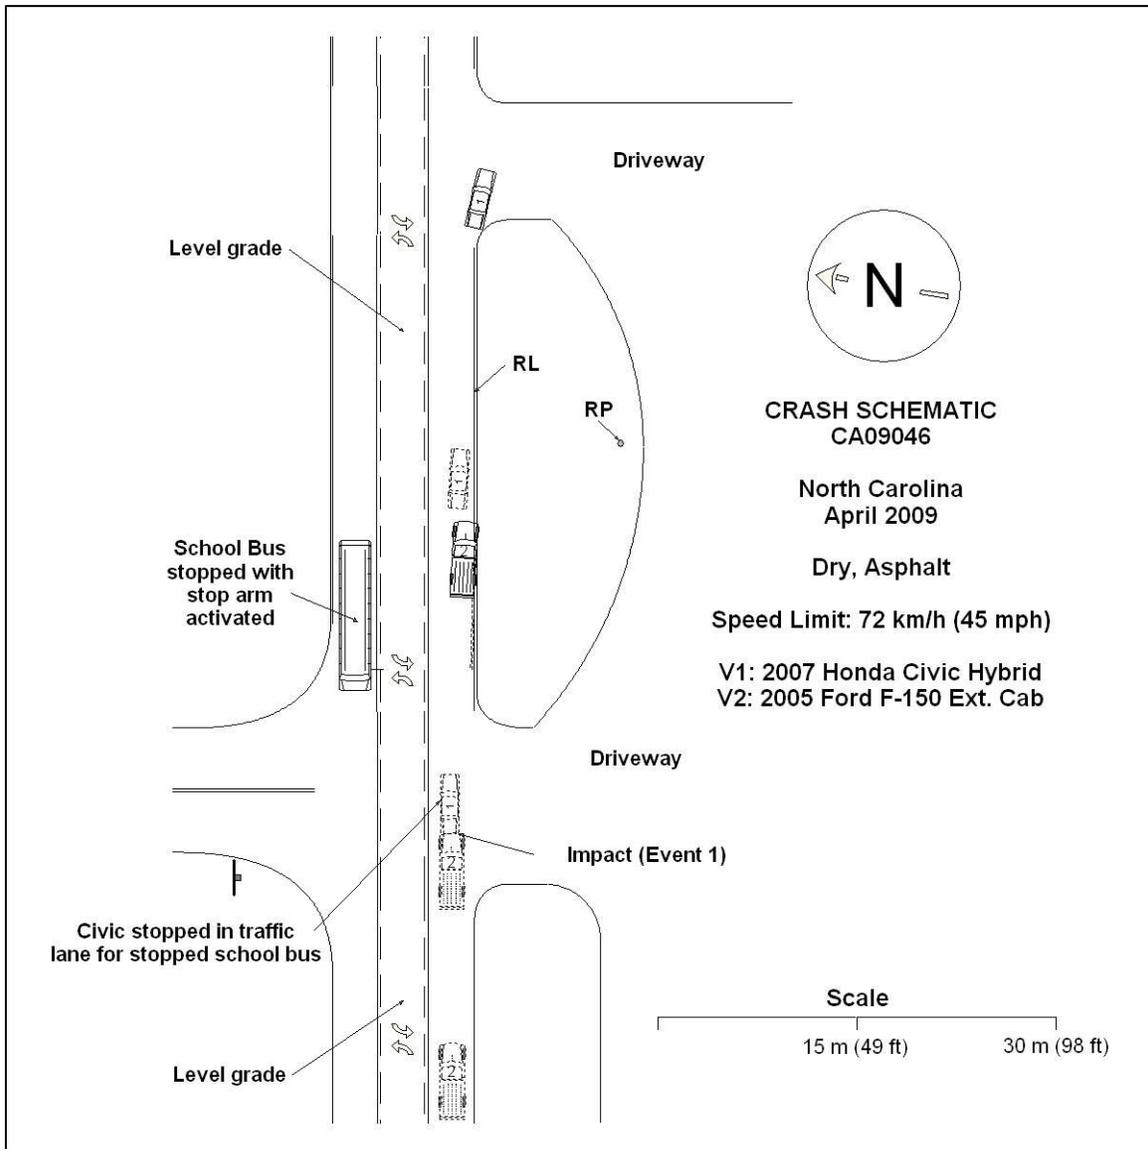
Figure 7: Crash Schematic

This crash occurred during the daylight hours of April 2009 in the eastbound lane of a three-lane roadway, inclusive of a center left turn lane. The roadway extended in an east/west direction and was straight and level in the area in which the crash occurred. The roadway was crowned in the center lane with a negative 1.6 percent superelevation extending to both roadsides. An intersecting two-lane roadway extended north from the area of the crash. The conditions at the time of the crash were dry and clear. The traffic lanes were surfaced with asphalt and were 3.6 m (11.8 ft) in width. Both roadsides were bordered by narrow asphalt shoulders, 0.2 m (0.7 ft) in width. On the south roadside were parking lot driveways surfaced in asphalt and grass shoulders. The posted speed limit was 72 km/h (45 mph). The Crash Schematic is included as **Figure 7** of this report.
