**CALSPAN ON-SITE HYBRID VEHICLE CRASH INVESTIGATION
SCI CASE NO.: CA09048**

VEHICLE: 2006 TOYOTA PRIUS HATCHBACK

LOCATION: NORTH CAROLINA

CRASH DATE: JUNE 2009

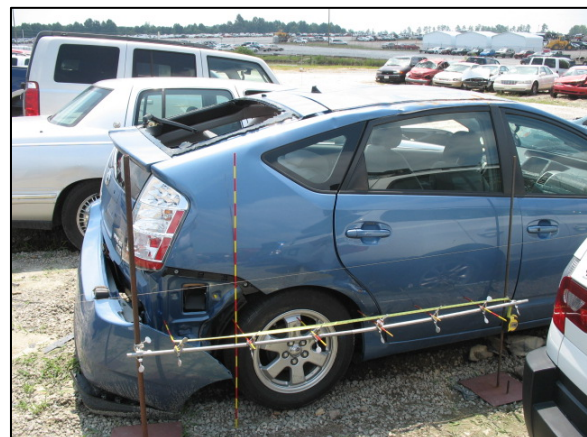
The exterior of the Toyota Prius sustained moderate severity damage to the right, top and left planes as a result of this multiple event crash. The rear aspect of the right plane sustained damage in the initial impact (**Figure 5**). Both right side door latches remained engaged, and all doors remained closed during the crash and operational after the crash. The direct damage measured 147 cm (57.9 in) and began 182 cm (71.7 in) rear of the right front axle and extended rearward to the rear right bumper corner area. The maximum crush measured 8 cm (3.1 in) and was located at C4,

Figure 5: Initial impact damage to the Toyota.

241 cm (94.9 in) aft of the right front axle. The documented crush profile for the initial impact was as follows: C1 = 0 cm, C2 = 5 cm (2 in), C3 = 3 cm (1.2 in), C4 = 8 cm (3.1 in), C5 = 0 cm, C6 = 0 cm. The Collision Deformation Classification (CDC) assigned for this impact was 02RZEW1.

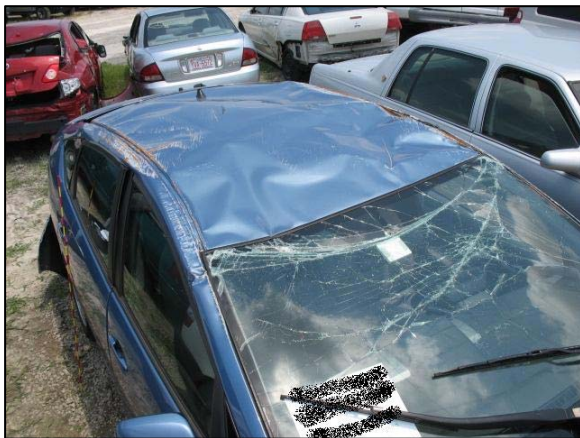
As a result of the rollover event, the Toyota sustained moderate severity damage to the left and top planes. The windshield glazing was 60 percent fractured with significant damage to the upper aspect. The left front, left rear quarter window, and backlight disintegrated as a result of the rollover event. The left rear door window and all right side glazing were undamaged. The scratches on the roof were oriented laterally. The direct contact damage to the roof extended 121 cm (47.6 in) laterally from the left roof side rail to the right roof side rail. The longitudinal direct contact damage extended 347 cm (136.6 in) from the leading edge of the hood to the approximate center of the C-pillars. The maximum vertical crush was located on the windshield header 24 cm (9.4 in) left of the right A-pillar. The maximum vertical crush measured 6 cm (2.4 in). The maximum lateral crush was located on the left roof side rail 26 cm (10.2 in) forward of the C-pillar and measured 4 cm (1.6 in). **Figures 6 and 7** depict the rollover damage sustained by the Toyota. The CDC assigned for the rollover was 00TDDO2.

Figure 6: Toyota rollover damage from above, right front.

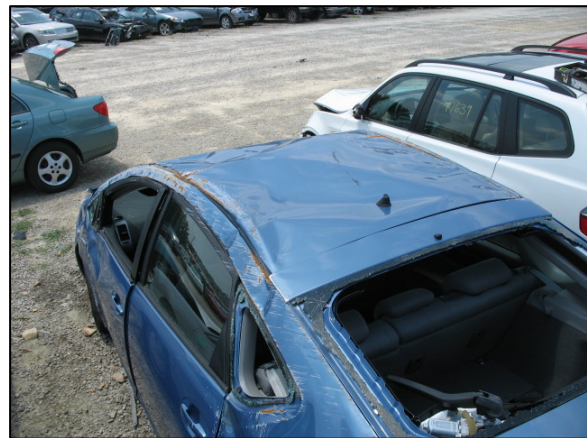
Figure 7: Toyota rollover damage from above, left rear.

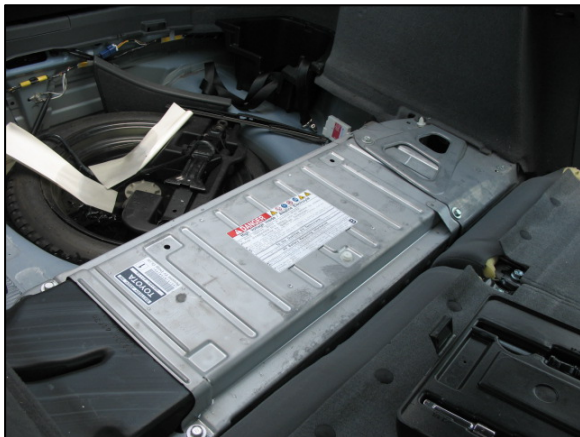
Figure 8: Toyota hybrid battery with aluminum cover in place.

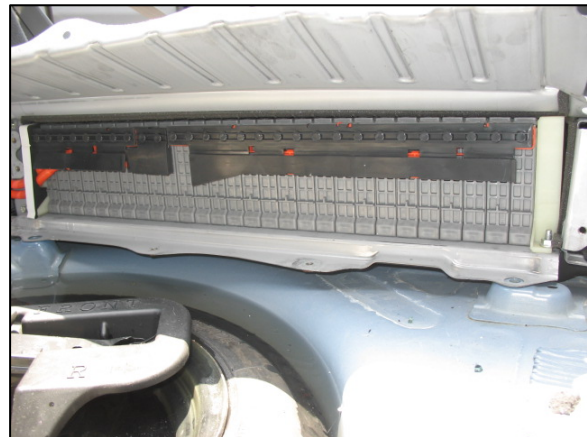
Figure 9: Individual cells of Toyota hybrid battery with cover elevated.

The Toyota was visually inspected for compliance with FMVSS No. 305. The right side impact damage did not involve the area of the propulsion battery. There was no intrusion into the battery compartment, or damage to the battery or battery cover. There was no leakage detected during the SCI vehicle inspection. The battery propulsion system components were not displaced or damaged by this impact event. The electrical isolation test was not conducted.

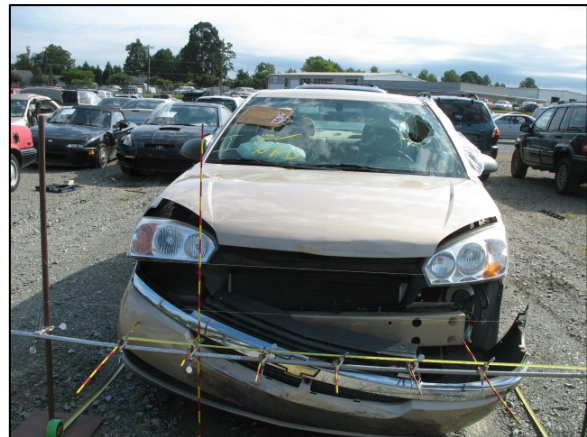
The front plane of the Chevrolet Malibu sustained moderate-severity damage in the initial impact with the Toyota. The direct contact damage extended from bumper corner to bumper corner on the front plane and measured 112 cm (44 in) in width (**Figure 10**). The maximum crush to the bumper beam measured 5 cm (2 in) and was located at C2, 26 cm (10.2 in) left of the centerline of the Chevrolet. A crush profile was documented along the full length of the damaged front bumper beam. This crush profile was as follows: C1 = 4 cm (1.6 in), C2 = 5 cm (2 in), C3 = 4 cm (1.6 in), C4 = 4 cm (1.6 in), C5 = 5 cm (2 in), C6 = 2 cm (0.8 in). The CDC assigned for this impact was 11FDEW1.

Figure 10: Overall view of the frontal damage to the Chevrolet.
