**CALSPAN ON-SITE ROLLOVER CRASH INVESTIGATION
SCI CASE NO.: CA09050**

VEHICLE: 2008 FORD ESCAPE XLT

LOCATION: NORTH CAROLINA

CRASH DATE: JULY 2009

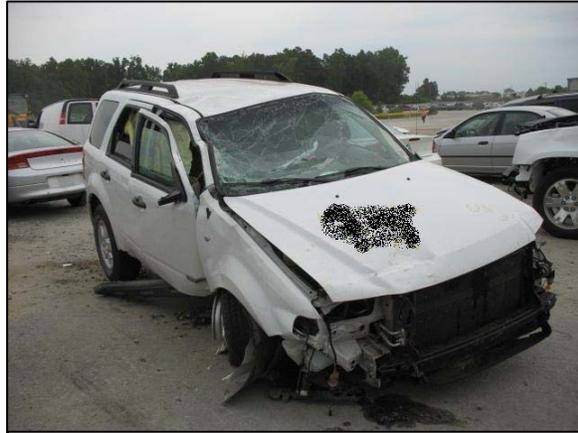
Figure 1: 2008 Ford Escape case vehicle.

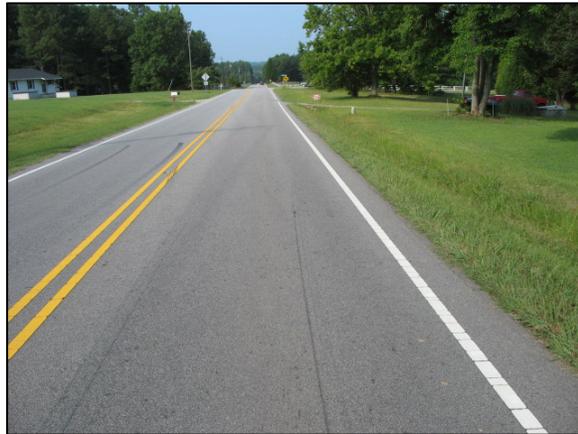
The restrained 20-year-old female driver of the Ford was en route to her residence and was traveling westbound on the two-lane roadway (**Figure 2**). She accelerated from an intersection that was located approximately 150 m (492 ft) east of the crash site to a driver-estimated speed of 64 km/h (40 mph). The police-estimated speed of the Ford was 89 km/h (55 mph). For an unknown reason, the driver relinquished directional control of the Ford and the right tires of the Ford departed the roadway. She initiated a slight steering input to the left; however, the Ford entered the ditch. The driver did not apply the brakes.

Figure 2: Westbound approach to the crash scene.

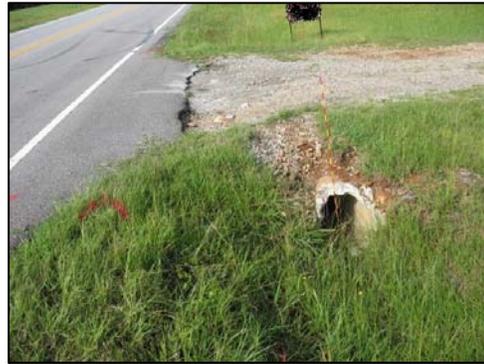
The front right area of the Ford impacted the concrete culvert on the north roadside. The impact with the culvert damaged the front bumper beam and extended rearward to the right front wheel. The right front wheel was separated from the axle and was displaced rearward. The right front wheel fractured and the tire was cut. The direction of force to the Ford was within the 12 o'clock sector. The Damage Algorithm of the WinSMASH

program was used to calculate a total delta-V of 21 km/h (13 mph) with a longitudinal delta-V of -21 km/h (-13 mph) and a lateral component of 0 km/h. **Figure 3** is a view of the initial impact location with the culvert.

Figure 3: Westward view of the area of initial impact with the culvert.

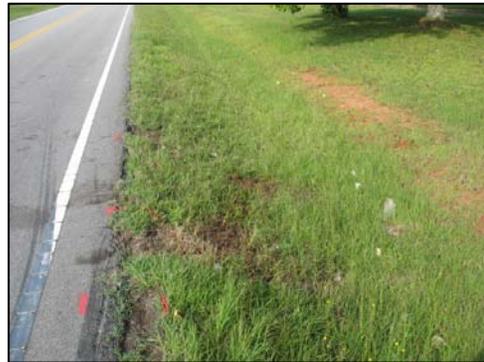
The offset right impact induced a clockwise yaw to the Ford as its center of gravity continued in a westerly direction as it traversed the driveway. The Ford traveled in the left side leading yaw for approximately 9 m (14.5 ft) evidenced by a left rear yaw mark that was 3.5 m (11.5 ft) in length. The yaw mark began near the north fog line of the roadway and extended off the roadway into the grass. The Ford rotated approximately 95 degrees clockwise before initiating a rollover event to the left. The left side tires tripped as the vehicle traveled on the grass down slope of the ditch. The Ford rolled two-quarter turns to the left over a distance of 7 m (23 ft). The rollover was not an interrupted event. **Figure 4** is a view of the trip point for the rollover of the Ford. The Ford came to rest on its roof facing in a northeasterly direction on the north roadside.

Figure 4: Westward view of the location of the rollover.

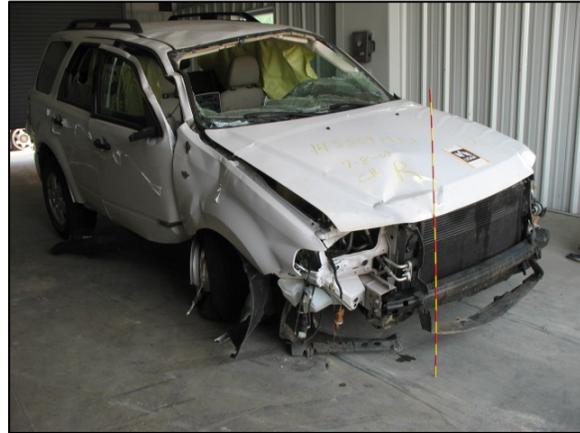
The Ford sustained moderate severity damage to the front, left and top planes as a result of this multiple event crash. The right front area of the Ford sustained damage from the initial impact (**Figure 5**). The direct contact damage began 47 cm (18.5 in) right of the centerline and extended 24 cm (9.4 in) to the front right bumper corner. The combined direct and induced damage (Field L) was 113 cm (44.5 in) and extended from bumper corner-to-bumper corner. The crush profile was documented along the full length of the bumper beam and was as follows: C1 = 0 cm, C2 = 1 cm (0.4 in), C3 = 2 cm (0.8 in), C4 = 5 cm (2 in), C5 = 8 cm (3.1 in), C6 = 13 cm (5.1 in).

Figure 5: Initial impact damage to the Ford.

As the vehicle continued forward, the right front tire and wheel engaged the culvert. The impact punctured the sidewall and fractured the alloy wheel. The impact also fractured the drive axle inboard of the steering upright. As a result of the tire/wheel contact, the tire and wheel were displaced rearward resulting in a reduction of the right wheelbase of 59 cm (23 in). The Collision Deformation Classification (CDC) assigned for the initial impact was 12FREE4.

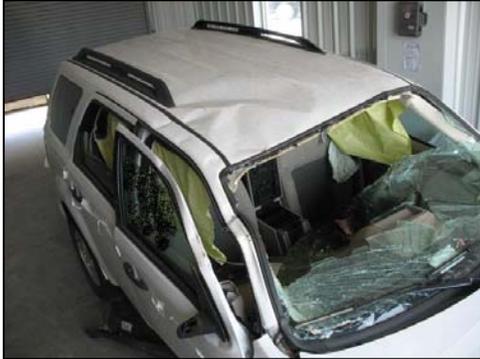
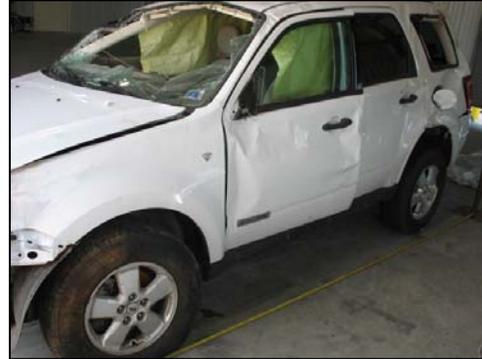
As a result of the rollover event, the Ford sustained moderate severity damage to the left and top planes. The direct contact damage to the roof extended laterally 108 cm (42.5 in) from roof side rail-to-roof side rail. The longitudinal direct contact damage measured 374 cm (147.2 in) and extended from the front left corner of the hood rearward to the backlight header. The maximum vertical and lateral crush was located at the same position on the right roof side rail, 5 cm (2 in) rearward of the windshield header. The maximum vertical crush measured 10 cm (3.9 in). The maximum lateral crush was 6 cm (2.4 in). **Figures 6 and 7** depict the rollover damage sustained by the Ford. The CDC assigned for the rollover was 00TDDO3.

Figure 6: Rollover damage from above, right front.

Figure 7: Rollover damage from left side.

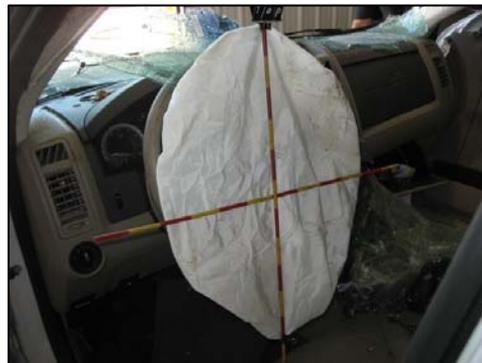
The Ford Escape was equipped with the CAC frontal air bag system. The manufacturer of the Ford certified that the vehicle was compliant to the advanced air bag requirements of Federal Motor Vehicle Safety Standard No. 208. The driver's frontal air bag deployed during the crash. The frontal air bag was concealed within the center hub of the four-spoke steering wheel by two cover flaps. The flaps were symmetrical and were 7 cm (2.8 in) in width and 12 cm (4.7 in) in height with a vertical tear seam. There was a Ford medallion attached to the left cover flap that extended into the right cover flap. The air bag (**Figure 8**) was 60 cm (23.6 in) in diameter in its deflated state. The air bag was vented by two vent ports at the 11 and 1 o'clock positions at the rear aspect of the air bag. The air bag was tethered by two tethers at the 12 and 6 o'clock positions.

Figure 8: Deployed driver's frontal air bag.

There were no occupant contact points on the air bag; however, the right side of the face of the air bag was covered by small drops of soda consistent with soda carried in the vehicle that also stained both front seats, the left IC air bag and the front left safety belt.

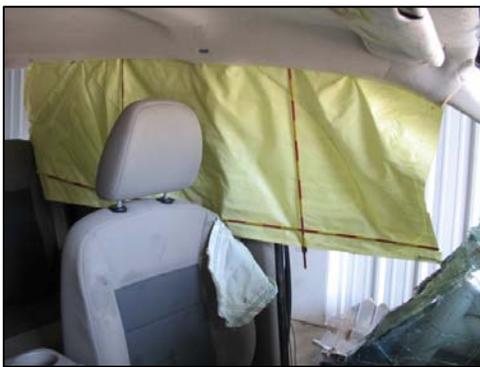
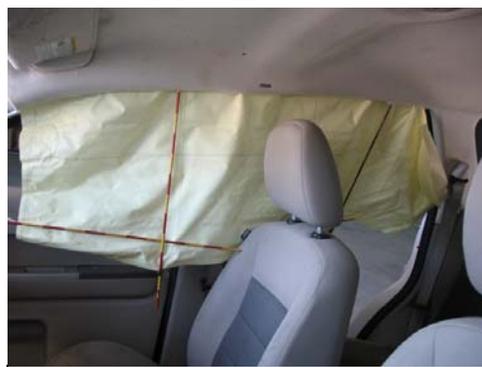
The IC air bags deployed from their respective roof side rails at the on-set of the rollover. The air bags measured 148 cm (58.3 in) in length. At the front and rear left seating positions, the IC was 48 cm (18.9 in) in height. The air bag was tethered to the A-pillar by a 40 cm (15.7 in) tether strap and to the C-pillar by a 10 cm (3.9 in) strap. The IC provided complete longitudinal coverage across the rear side glazing, and coverage across the front side glazing with the exception of an open area at the A-pillar area, at the front of the curtain. This void measured 16 cm (6.3 in) in width and 14 cm (5.5 in) and 8 cm (3.1 in) at the rear and front of the opening, respectively. Vertically, the IC air bag extended below the belt line at each outboard position. **Figures 9 and 10** depict the IC air bags.

The front inboard aspect of the left IC was covered with numerous small droplets of a beverage, but was free of occupant contact.

Figure 9: Left curtain air bag.

Figure 10: Right curtain air bag.

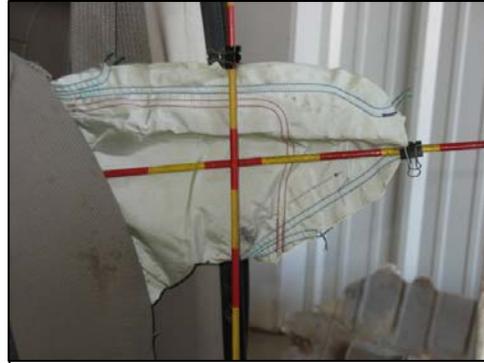
The left side impact air bag deployed from a panel in the upper outboard aspect of the left seat back. The air bag measured 28 cm (11 in) in width and 20 cm (7.9 in) in height. It contained one vent port at the forward seam and was not tethered. There was smeared body fluid on the entire outboard aspect of the membrane. There was no damage to the air bag or contact evidence on the inboard side. **Figure 11** depicts the front left side air bag.

Figure 11: Left side impact air bag.

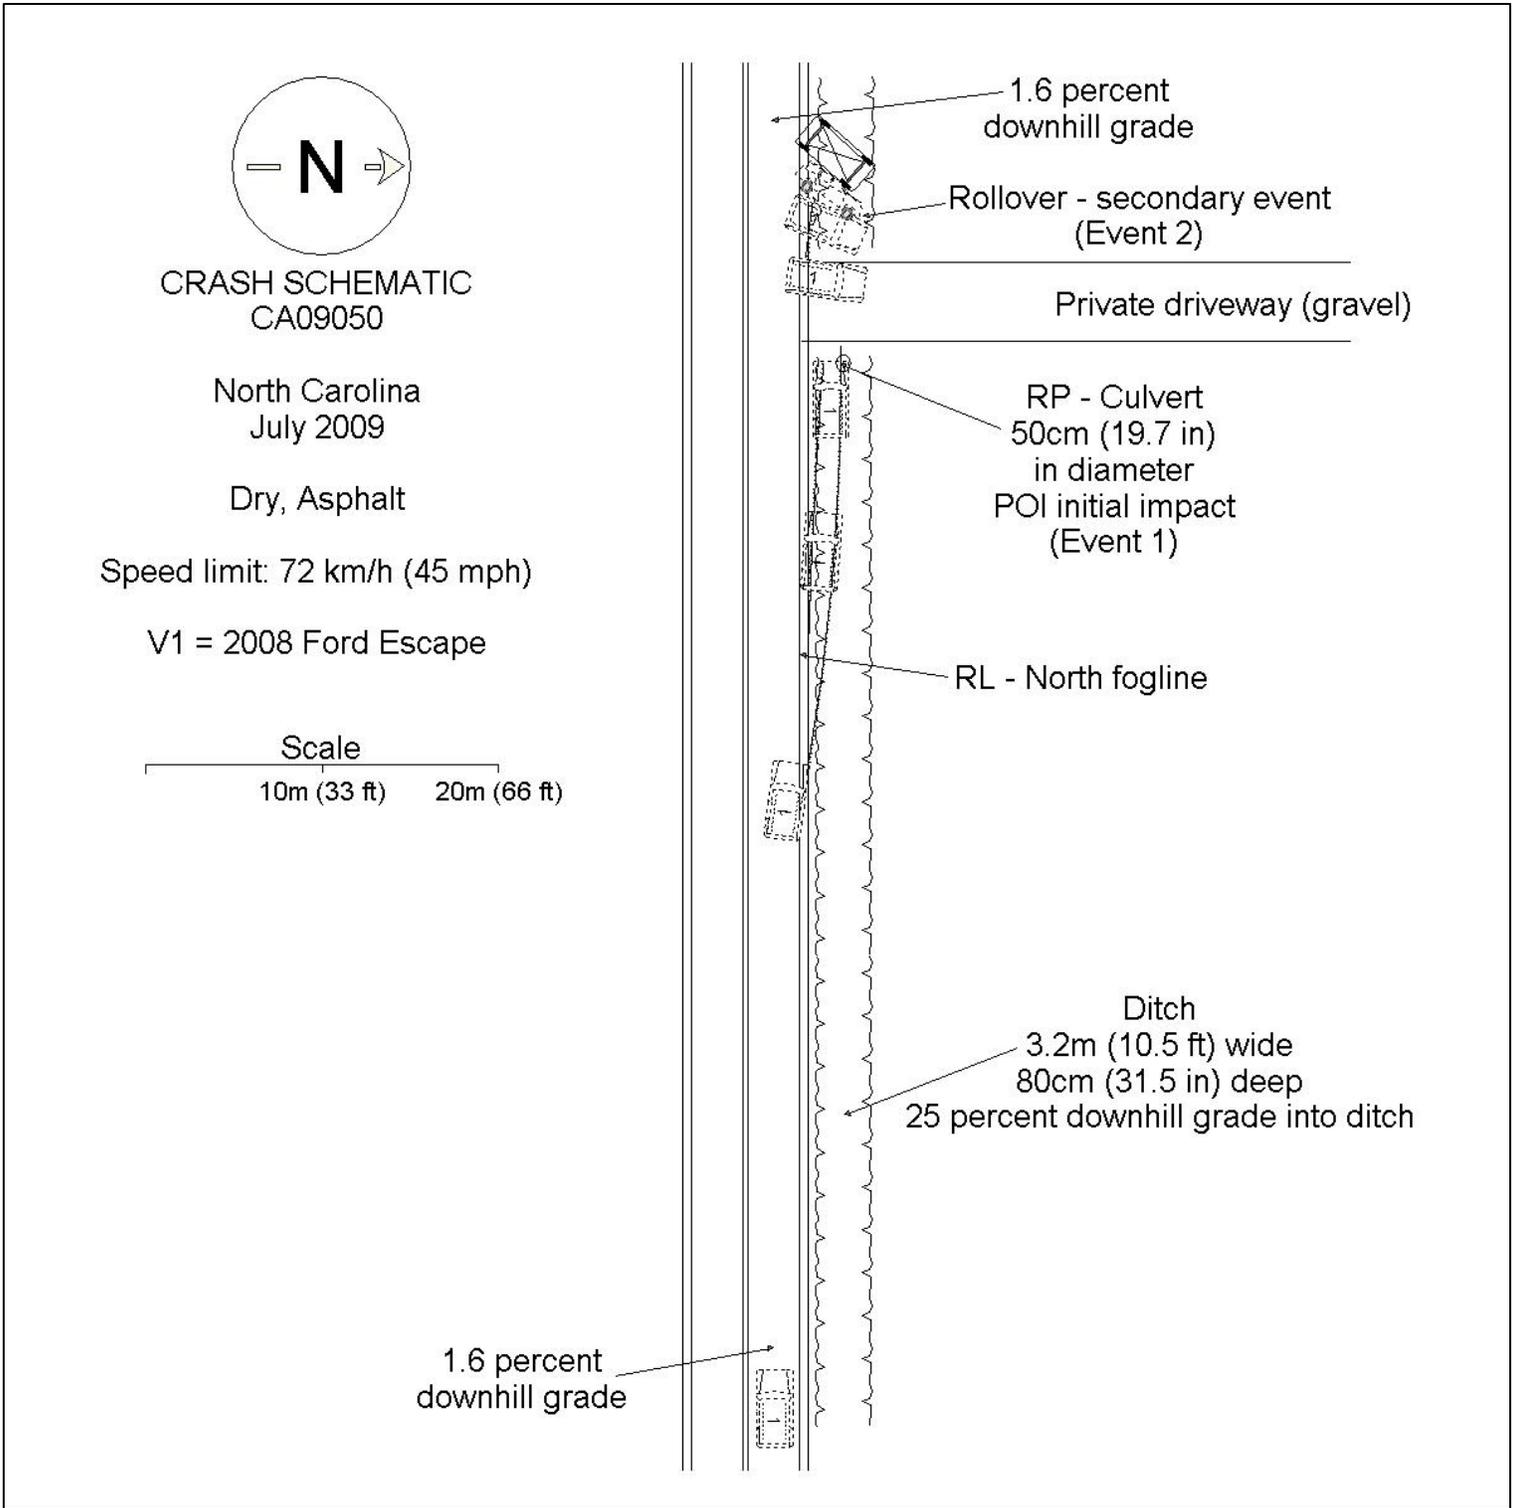
Figure 12: Crash Schematic

lowest point. This ditch was surfaced with grass. The posted speed limit for the area was 72 km/h (45 mph). Extending north and south from the roadway were multiple private driveways. The driveway at this crash scene was 4.4 m (14.4 ft) in width and surfaced with gravel. There was a 50 cm (20 in) diameter concrete culvert that extended under the private driveway. The driver of the Ford lived nearby and was familiar with the area of the crash. The Crash Schematic is included as **Figure 12** of this report.
