**CALSPAN ON-SITE ROLLOVER CRASH INVESTIGATION**  
**SCI CASE NO: CA09065**

**VEHICLE: 2007 DODGE CARAVAN**  
**LOCATION: PENNSYLVANIA**  
**DATE: AUGUST 2009**

1. Report No. CA09065	2. Government Accession No.	3. Recipient's Catalog No.	
4. Title and Subtitle Calspan On-Site Rollover Crash Investigation Vehicle: 2007 Dodge Caravan Location: Pennsylvania		5. Report Date: May 2010

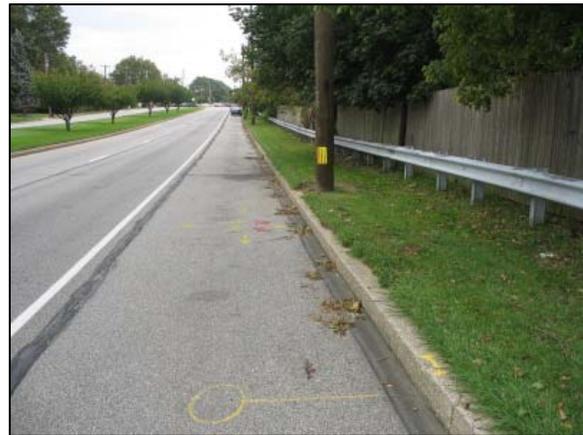
The right front and right rear tires struck and mounted the south barrier curb (Events 1 and 2). A curb strike that measured 23 cm (9 in) long was identified during the SCI scene inspection. The curb impacts cut the sidewall of the right front tire and deformed the right rear wheel rim. The right rear tire subsequently deboned. The Dodge continued along its SE trajectory a distance of 8 m (26.2 ft) and impacted a wooden utility pole with the right aspect of the front plane (Event 3). The safety belt pretensioner and the CAC driver air bag and knee air bag deployed as a result of the impact. **Figure 3** is a trajectory view of the curb strike and utility pole impact. The Barrier Equivalent Speed (BES) of the yielding object impact calculated by the Damage Algorithm of the WinSMASH program was 41.0 km/h (25.5 mph). The longitudinal and lateral components were -41.0 km/h (-25.5 mph) and 0, respectively.

**Figure 3: Trajectory view of the curb strike and utility pole impact.**

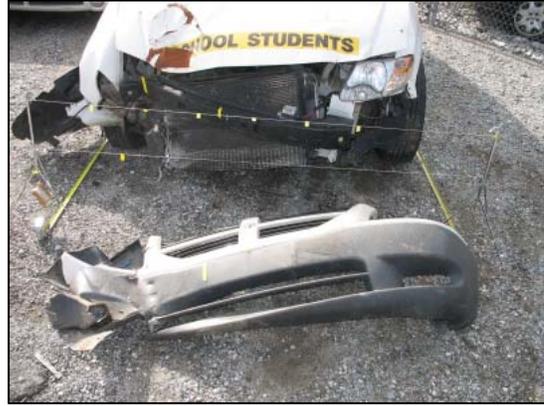
**Figure 4** is a view of the frontal damage to the vehicle from its impact to the utility pole (Event 3). The direct contact damage began 18 cm (7.1 in) right of center and extended 50 cm (19.7 in) to the right corner. The impact resulted in crush to the fascia, bumper reinforcement bar, right front suspension components and structures of the right fender. The contact damage extended onto the hood 20 cm (8.0 in). The residual crush profile measured to bumper reinforcement was as follows: C1 = 1 cm (0.4 in), C2 = 8 cm (3.1 in), C3 = 18 cm (7.1 in), C4 = 28 cm (11.0 in), C5 = 38 cm (15.0 in), C6 = 34 cm (13.4 in). The maximum crush measured 40 cm (15.7 in) and was located 50 cm (19.5 in) right of center. The right wheelbase was reduced 12 cm (4.6 in). There was no change in the left wheelbase dimension. The windshield was fractured. The CDC was 12FZEW3.

**Figure 4:** Front view of the damage to the Dodge Caravan resultant to the utility pole

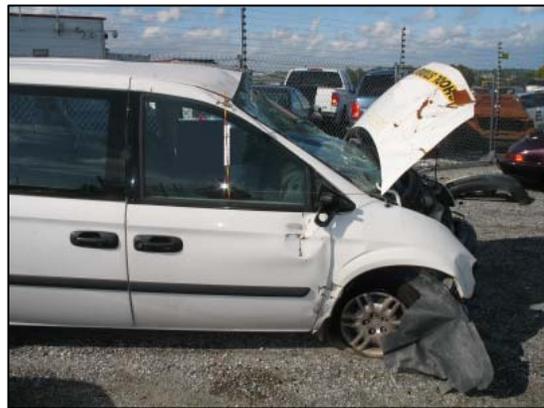
The rollover damage (Event 4) consisted of minor body panel deformation and abrasion to the left, top and right planes. **Figure 5** is a right side view of the Dodge depicting a portion of the damage. The maximum vertical and lateral deformations of the rollover damage were located at the right A-pillar. The maximum vertical deformation measured 6 cm (2.5 in). The maximum lateral deformation measured 3 cm (1.0 in). The glazing of the left second window and the left and right third windows disintegrated during the rollover. All the doors remained closed during the crash sequence and were operational post-crash. The CDC was 00TDDO3.

**Figure 5:** View of the rollover damage to the forward right plane.

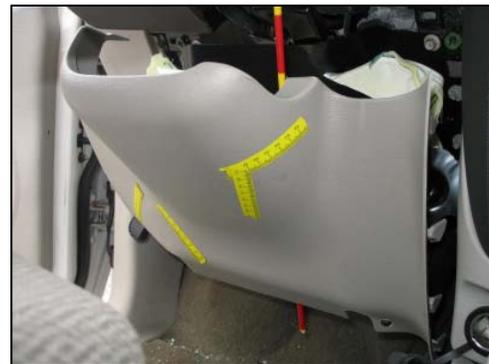
The rigid knee bolster panel exhibited two scuffs from contact with the driver's lower extremities (**Figure 7**). A 13 cm x 3 cm (5 in x 1 in) scuffed area was located 11 cm (4.5 in) right of the steering column and 53 cm (21.0 in) above the floor. This contact was attributed to the right lower extremity. A 5 cm x 3 cm (2 in x 1 in) scuff was located 14 cm (5.5 in) left of the steering column. This scuff was located 41 cm (16.0 in) above the floor and was attributed to the left lower extremity contact.

**Figure 7: View of the knee bolster contacts.**

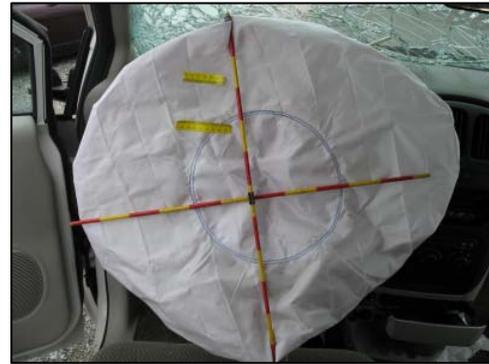
The 2007 Dodge Caravan was equipped with CAC frontal air bags for the driver and front right passenger. The vehicle's manufacturer certified that the frontal air bags were compliant to the advanced air bag portion of Federal Motor Vehicle Safety Standard (FMVSS) No: 208. The driver air bag module was located in the center hub of the steering wheel rim and the air bag had deployed as a result of the pole impact (**Figure 8**). The driver air bag module had a single semi-circular flap that was hinged along its top aspect. The width and height of the cover flap measured 20 cm (7.9 in) and 12 cm (4.8 in), respectively. There was no contact evidence or damage to the cover flap. The diameter of the deployed driver air bag measured 66 cm (26 in) in its deflated state. It was tethered by two internal straps sewn to the face of the bag and was vented by two 2 cm (0.8 in) diameter ports. An 8 cm x 5 cm (3 in x 2 in) abrasion was noted on the face of the air bag. It was located in the 12 o'clock sector, 16 cm (6.3 in) above and 6 cm (2.5 in) left of the center of the bag. The 5 to 7 o'clock sectors of the air bag were soiled from exposure to the elements.

**Figure 8: View of the deployed driver air**

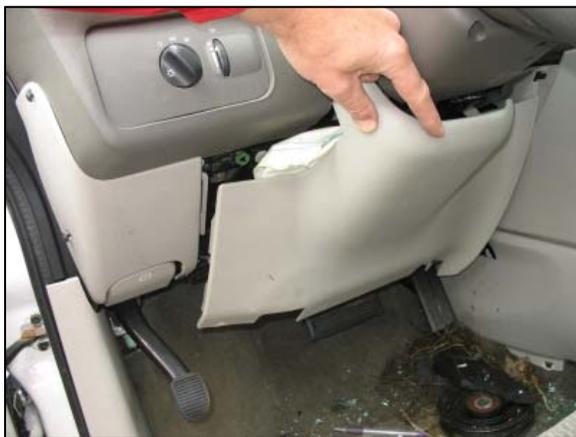
**Figures 9 – 11** are views of the knee air bag located in the lower aspect of the left instrument panel. The driver knee air bag was attached between to the fixed structure of the lower instrument panel and the vinyl bolster panel. At deployment, the bolster separated from the instrument panel and expanded toward the driver as the knee air bag inflated. The rearward excursion of the panel measured 13 cm (5 in). The air bag was rectangular and measured 42 cm x 24 cm (16.5 in x 9.5 in), width by height. There was no direct contact between the knee air bag and the driver. The driver's lower extremities contacted the bolster panel as evidenced by the identified contacts.

**Figure 9: View of the reconstructed position of the knee bolster prior to the deployment of the knee air bag.**

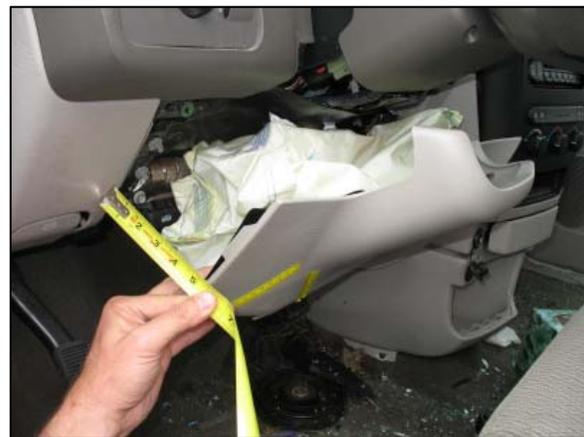
**Figure 10: View of the deployed knee air bag depicting the rearward excursion of the bolster panel.**

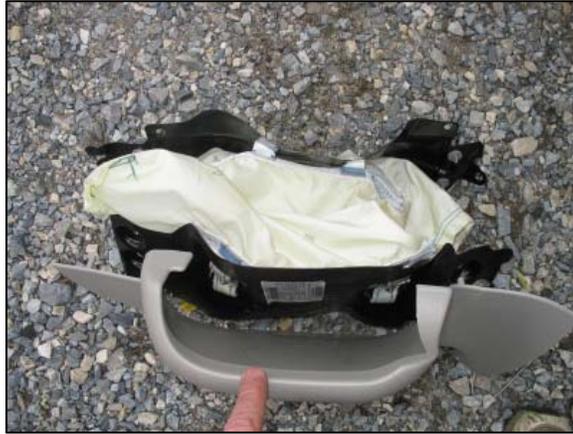
**Figure 11: Overhead view of the knee air bag assembly removed from the vehicle.**
