**CALSPAN ON-SITE CERTIFIED ADVANCED 208-COMPLIANT
VEHICLE CRASH INVESTIGATION
SCI CASE NO.: CA09066**

VEHICLE: 2009 ACURA TSX SEDAN

LOCATION: NORTH CAROLINA

CRASH DATE: AUGUST 2009

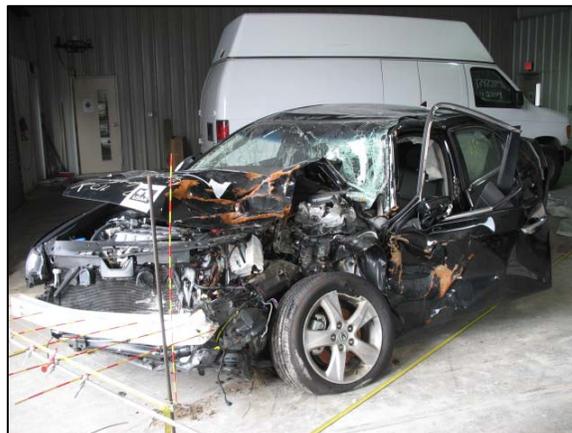
Figure 1: Left front oblique view of the 2009 Acura TSX.

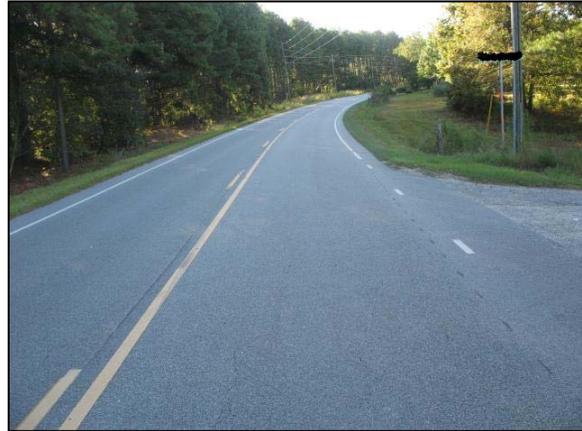
The restrained 53-year-old female driver of the Acura was operating the vehicle southbound on the rural roadway at a driver estimated speed of 72 km/h (45 mph). **Figure 2** depicts the Acura's pre-crash trajectory. The restrained 20-year-old male driver of the Chevrolet was operating the vehicle northbound in a left curve on the same roadway. The Chevrolet crossed the center line and entered the southbound travel lane directly into the path of the Acura. The driver of the Acura detected the Chevrolet entering her lane, and initiated an avoidance maneuver by steering to the right and braking.

Figure 2: Pre-crash trajectory of the Acura.

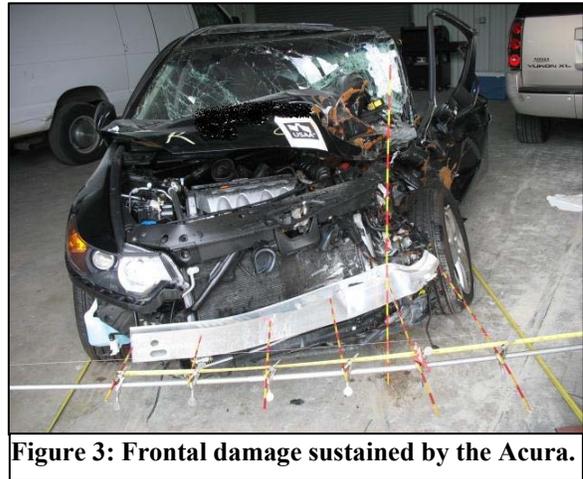
The front left corner of the Acura sustained moderate damage in this offset frontal crash (**Figure 3**). On the frontal plane, the direct contact damage to the bumper beam began 45 cm (17.7 in) left of the vehicle's centerline and extended left 14 cm (5.5 in) to the front bumper corner. The maximum crush was located at C2, 36 cm (14.2 in) right of the front left bumper corner and measured 46 cm (18.1 in). The combined direct and induced damage (Field L) extended along the full length of the front bumper beam. A residual crush profile was documented along this full width and was as follows: C1 = 45 cm (17.7 in), C2 = 46 cm (18.1 in), C3 = 37 cm (14.6 in), C4 = 21 cm (8.3 in), C5 = 8 cm (3.1 in), C6 = 0 cm.

Figure 3: Frontal damage sustained by the Acura.

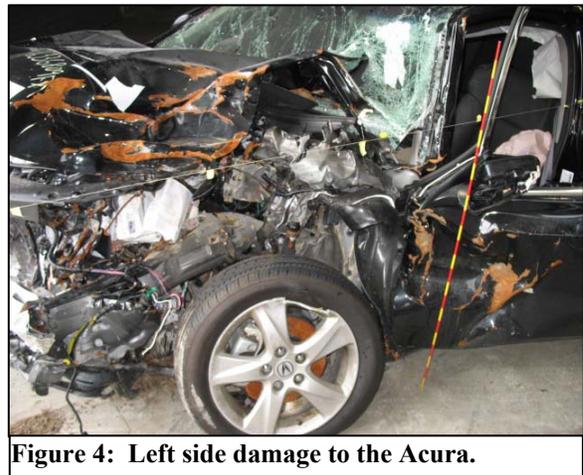
Due to the offset impact configuration, the direct contact damage wrapped around the left front corner onto the left plane (**Figure 4**). The direct contact extended rearward 214 cm (84.3 in) to the mid aspect of the front door. The left front door was jammed shut post-crash and pried open by the first responders. The left rear and both right side doors remained closed during the crash and were operational post-crash. The windshield was completely fractured by the impact forces. There was a triangular laminate tear resulting from contact with the hood in the area forward of the front left seating position. This triangular tear measured 30 cm (11.8 in) along the upper aspect, 22 cm (8.7 in) along the lower aspect and 13 cm (5.1 in) in height along the left aspect and was located 29 cm (11.4 in) below the windshield header and 27 cm (10.6 in)

Figure 4: Left side damage to the Acura.

inboard of the left A-pillar. The left rear corner of the hood penetrated the windshield 10 cm (3.9 in) and caused the laminate tear. The front side windows were both disintegrated by the impact forces. The rear side windows, backlight glazing and sunroof glazing were not damaged in this crash. The Collision Deformation Classification (CDC) assigned for this impact was 12FLEE7.

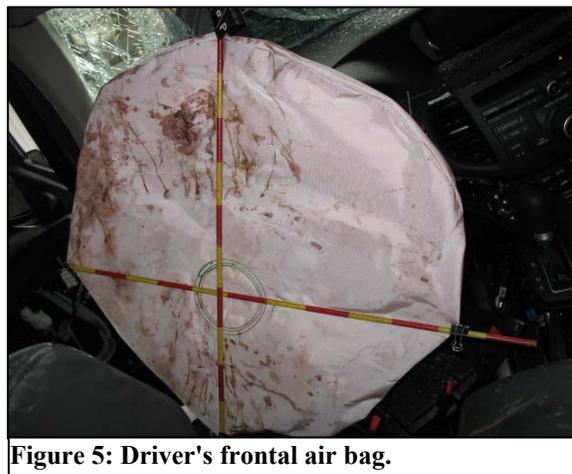
The Acura was equipped with a CAC frontal air bag system. The CAC system consisted of dual-stage frontal air bags for the driver and right front passenger positions, seat track positioning sensors, safety belt buckle switches, retractor pretensioners, and a front right occupant presence sensor. The driver's air bag was concealed within the center hub of the 3-spoke steering wheel by a tri-flap design. The upper flap measured 13 cm (5.1 in) in width at the horizontal tear seam and 5 cm (2 in) in height. The lower flaps were triangular in shape and were 7 cm (2.8 in) in width and 8 cm (3.1 in) in height at the vertical tear seam. The driver's air bag (**Figure 5**) was 50 cm (19.7 in) in diameter in its deflated state. The air bag was vented by two circular vent ports located on the upper rear aspect of the air bag at the 11 and 1 o'clock positions. The air bag was tethered by two tethers attached to the face of the bag at the 12 and 6 o'clock positions with a 9 cm (3.5 in) tether seam on the face of the air bag. The face of the air bag was covered by post-crash body fluid, more heavily on the left aspect of the face of the bag. No crash-related damage was present on the driver's air bag.

Figure 5: Driver's frontal air bag.

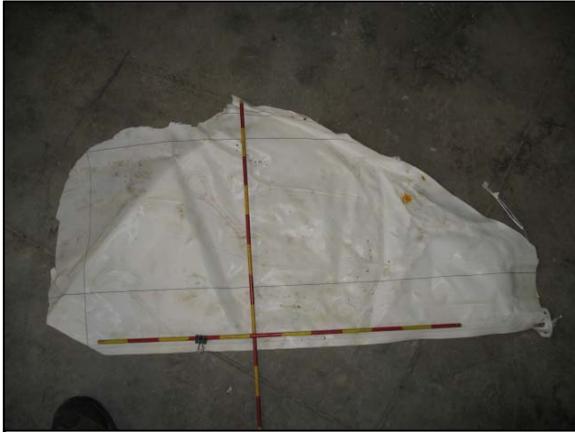
cut by EMS during the extrication of the driver. The left IC was free from occupant contacts and crash-related damage. The section of the IC that had been cut out was found on the floor of the vehicle and contained stains of an unknown origin at the time of the SCI inspection. **Figures 6 and 7** depict the left IC. The air bag was labeled with the following nomenclature: >VMQ, PA66< 6096902 S107 M11B.

Figure 6: Forward section of left IC cut from the vehicle.

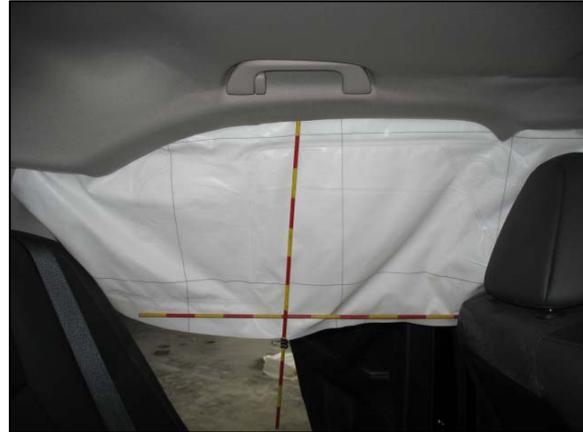
The left IC deployed from the roof side rail. The IC measured 155 cm (61 in) in length and provided complete longitudinal coverage across the entire left side glazing. At the front and rear seating positions, the IC was 40 cm (15.7 in) in height and extended below the beltline at each outboard position. The IC was cut by emergency medical personnel 11 cm (4.3 in) forward of the B-pillar. The cut extended from the lower edge to the top of the IC, and forward to the front edge of the air bag. The IC was tethered to the A-pillar by a webbing strap. This strap was also

Figure 7: Left IC in second row of the Acura.

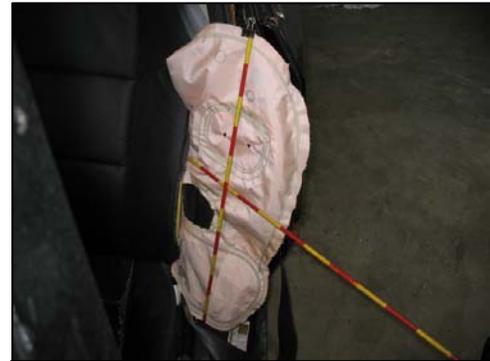
The left side impact air bag deployed from a 42 cm (16.5 in) panel in the outboard aspect of the driver seat back. The air bag measured 20 cm (7.9 in) in width and 57 cm (22.4 in) in height (**Figure 8**). The air bag contained one vent port at the 12 o'clock position on the outboard aspect and no tethers. There was no damage or contact evidence on the side air bag.

Figure 8: Left side impact air bag.

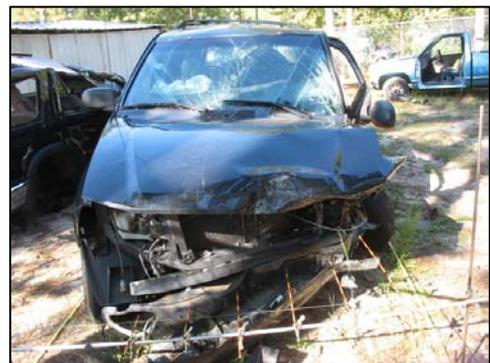
The front plane of the Chevrolet Trailblazer sustained moderate-severity damage as a result of the impact with the Acura. The direct contact damage began 2 cm (0.8 in) left of the vehicle centerline and extended left 74 cm (29.1 in) to the corner. The maximum crush was located at the front left bumper corner and measured 59 cm (23.2 in). **Figure 9** depicts the frontal damage to the Chevrolet. A crush profile was documented along the full width of the front bumper reinforcement. This crush profile was as follows: C1 = 59 cm (23.2 in), C2 =

Figure 9: Frontal damage to the Chevrolet.

47 cm (18.5 in), C3 = 46 cm (18.1 in), C4 = 30 cm (11.8 in), C5 = 10 cm (3.9 in), C6 = 0 cm. The CDC assigned for this impact was 12FYEW3.

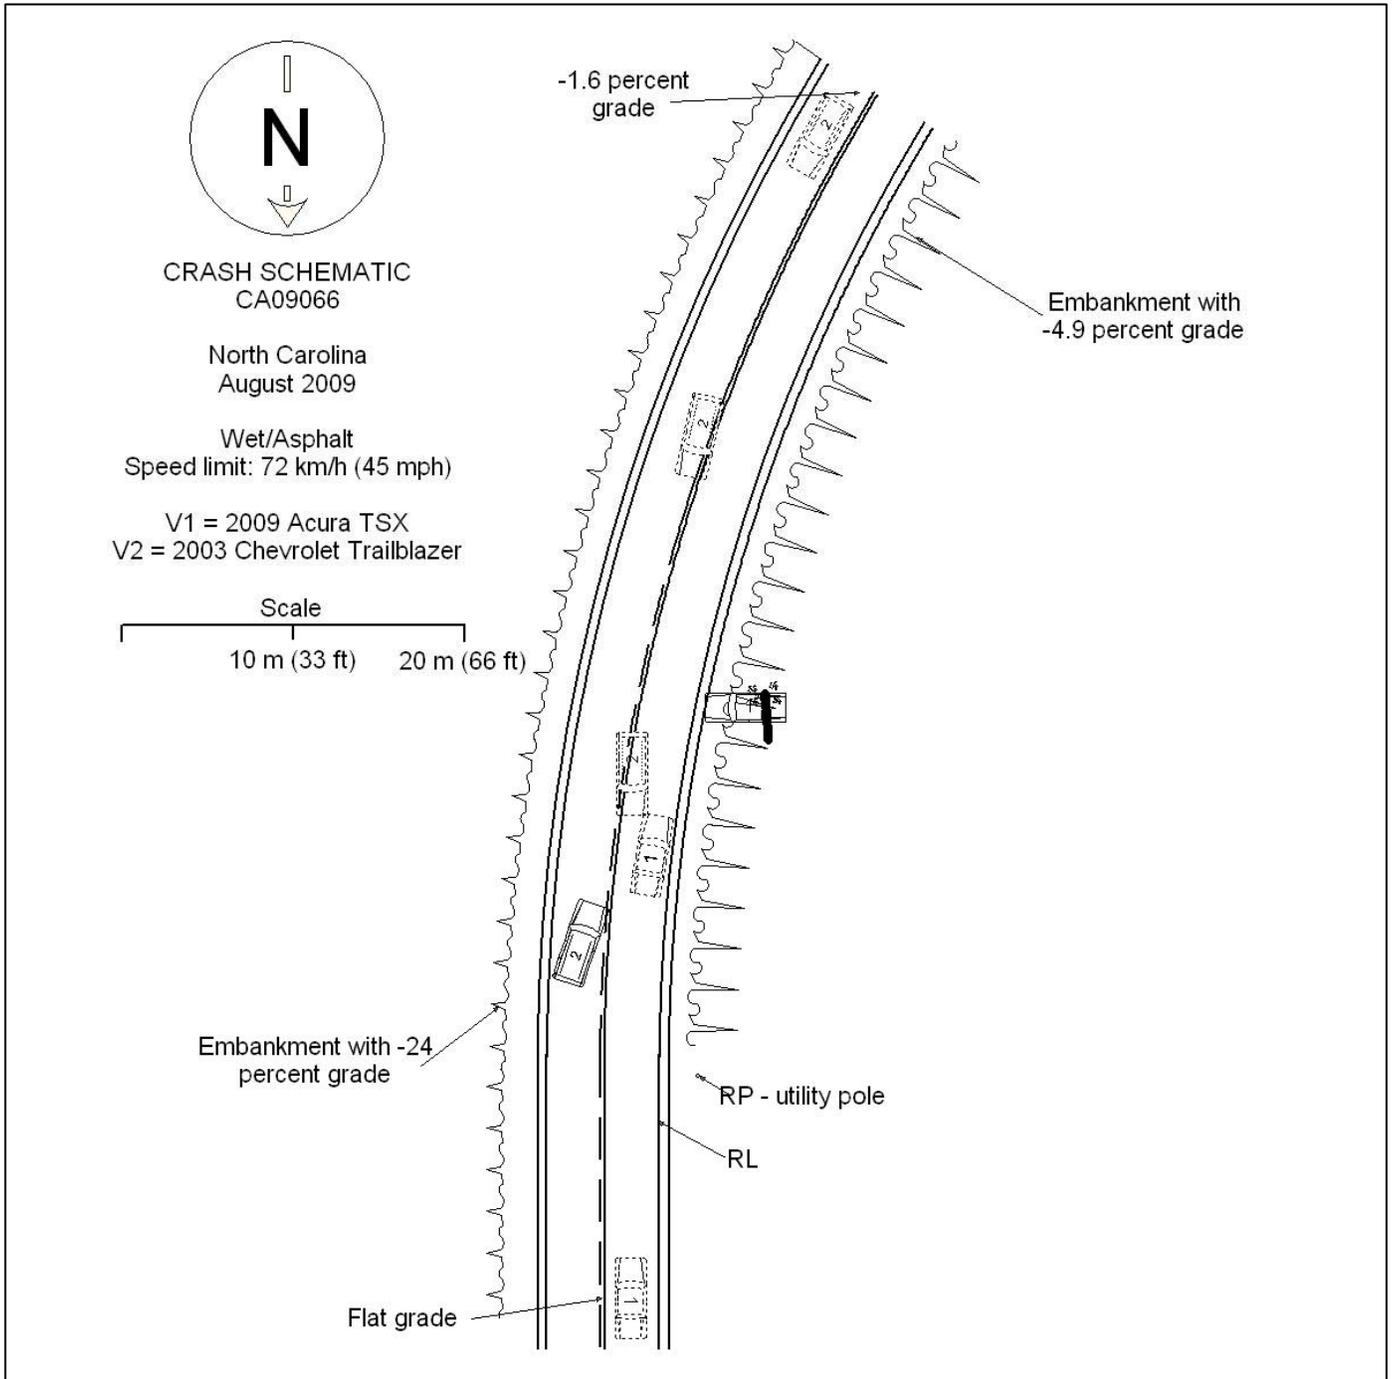
Figure 10: Crash Schematic

This crash occurred during the daylight hours of August 2009 on a two-lane north/south rural roadway. The environmental conditions were rain with a wet roadway at the time of the crash. The roadway consisted of two asphalt surfaced travel lanes. Each traffic lane measured 3.3 m (10.8 ft) in width and was bordered by narrow asphalt shoulders. The west shoulder measured 0.6 m (2 ft) in width and the east shoulder measured 0.5 m (1.6 ft) in width. Grass roadsides, with embankments sloping away from the roadway, extended outboard of the shoulders. The embankment on the east roadside began 1.9 m (6.2 ft) east of the road edge and had a negative 25 percent grade. On the west roadside, the embankment began 1 m (3.2 ft) west of the road edge and had a negative 4.9 percent grade. In the pre-crash area for the Acura, the roadway was straight and had a level grade. The pre-crash area for the Chevrolet included a curve to the left with a radius of curvature of 110 m (361 ft) and a negative grade of -1.6 percent. The curved section of roadway also included a superelevation of -1.6 percent from east to west. The posted speed limit in the area of the crash was 72 km/h (45 mph). The Scene Schematic is included as **Figure 10** of this report.
