CALSPAN REMOTE ROLLOVER CRASH INVESTIGATION

SCI CASE NO.: CA09069

VEHICLE: 2006 FORD EXPLORER EDDIE BAUER

CRASH DATE: SEPTEMBER 2007

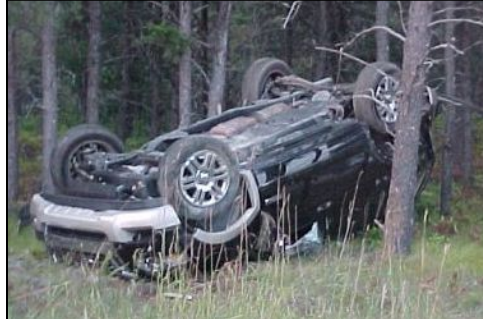
This remote investigation focused on the rollover of a 2006 Ford Explorer Eddie Bauer sport utility vehicle that resulted in the ejection and death of the 84-year-old male driver. The Ford was equipped with all-wheel drive, Electronic Stability Control (ESC), Certified Advanced 208-Complaint (CAC) frontal air bags, and Inflatable Curtain (IC) air bags with rollover sensing. The IC air bags deployed during the rollover event. **Figure 1** is an on-scene image of the Ford at final rest.

Figure 1. Final rest position of the 2006 Ford Explorer. (Image provided by the investigating police department.)

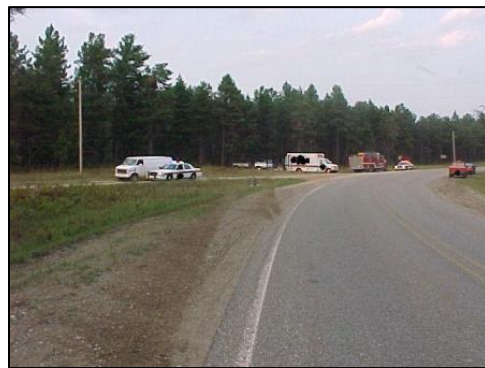
This single vehicle impact/rollover crash occurred on a rural two lane road during daylight hours. At the time of the crash, it was clear and dry. The roadway was oriented in a southwest to northeast direction and was asphalt surfaced with a posted speed limit of 89 km/h (55 mph). The roadway curved to the right with respect to the direction of travel of the Ford and was level with a slight super elevation noted at the apex of the curve (**Figure 2**). The travel lanes were delineated by solid double yellow centerlines with solid white fog lines denoting both edges of the lanes. Gravel shoulders were located outboard of both fog lines and grassy areas were located outboard of the shoulders. A dirt and gravel surfaced two lane road intersected the paved roadway at the apex of the right curve. The grassy triangular area between the two roadways was depressed relative to the elevation of the road. An area of

Figure 2. Overall view of the crash site.

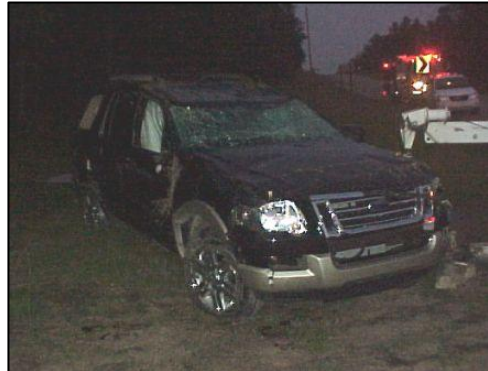
The case vehicle in this crash was a 2006 Ford Explorer Eddie Bauer, 4-door sport utility vehicle (**Figure 3**). The Ford was identified by Vehicle Identification Number (VIN): 1FMEU74886Z (production number deleted). The Ford was equipped with four-wheel drive, four-wheel antilock, traction control, ESC, CAC frontal air bags, IC air bags with rollover sensing and seat back-mounted side impact air bags. The tires were an all-season tread design, mounted on OEM multi-spoke alloy wheels. Although the specific tire data was not police reported, the left front tire remained inflated while the right front and both rears appeared to be flat. The left rear alloy wheel appeared to have been damaged in the crash. The Explorer was not equipped with a sunroof. A trailer hitch-mounted cargo carrier was in place at the time of the crash.

Figure 3. Front right three-quarter view of the Ford Explorer.

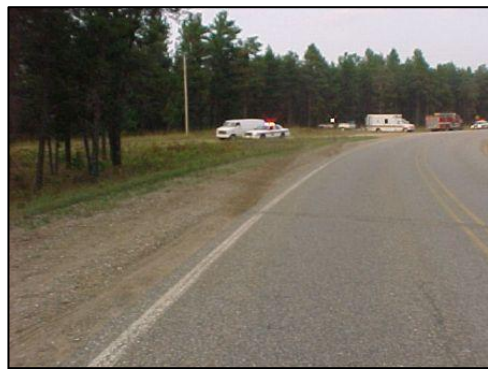
Prior to the crash, the Ford was police reported as traveling on the roadway in a northeasterly direction at or near the posted speed limit. The investigating officer indicated that the driver may have experienced a medical episode prior to the crash. As the Ford entered the right curve, the driver continued on a straight trajectory and crossed the centerline and the opposing travel lane. The Ford exited the west edge of the roadway onto the gravel shoulder (**Figure 4**). Four tire marks were present on the gravel shoulder that indicated the vehicle was in a slight clockwise (CW) yaw, probably induced by a (CW) steering input by the driver. The Ford departed the shoulder and entered the depressed grass area on the west roadside. The vehicle traveled a police reported distance of 36 m (119 ft) from the departure point across the gravel and grass surfaces.

Figure 4. Left side road departure.

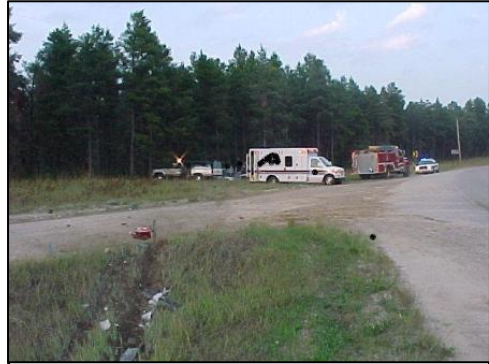
As the Ford traversed the grass area between the intersecting roads, the front left area of the vehicle impacted a road sign. This sign impact did not alter the trajectory of the vehicle. The Ford traveled an additional 7 m (24 ft) and struck a stop sign oriented for the intersecting east/west roadway with its front left area. **Figure 5** is a view of the area of the sign impacts.

Figure 5. Impact locations with the road signs.

The front left area of the Ford impacted two sign posts that produced minimal bumper crush. The yielding object impacts fractured the left headlamp assembly and dented the face of the hood.

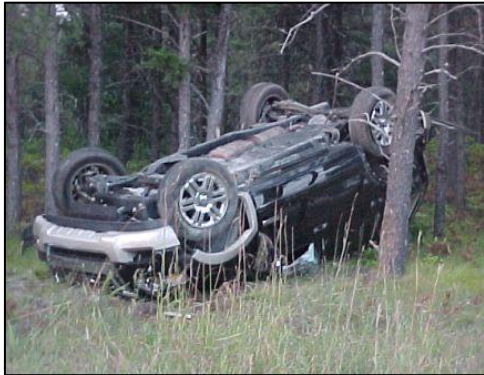
Figure 6. Right side view of the Ford at final rest.

As the Ford initiated the sixth-quarter turn, the right rear side area impacted a tree resulting in damage to the quarter panel and the taillight assembly. The left rear door of the Ford impacted a 15-20 cm (6-8 in) diameter tree as the vehicle came to rest. The non-horizontal impact crushed the door and sill to an estimated depth of 10-15 cm (4-6 in).

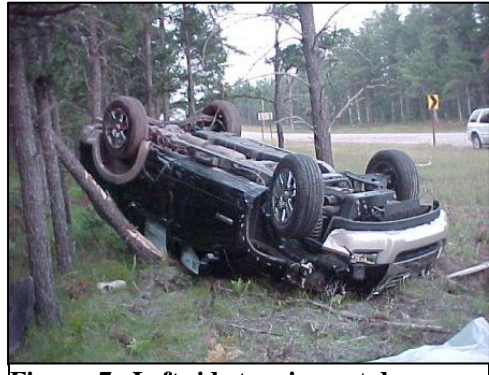
Figure 7. Left side tree impact damage.

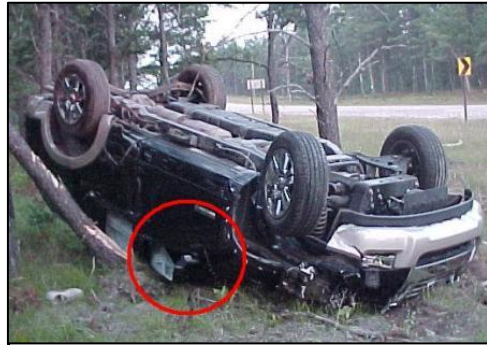
Figure 8. Suspected tear of the left IC tether.

An on-scene image of the Ford indicates the left IC tether may have torn during the rollover as a result of driver loading (**Figure 8**). With the Ford inverted, the IC air bag is partially extended out of the left front door window opening. The tether area is concealed by the outside mirror.

A close review of the available images indicated the forward tether for the left IC air bag may have been torn by the driver as he loaded the IC air bag during the rollover event, thus resulting in an ejection portal through the left front window opening.

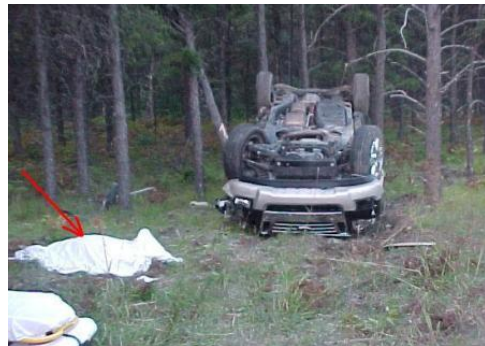
As the Ford initiated its tripped rollover event, the IC air bags deployed from the roof side rails. This 2006 Ford Explorer was equipped with a sail panels at the leading edge of the IC air bags. In addition, the leading edge of the sail panels should have been tethered to the A-pillars. The IC air bags provided coverage from the A- to the C-pillars and the full-height of the glazing. The driver was completely ejected from the Ford and was found approximately 5 m (18 ft) from the final rest position of the vehicle (**Figure 9**).

Figure 9. Final rest position of the driver in relation to the Ford Explorer.

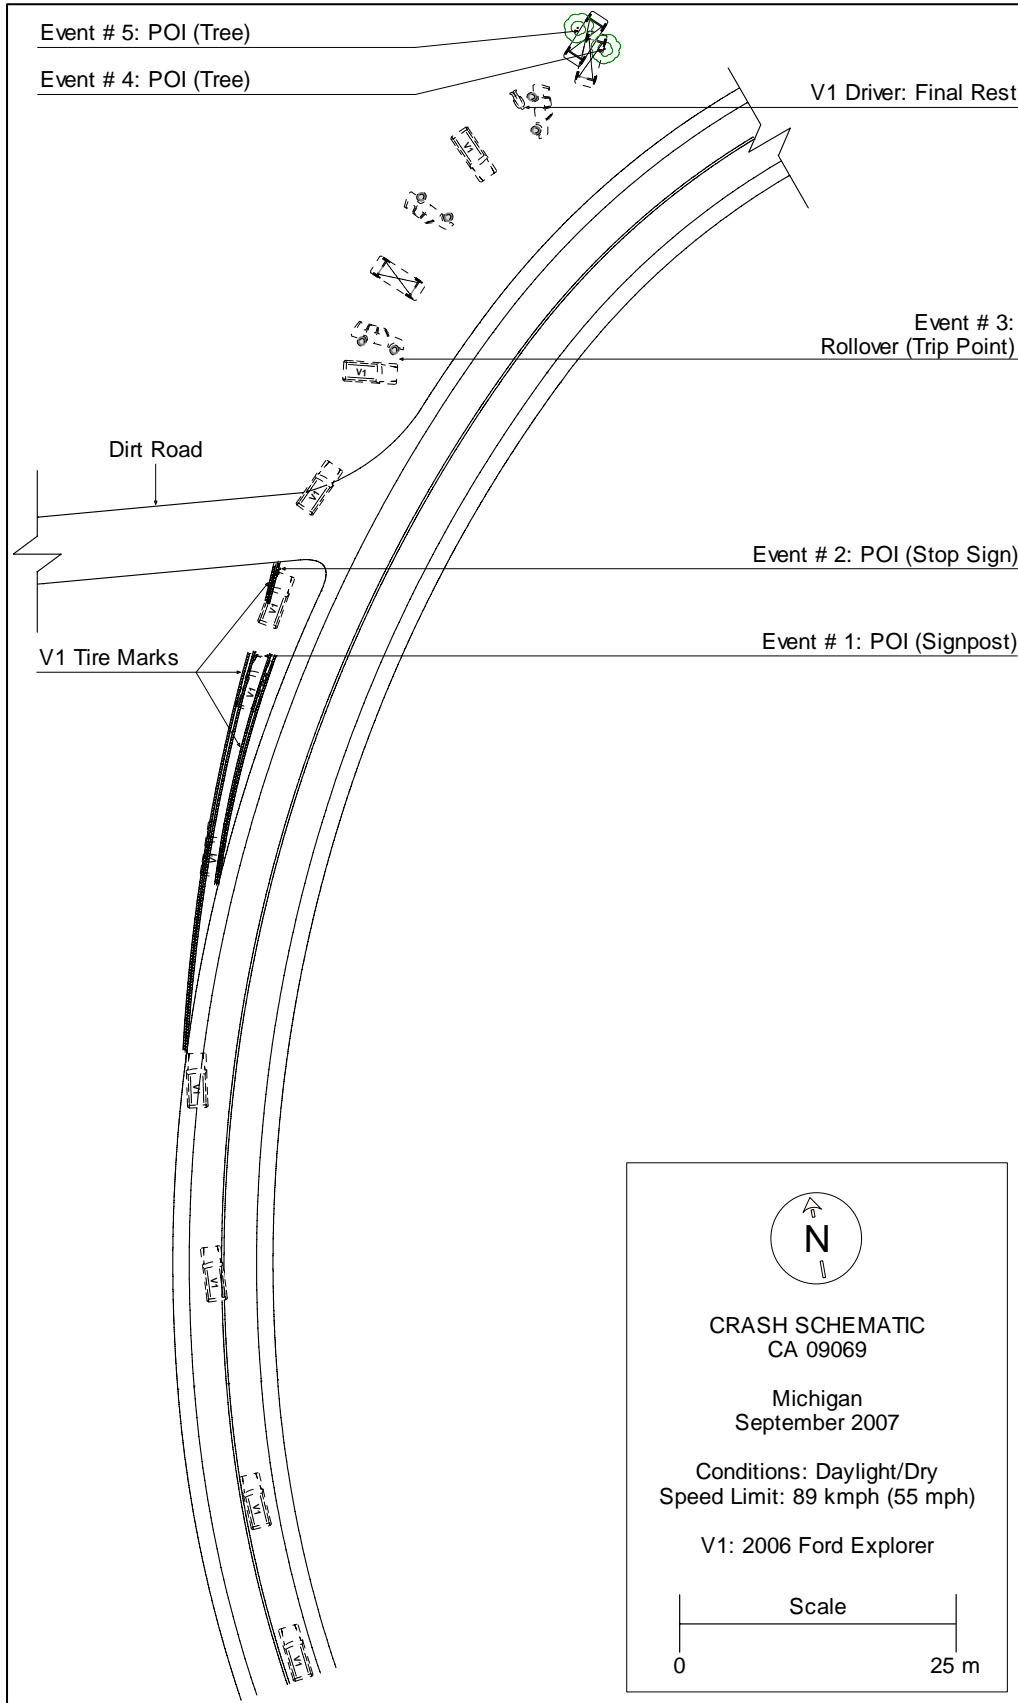
Figure 10. Crash Schematic

trees with diameters of 10-20 cm (4-8 in) was located north of the intersecting roadway. The crash schematic is included as **Figure 10**.
