**CALSPAN ON-SITE ROLLOVER CRASH INVESTIGATION**

**SCI CASE NO.: CA09072**

**VEHICLE: 2007 FORD FOCUS SE**

**CRASH DATE: SEPTEMBER 2009**

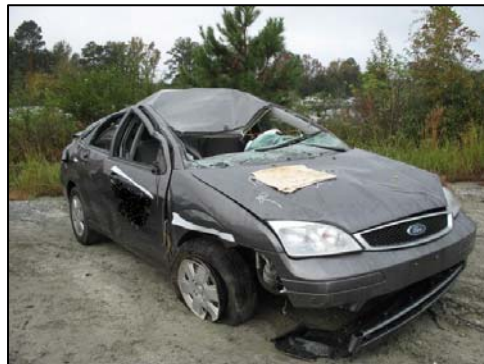
**Figure 1: 2007 Ford Focus case vehicle.**

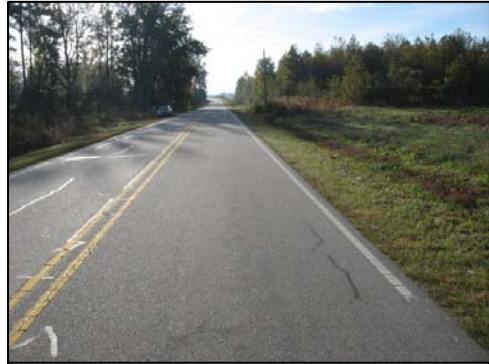
The restrained 23-year-old female driver of the Ford was operating the vehicle southbound on the rural roadway at a police estimated speed of 89 km/h (55 mph). She departed her work place and was en route to her residence and was approximately 8 km (5 mi) from her destination when the crash occurred. **Figure 2** depicts the pre-crash trajectory of the Ford. The mother of the driver reported that a deer ran into the roadway in front of the Ford. The driver initiated an avoidance maneuver by braking and steering to the right. The Ford departed the right side of the roadway at a degree angle of approximately 10 degrees and entered the ditch in a tracking mode. The right front tire rutted the soft soil of the ditch located between the west road edge and the east ditch wall and adjacent to the culvert and driveway.

**Figure 2: Pre-crash trajectory of the Ford.**

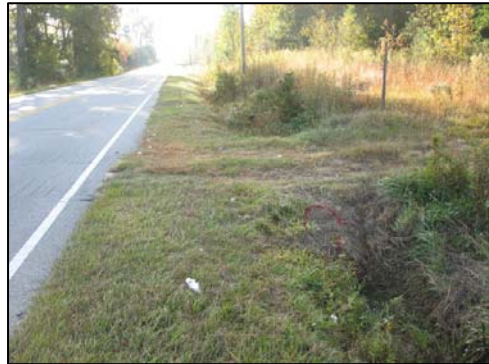
The front right corner area of the bumper fascia and the right front tire of the Ford impacted the driveway culvert. The impact reduced the right wheelbase by 21 cm (8.3 in). The impact actuated the driver's safety belt pretensioner and deployed the driver's frontal air bag. The Ford then rotated approximately 65 degrees clockwise (CW) as it traveled up the embankment onto the driveway. As the Ford traversed the grass driveway, the left tires engaged the ruts in the driveway that tripped the vehicle into a left side leading rollover along the west roadside. **Figure 3** depicts the location of the impact with the culvert and the initiation of the rollover. The Ford rolled six-quarter turns over a distance of 21 m (68.9 ft). Three gouges were noted to the grass roadside from the overturning vehicle. As it rolled, the Ford entered the ditch that interrupted the rollover. The Ford slid on its roof prior to coming to rest and came to rest in the ditch facing in a southerly direction. A 3.8 m (12.5 ft) section of disturbed soil on the west ditch wall and debris in the ditch evidenced the slide and final rest position of the Ford.

**Figure 3: Initial impact location and tripping point of the Ford on the driveway.**

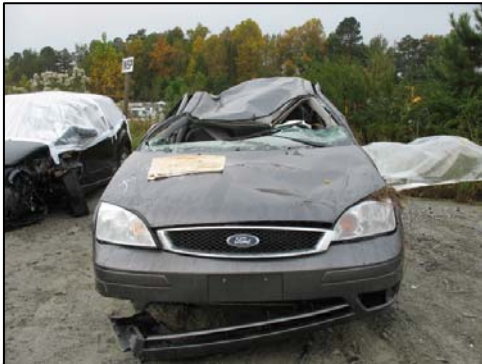
The initial impact to the culvert resulted in minor damage to the lower right corner of the front bumper fascia and the displacement of the right front axle. The front bumper beam was not damaged; therefore there was no residual crush. The right front axle was displaced 21 cm (8.3 in) rearward. The CDC for this event was 12-FRLE-3.

As a result of the rollover, the Ford sustained moderate severity damage to the left and right planes, and severe damage to the top plane. **Figures 4 and 5** depict the roof damage to the Ford. The scratches on the roof were oriented laterally and longitudinally, indicating the vehicle had rolled over the roof multiple times. The direct contact to the top plane extended 383 cm (150.8 in) longitudinally from the leading edge of the hood to aft of the C-pillars and 109 cm (42.9 in) laterally from the left roof side rail to the right roof side rail. The maximum vertical crush was located on the windshield header 40 cm (15.7 in) right of the left roof side rail and measured 32 cm (12.6 in) in depth. The maximum lateral crush measured 12 cm (4.7 in) and was located on the right roof side rail, located 6 cm (2.4 in) aft of the windshield header. The windshield was 100 percent fractured and the laminate was torn along the full-length of the windshield header and vertically along the upper half of the A-pillars. All glazing on the left and right sides and the backlight disintegrated as a result of the rollover. All four doors remained closed during the crash sequence. The right front door was jammed closed post-crash. The left front, left rear and right rear doors were operational post-crash. The CDC assigned for this rollover event was 00-TDDO-4.

**Figure 4: Front bumper fascia damage and roof crush from the front of the Ford.**

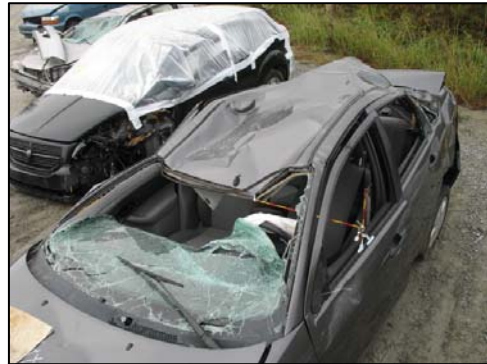
**Figure 5: Rollover damage from above, left front.**

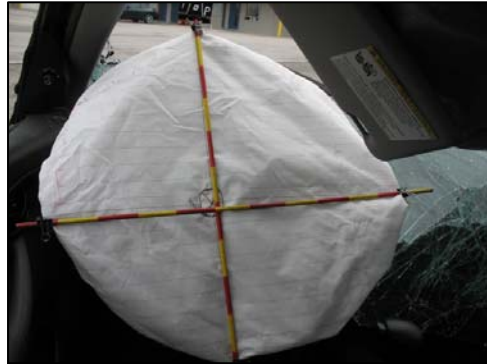
The driver's air bag was concealed within the center hub of the four-spoke steering wheel by two cover flaps. The upper cover flap measured 6 cm (2.4 in) in height and 18 cm (7.1 in) in width at the horizontal seam. The lower cover flap was trapezoidal in shape and measured 9 cm (3.5 in) in height, 6 cm (2.4 in) in width at the lower aspect and 18 cm (7.1 in) in width at the horizontal tear seam. There was an oval-shaped Ford logo in the center of the flaps, attached to the upper cover flap that measured 2.5 cm (1 in) in height and 6 cm (2.4 in) in width. The driver's air bag (**Figure 6**) measured 48 cm (18.9 in) in diameter in its deflated state. The air bag was vented by petal vents that were 3 cm (1.2 in) in width on the rear face of the air bag. There were three vents on the left aspect and two on the right. The air bag was tethered by one tether sewn to an oval-shaped seam at the center of the face of the air bag. This seam measured 3 cm (1.2 in) in height and 2 cm (0.8 in) in width. There were green and blue threads woven into the fabric of the air bag that tore as the air bag deployed to control the force and direction of the deployment. There was no damage or contact evidence to the driver's frontal air bag.

**Figure 6: Deployed driver's frontal air bag.**

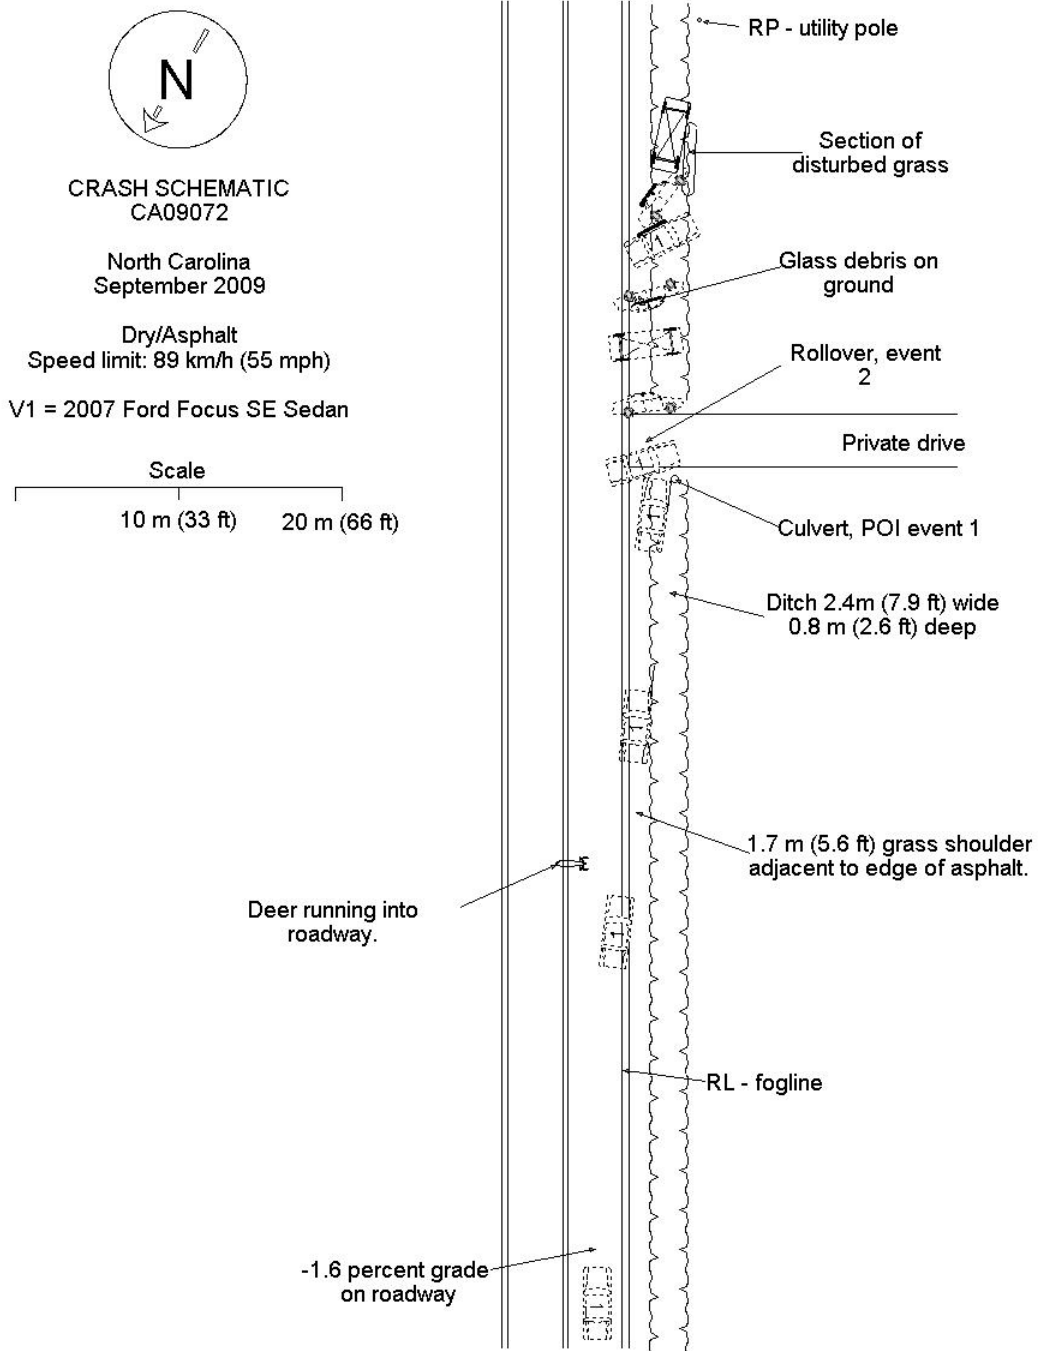
**Figure 7: Crash Schematic**

and was 2.4 m (7.9 ft) in width and 80 cm (31.5 in) in depth. There was a grass surfaced access driveway connecting the roadway to an agricultural field located west of the roadway. This driveway was 3.2 m (10.5 ft) in width and was located 24.2 m (79.4 ft) north of the reference point. In the pre-crash area of the Ford, the roadway was straight and had a negative grade of -1.6 percent. There was a curve unrelated to the crash that began 82.8 m (272 ft) north of the area in which the Ford departed the roadway to the right. The posted speed limit in the area of the crash was 89 km/h (55 mph). The crash schematic is included as **Figure 7** of this report.
