CALSPAN ON-SITE OFFICE OF DEFECTS INVESTIGATION

SCI CASE NO: CA09079

VEHICLE: 2005 SCION tC

LOCATION: ILLINOIS

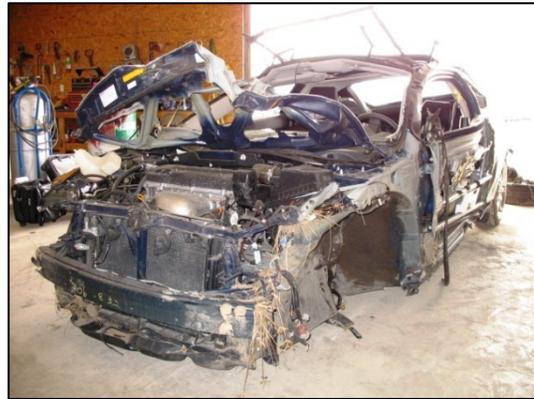
Figure 1: Left front oblique view of the rollover damage to the 2005 Scion tC.

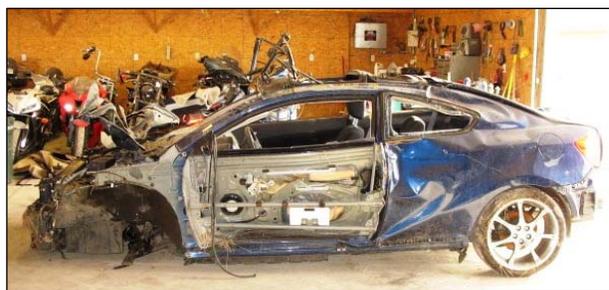
The 2005 Scion tC sustained extensive damage to all exterior surfaces as a result of the rollover crash, with corresponding separation of multiple body components. **Figure 5** depicts a left side view of the damaged Scion. Damage from the initial trip-over was located on the left rear wheel, which consisted of grass wedged between the tire bead and wheel with abrasions to the wheel face. Due to

Figure 5: Left side view of damaged Scion.

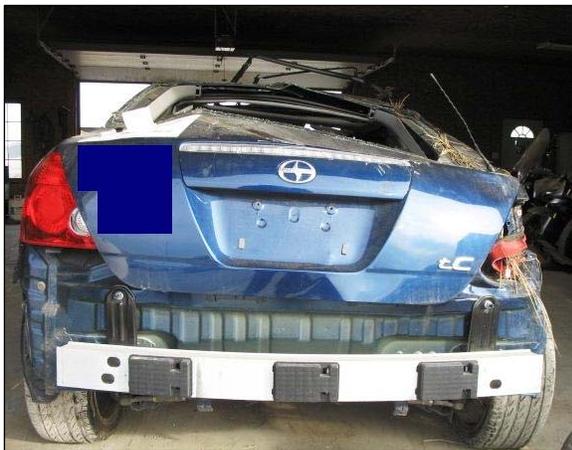
The direct contact and induced damage extended the full width and length of the vehicle on all planes. Accompanying damage consisted of abrasions and isolated dents, with soil and other debris embedded within the seams. The maximum vertical roof crush was located on the right side of the backlight header (Figure 6) and measured 6 cm (2.4 in) in depth, while the maximum lateral crush was located at the top of the left A-pillar (Figure 7) and measured 3 cm (1.2 in) in depth. The Collision Deformation Classification (CDC) for the rollover was 00TDDO3.

Figure 6: Vertical crush to right rear backlight header of the Scion.

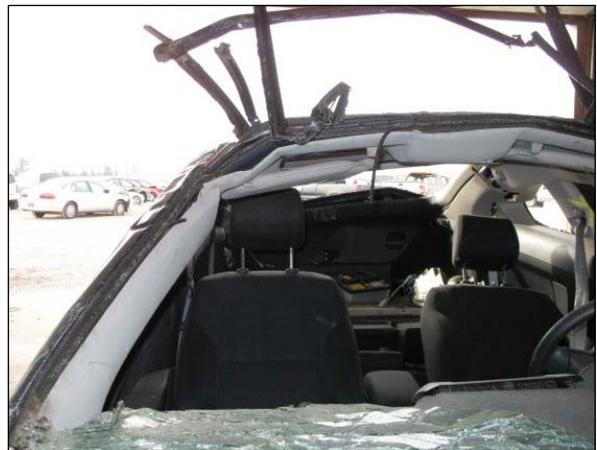
Figure 7: Maximum lateral crush to the right A-pillar of the Scion.

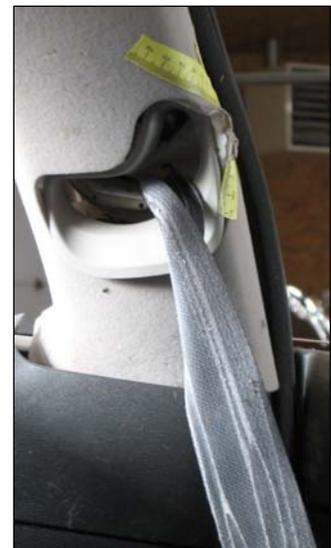
Figure 8: Upper safety belt webbing loading striations and B-pillar abrasions.

The upper portion of the webbing was gathered in the leading corner of the D-ring, with deep frictional abrasions to the forward aspect of the plastic D-ring housing and B-pillar trim panel (**Figure 8**). Longitudinal striations 30 cm (12 in) in length were identified on both sides of the upper portion of the webbing, originating just below the D-ring. These findings were attributed to the loading forces sustained by the webbing during the ejection of the driver.

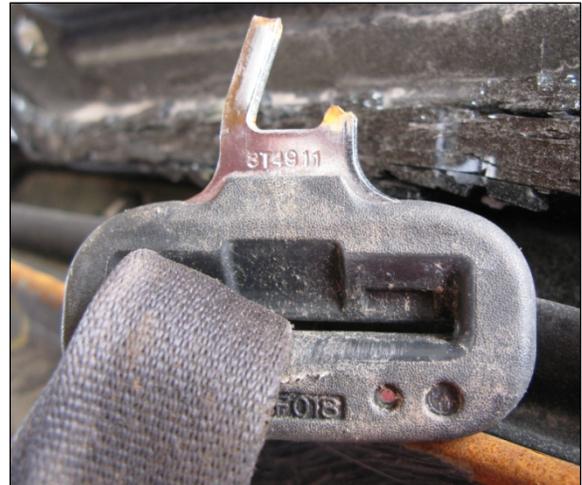
Figure 9: Latch plate loading evidence and fractured lock clasp.

Attached to the upper portion of the belt webbing was the latch plate, located 97 cm (38 in) from the D-ring anchor. Inspection of the latch plate revealed frictional abrasions to the full width of the plastic surface, and the webbing was folded in half and gathered to one side of the latch plate. The latch plate was fractured in two places at the lock clasp section (**Figure 9**), which produced a “J” shaped metal shard that was found fastened within the belt buckle locking mechanism.

Based on SCI findings, the fracturing of the latch plate and separation of the belt webbing were attributed to the severe stresses sustained by the safety belt system as a result of the loading forces associated with the driver’s kinematics during the rollover sequence.

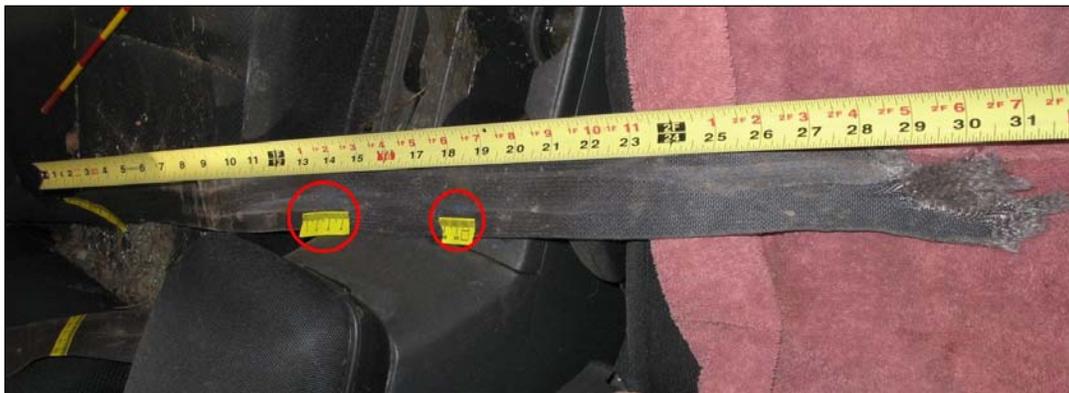
The lower section of the belt spanned 79 cm (31 in) in length from the lower anchor to the webbing tear point (**Figure 10**). Strands of blue fabric were found embedded in the underside aspect of the webbing, which matched the color shade of the shirt that the driver was wearing at the time of the crash.

Figure 10: Lower section of belt. *Note blue fabric transfer (encircled) and frayed end.*
