CALSPAN ON-SITE ROLLOVER CRASH INVESTIGATION

SCI CASE NO: CA09084

VEHICLE: 2009 CADILLAC SRX

CRASH DATE: OCTOBER 2009

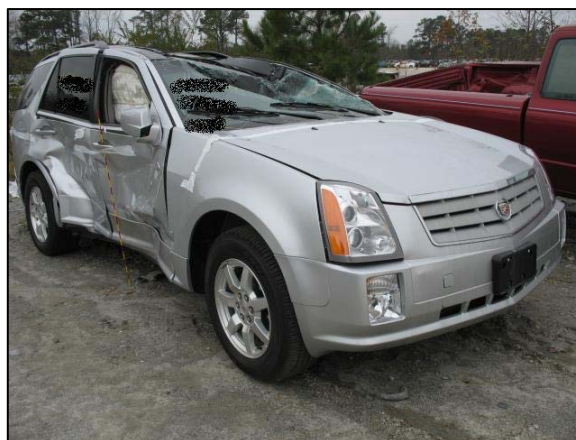
Figure 1: Front right oblique view of the 2009 Cadillac SRX.

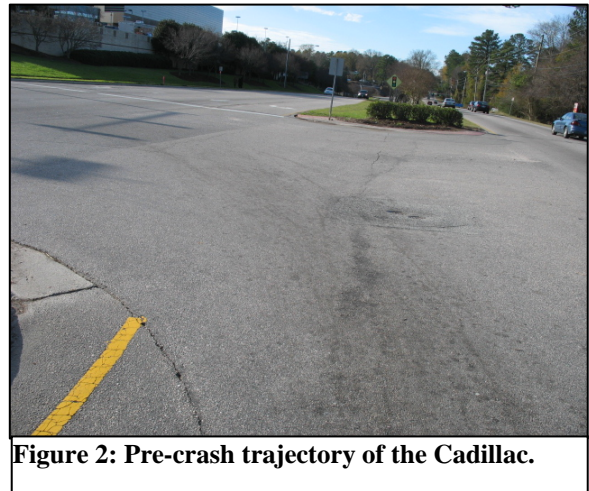
Figure 2: Pre-crash trajectory of the Cadillac.

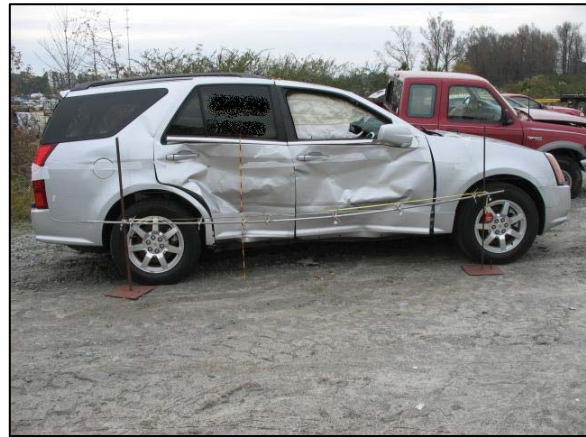
The right, left and top plane of the Cadillac sustained moderate-severity damage as a result of this multiple event crash sequence. The right plane of the Cadillac sustained direct contact damage across both doors as a result of the impact with the Saturn (Event 1). **Figure 3** depicts the initial impact damage. The direct contact damage began 37 cm (14.6 in) forward of the right rear axle and extended forward 172 cm (67.7 in). The maximum crush was located 71 cm (28 in) forward of the right rear axle and measured 19 cm (7.5 in). The height of the maximum crush above the ground was 55 cm (21.6 in). The Door-Sill Differential (DSD) was 5 cm (2.0 in). The combined direct and induced damage (Field L) began 16 cm (6.3 in) rear of the right rear axle and extended forward 274 cm (107.9 in). The residual crush profile resulting from the initial impact was as follows: C1 = 0 cm, C2 = 0 cm, C3 = 16 cm (6.3 in), C4 = 14 cm (5.5 in), C5 = 10 cm (3.9 in), C6 = 0 cm. The Collision Deformation Classification (CDC) assigned for the initial impact to the Cadillac was 01RPEW2.

Figure 3: Right side damage to the Cadillac.

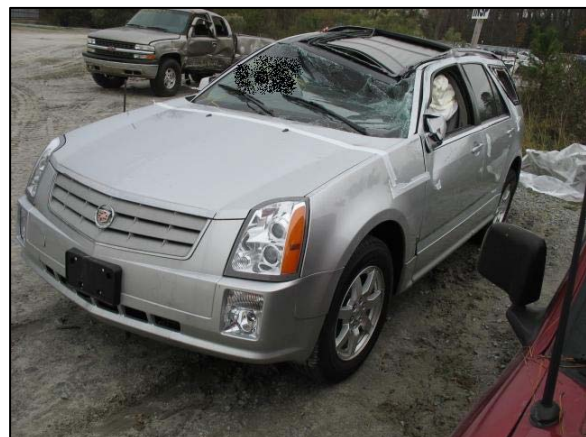
The exterior of the Cadillac sustained severe-severity damage to the top plane as a result of the rollover (Event 2). **Figure 4** depicts the rollover damage sustained by the Cadillac. The direct contact to the top plane extended 126 cm (49.6 in) laterally from roof side rail to roof side rail and 430 cm (169.3 in) from the leading edge of the hood rearward to the backlight header. The maximum vertical crush was located on the windshield header, 17 cm (6.7 in) inboard of the left roof side rail. The maximum vertical crush measured 21 cm (8.3 in). The maximum lateral crush was located at the junction of the left A-pillar and the windshield header, and measured 6 cm (2.4 in). The windshield glazing was completely fractured, with more significant damage along the upper aspect of the windshield and near the left A-pillar. There were no laminate tears in the windshield. The front door glazing on both sides, the left rear glazing adjacent to the cargo area, the backlight glazing and the roof glazing disintegrated during the crash sequence. The right side rear glazing and

Figure 4: Rollover damage to the left and top planes of the Cadillac.

the left rear door glazing were not damaged during the crash. All four doors remained closed during the crash. The left doors and tailgate were operational post-crash. The right doors were jammed closed post-crash. The CDC assigned for the rollover event was 00TDDO4.

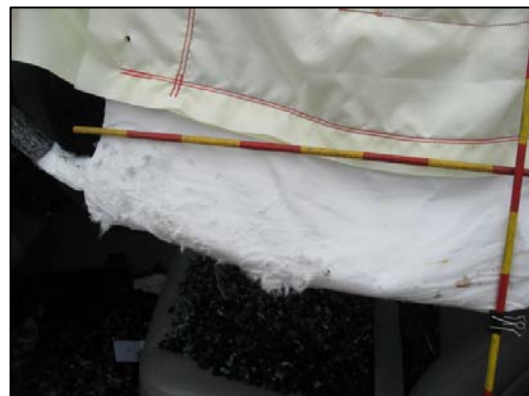
The left IC air bag contained post-crash body fluid on the inboard side in the first row. This body fluid was located 0-22 cm (0-8.7 in) above the lower edge of the air bag and 17-43 cm (6.7-16.9 in) aft of the front edge of the air bag and was attributed to the glass cuts on the palms of the driver's hands as she crawled out of the vehicle after it came to final rest. There was an abrasion on the outboard aspect of the left curtain located 0-11 cm (0-4.3 in) above the lower edge of the air bag and 0-38 cm (0-15 in) aft of the front edge of the air bag. This abrasion was attributed to contact with the ground and the disintegrated glass fragments from the front left window as the Cadillac rolled. **Figure 5** depicts this abrasion. There was no damage or contact evidence on the right curtain air bag. **Figures 6 and 7** are overall interior views depicting the IC air bags.

Figure 5: Abrasion to the outer aspect of the left curtain.

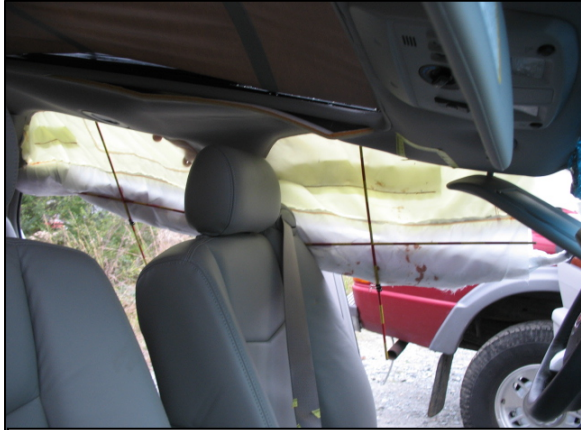
Figure 6: Left IC air bag of the Cadillac SRX.

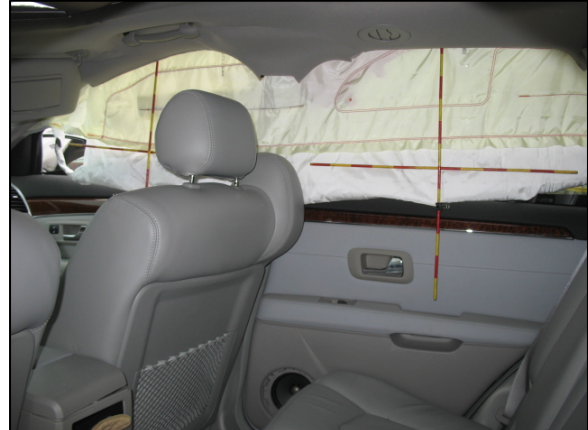
Figure 7: Right IC air bag.

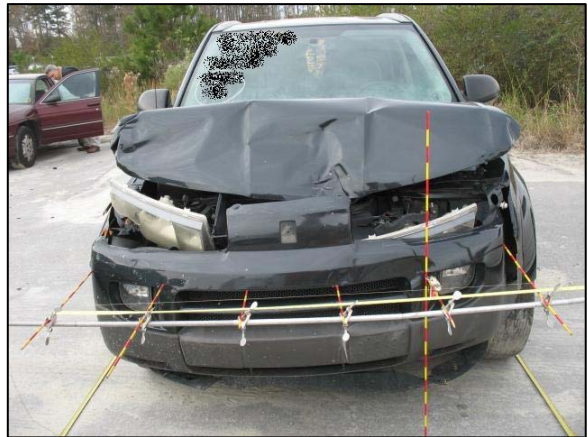
The front plane of the Saturn sustained moderate-severity damage as a result of the impact with the Cadillac (**Figure 8**). The direct damage extended from the front left bumper corner to the front right bumper corner of the Saturn. The maximum crush was located at C3; 15 cm (5.9 in) left of the vehicle centerline and measured 15 cm (5.9 in). A crush profile was documented along the full width of the damaged front bumper. This crush profile was as follows: C1 = 10 cm (3.9 in), C2 = 13 cm (5.1 in), C3 = 15 cm (5.9 in), C4 = 14 cm (5.5 in), C5 = 14 cm (5.5 in), C6 = 12 cm (4.7 in). The CDC assigned for this impact was 11FDEW1.

Figure 8: Frontal damage to the Saturn.

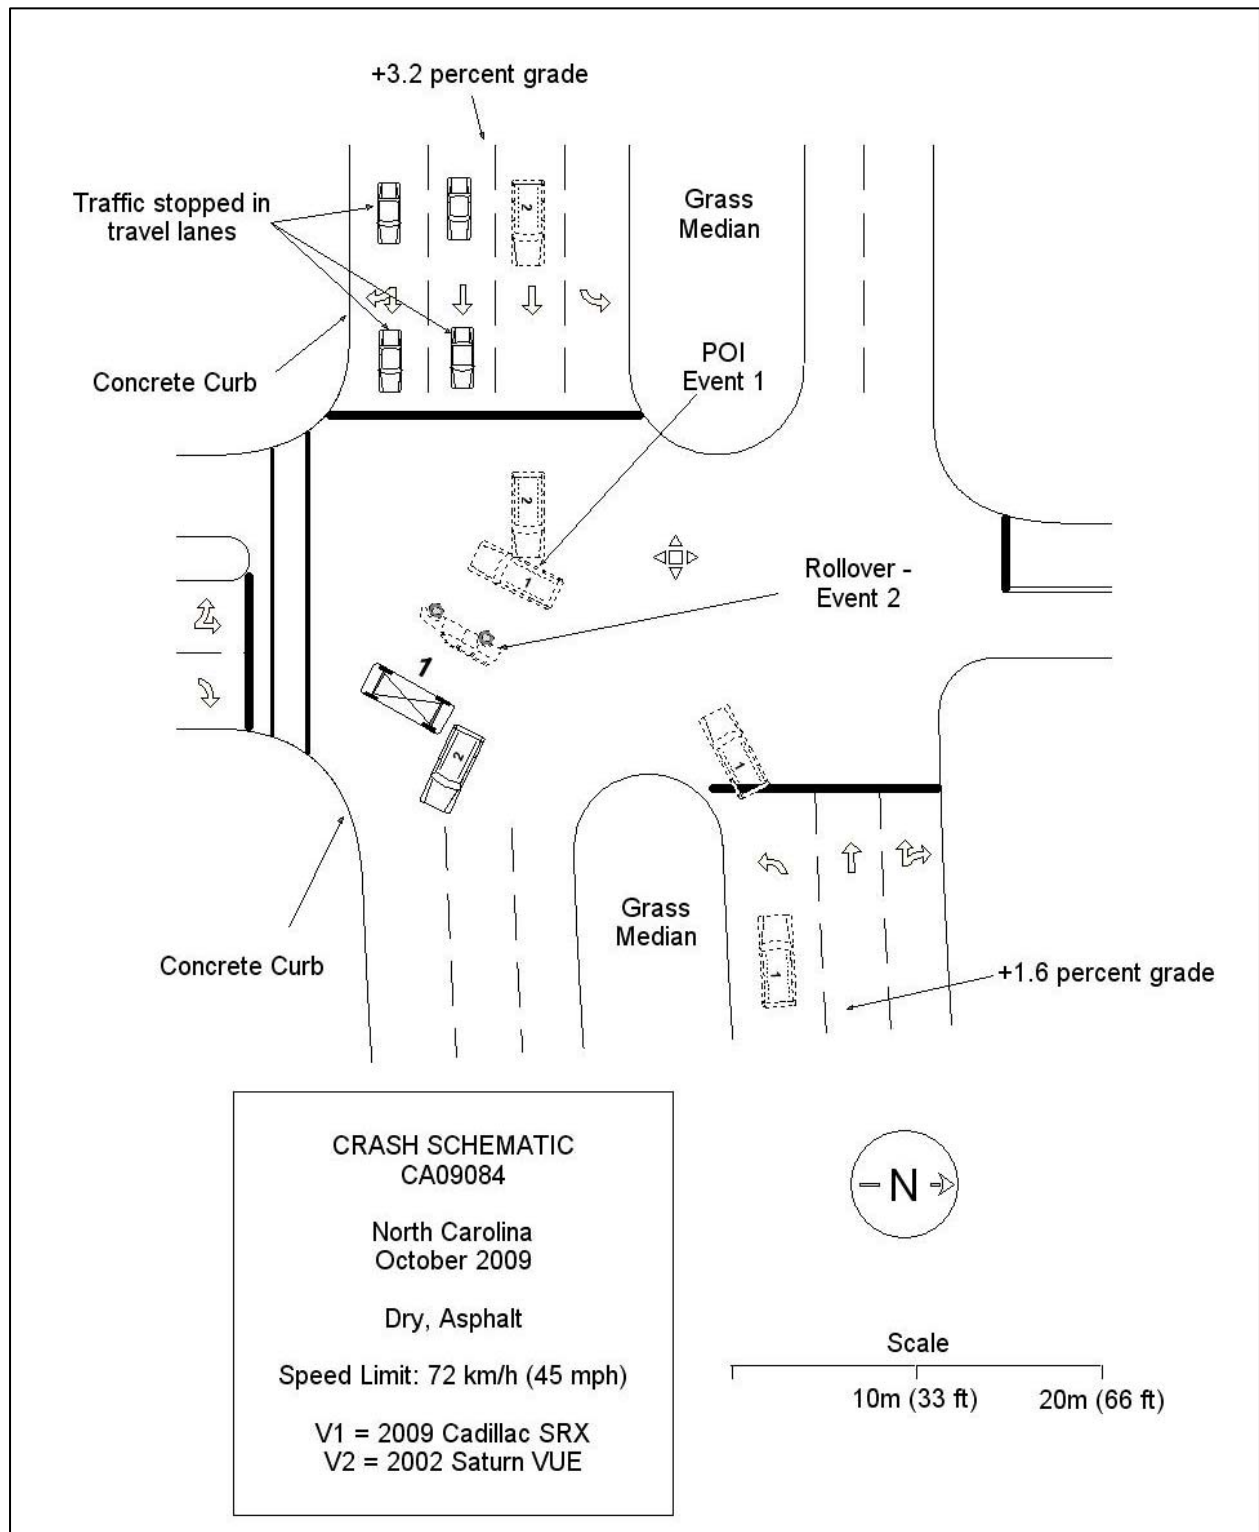
Figure 9: Crash Schematic

The momentum of the Saturn and the angle of the impact displaced the Cadillac to the left subsequent to the initial impact. The left tires of the Cadillac tripped on the asphalt of the roadway and the Cadillac initiated a left side leading rollover in the intersection. Asphalt was observed embedded within the rims of both left side wheels during the SCI inspection. The Cadillac rolled two quarter turns to the left for a distance of approximately 9 m (29.5 ft). The rollover was not interrupted. The Cadillac came to rest on its roof facing southwest in the southeast corner of the intersection. The Saturn's trajectory was redirected approximately 20 degrees to its right and the vehicle came to rest in the southeast corner of the intersection facing southeast.
