On-Site Rollover Investigation  
Dynamic Science, Inc. (DSI), Case Number DS10002  
2008 Ford Escape Hybrid  
California  
January 2010

1. Report No. DS10002	2. Government Accession No.	3. Recipient Catalog No.	
4. Title and Subtitle  On-Site Rollover Investigation		5. Report Date December 21, 2010

**Dynamic Science, Inc.**  
**Crash Investigation**  
**Case Number: DS10002**

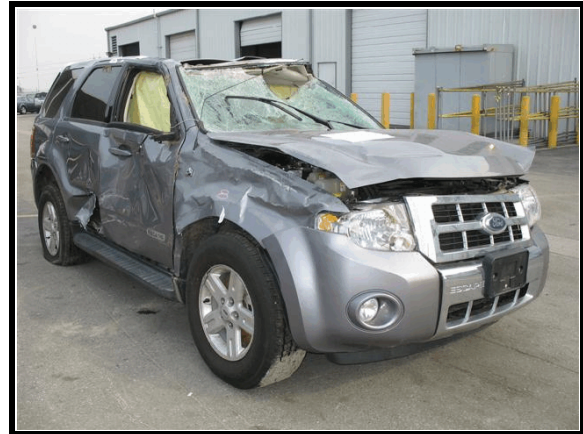
This on-site investigation focused on a 2008 Ford Escape Hybrid that was involved in a minor vehicle-to-vehicle impact and subsequent rollover (**Figure 1**). This crash occurred in January 2010 at 1505 hours in an unincorporated area of California. The crash site was the three westbound lanes of a divided interstate highway. It was raining at the time of the crash. The subject vehicle was being driven in the middle lane by a 35-year-old male. A 2008 Dodge Dakota that was being driven by a 24-year-old female was traveling ahead of the Ford in the third lane. A 1996 Peterbilt three-axle tractor was being driven by a 44-year-old male in the first lane. The Peterbilt was pulling a 2008 Western 2-axle trailer. The Dodge began changing lanes to the right into the Ford's travel lane. There was no contact between the vehicles. The driver of the Ford steered to the right to avoid the Dodge and the right side of the Ford impacted the left side of the Peterbilt. The driver of the Ford steered sharply to the left, steered back to the right, and lost control of the vehicle. The Ford began a clockwise rotation, departed the roadway on the right, and began a left side leading rollover down an embankment. The Ford rolled five quarter turns before impacting a metal fence and coming to rest on its left side. The driver sustained minor injuries and was transported to a local hospital where he was treated and released. The Ford was towed from the scene due to damage and was later declared a total loss by the insurance company. The Dodge did not sustain any damage and was driven from the scene. The Peterbilt sustained minor damage and was towed from the scene.

**Figure 1.** Subject vehicle, 2008 Ford Escape Hybrid

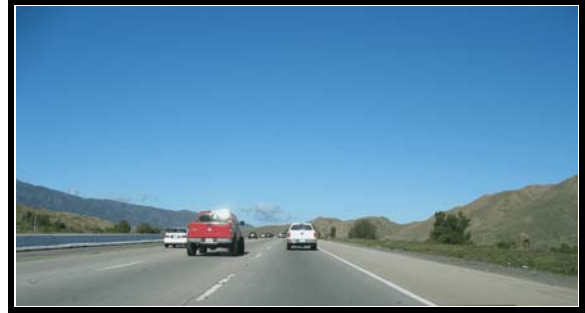
The crash site was the westbound lanes of an interstate highway (**Figure 2**). The highway was configured with three lanes that were separated by dashed white lines. The concrete, rain-grooved roadway was straight, level, and was wet at the time of the crash. The roadway was bordered on the north by a 3.3 m (11.0 ft) paved concrete shoulder, a 6.7 m (22.0 ft) level area of grass, a 58 percent

**Figure 2.** Westbound approach

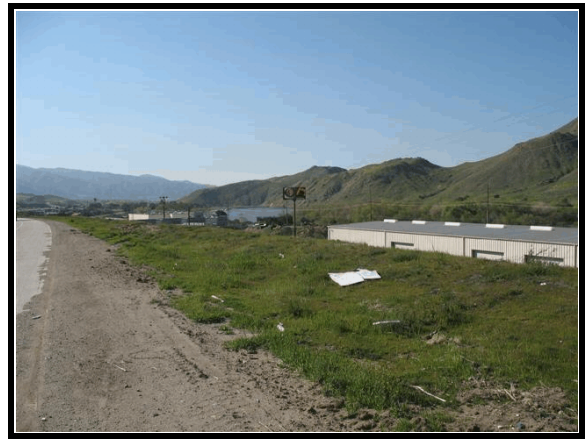
**Figure 3.** Right side road departure (north)

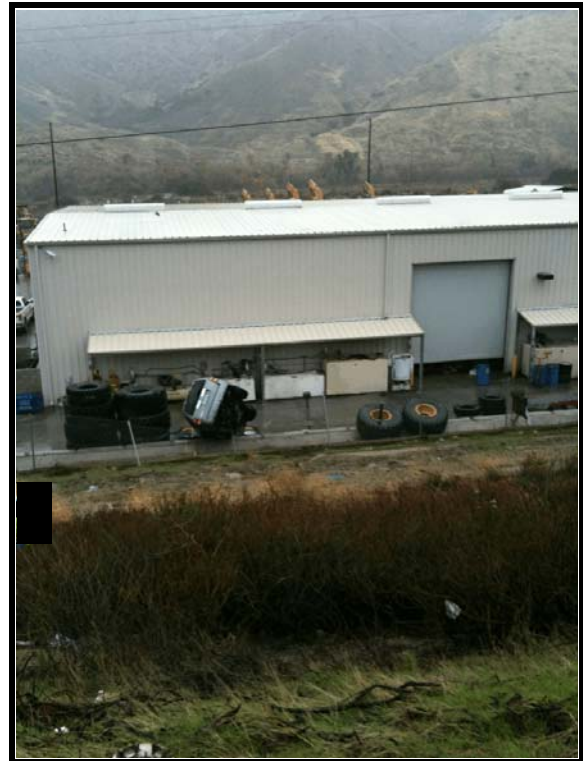
The driver of the Ford steered to the right and the right side of the Ford impacted the left side of the Peterbilt (Event 1). The driver of the Ford steered sharply to the left, then steered back to the right, and lost control of the vehicle. The Ford began a clockwise rotation and departed the roadway on the right (**Figure 3**). The vehicle continued the rotation, crossed the level area of grass, and began traveling down the embankment. Due to the steepness of the embankment and surface irregularity the Ford began a left side leading fall-over type rollover (Event 2). The vehicle traveled approximately 60 m (197 ft) prior to the rollover event. The Ford rolled five quarter turns before impacting a metal fence (Event 3) and coming to rest on its left side straddling the fence and tipped downward into the adjacent lot (**Figure 4**).

**Figure 4.** Final rest of subject vehicle looking north (police photo)

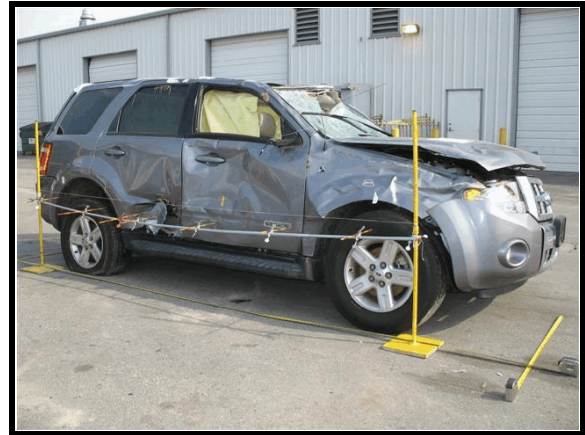
The Ford sustained direct and induced damage to the right side from the impact with the Peterbilt (**Figure 5**). The damage began 26.0 cm (10.2 in) aft of the rear axle, extended forward 287.0 cm (112.9 in), and ended just forward of the front axle. Within this area of damage, forward of the rear axle, there was a 26.0 cm (16.1 in) x 30.0 cm (18.6 in) hole in the sheet metal that had been caused by contact with one of the Peterbilt's left side wheels/hubs. The Field L measurement was identical to the direct damage measurement. Six crush measurements were taken at the lower door level as follows:  $C_1 = 0$  cm,  $C_2 = 0$  cm,  $C_3 = 3.0$  cm (1.2 in),  $C_4 = 2.0$  cm (1.2 in),  $C_5 = 1.0$  cm (0.4 in),  $C_6 = 0$  cm. The maximum crush was located at the window frame level above  $C_4$  and measured 10.0 cm (3.9 in). The Door Sill Differential (DSD) was located 139.0 cm (54.7 in) forward of the rear axle and measured 7.0 cm (2.8 in). The Collision Deformation Classification (CDC) for Event 1 was 05RDES2.

**Figure 5.** Right side damage, 2008 Ford Escape

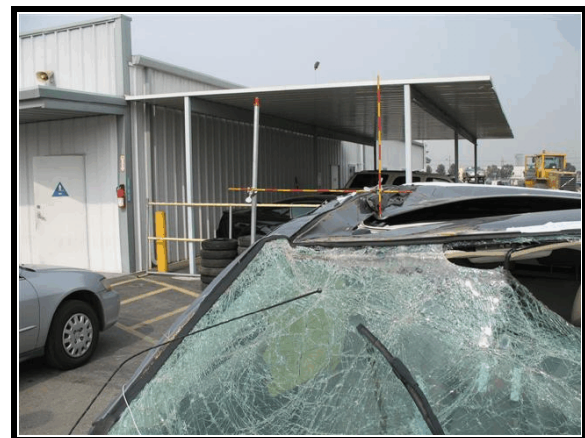
The Ford sustained damage to the left side, right side, front, and roof during the rollover event (**Figure 6**). The direct damage to the top of the vehicle extended laterally from roof side rail to roof side rail and measured 122.0 cm (48.0 in). The damage extended from the hood rearward 374.0 cm (147.2 in). The maximum vertical crush measured 13.0 cm (5.1 in) and was located 71.0 cm (27.9 in) rearward of the windshield header and 8.0 cm (3.1 in) inboard of the right roof side rail. Both roof racks were deformed. A 46.0 cm (19.1 in) wide by 42.0 cm (16.5 in) high section of the rear bumper fascia was displaced from the vehicle. The CDC for Event 2 was 00TDDO2.

**Figure 6.** Maximum vertical crush, 2008 Ford Escape

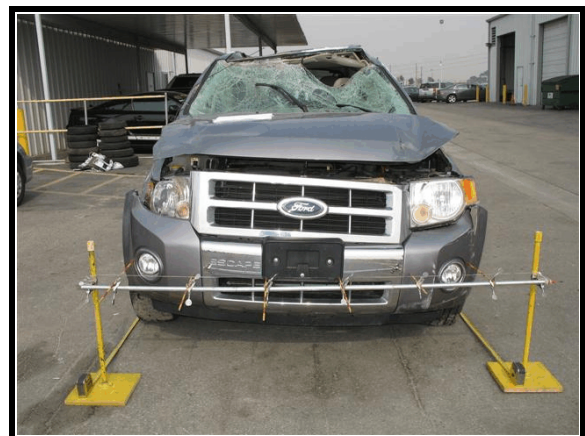
The Ford sustained minor front end damage from the impact with the fence (**Figure 7**). The vehicle also possibly contacted a set of large tires that were stacked in the lot of the repair company. The direct damage began at the left front bumper corner and extended 36.0 cm (14.1 in) to the right. Six crush

**Figure 7.** Frontal damage, 2008 Ford Escape

measurements were taken at the bumper level as follows:  $C_1 = 0$  cm,  $C_2 = 2.0$  cm (0.8 in),  $C_3 = 0$  cm,  $C_4 = 0$  cm,  $C_5 = 1.0$  cm (0.4 in),  $C_6 = 0$  cm. The CDC for Event 3 was 00FDEW1. The entire front end of the vehicle was included in the CDC because the vehicle penetrated the fence.

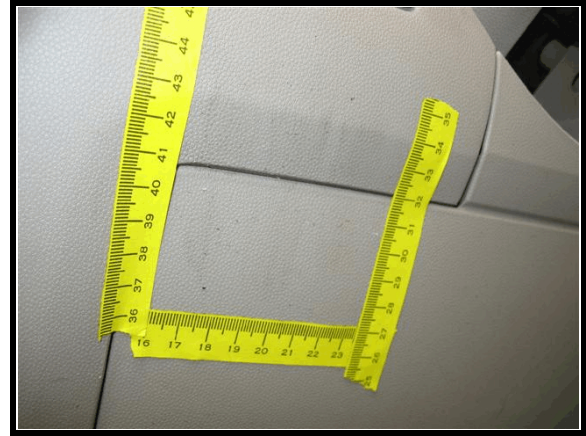
The Ford sustained moderate interior damage as a result of intrusions, occupant loading, and occupant contacts. Vertical intrusion was located in the front row at the right A-pillar, right/middle/left windshield header, and right roof side rail. Lateral intrusion was located in the front row at the rear upper quadrant of the front right door, forward upper quadrant of the left front door, and left and right A-pillars. Vertical intrusion was located in the second row across the entire roof. Evidence of occupant loading and contacts were documented to the driver's safety belt, the safety belt latch plate, left lower instrument panel (**Figure 8**), left upper door panel, (**Figure 9**) left seat-mounted side air bag, and left inflatable curtain (IC) air bag.

**Figure 8.** Lower instrument panel contact

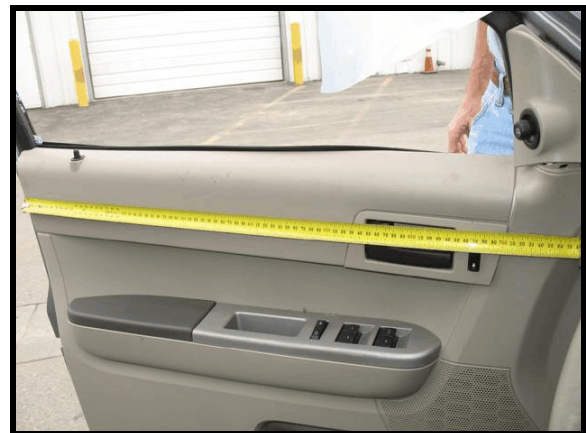
**Figure 9.** Left door contact

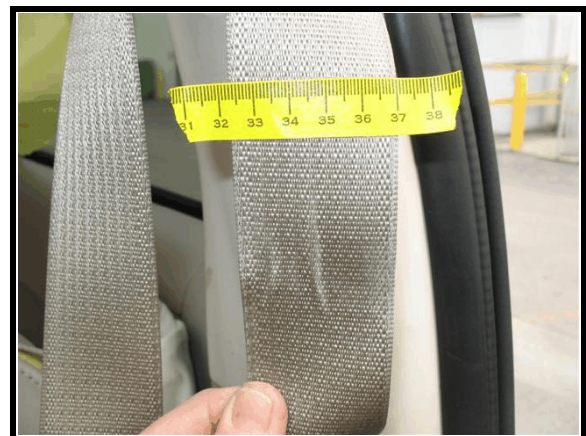
The driver's safety belt D-ring anchorage was set in the full-up position. The latch plate was scratched indicating historical usage. The retractor pretensioner actuated and the safety belt was locked in place. The buckle stalk was compressed 2.0 cm (0.8 in). There were areas of loading and scuffing to the safety belt webbing (**Figure 10**).

**Figure 10.** Scuff to driver's safety belt

The first area measured 5.0 cm (2.0 in) wide and was located 115.0 cm (45.2 in) from the stop button. The second was located 49.0 cm (19.3) from the stop button and measured 12.0 cm (4.7 in) in length.

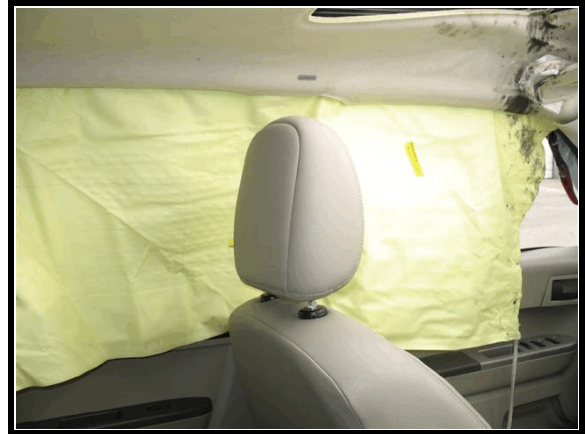
This vehicle's Supplemental Restraint System (SRS) included a Restraint Control Module (RCM), driver and passenger frontal air bags, seat-mounted side air bags for the front row, rollover/side impact IC air bags, and safety belt pretensioners for the front row. The Ford was a Certified Advanced 208-Compliant (CAC) vehicle and was equipped with advanced frontal air bags. The multi-stage air bags were certified by the manufacturer to be compliant with the advanced air bag requirements of Federal Motor Vehicle Safety Standard (FMVSS) No. 208. The driver's air bag was located within the steering wheel hub and the front right passenger air bag was located within the middle of the right instrument panel. During the crash, the left and right IC air bags and the driver's side seat-mounted side air bag deployed (**Figure 11**).

**Figure 11.** Left IC air bag, interior view

The tether that attached the left IC air bag to the A-pillar had been cut, presumably by rescue personnel. On the inboard panel there were several areas of scuffing and dirt. A 4.0 cm (1.6 in) long scuff was located 35.0 cm (13.8 in) from the leading edge and 8.0 cm (3.1 in) from the cladding. Along the leading edge, there was an area of grease and dirt that measured 20.0 x 53.0 cm (7.9 x 20.9 in). There was 6.0 x 5.0 cm (2.4 x 1.9 in) area of dirt near the B-pillar. On the outboard panel there was an area of grease along the leading edge. There was also a 17.0 cm (6.7 in) long diagonal cut that was located 20.0 cm (7.9 in) from the leading edge at the top of the cut and 6.0 cm (2.4 in) at the bottom of the cut.

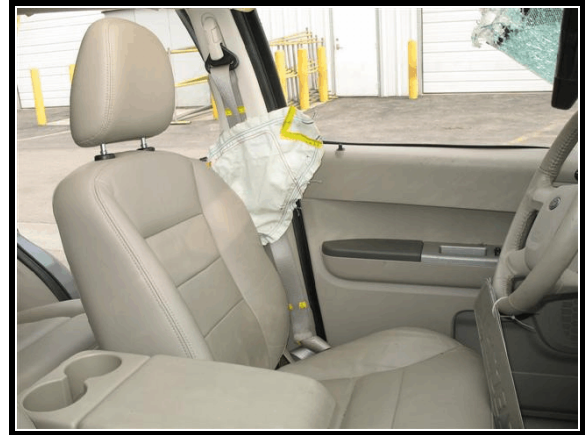
The driver's seat-mounted side air bag deployed from the seat back (**Figure 12**). The air bag was semi-circular in shape and measured 28.0 cm (11.0 in) in width and 32.0 cm (12.6 in) in length. There was a 5.0 x 5.0 x 5.0 cm (2.0 x 2.0 x 2.0 in) triangular shaped fabric transfer on the inboard panel.

**Figure 12.** Seat-mounted side air bag

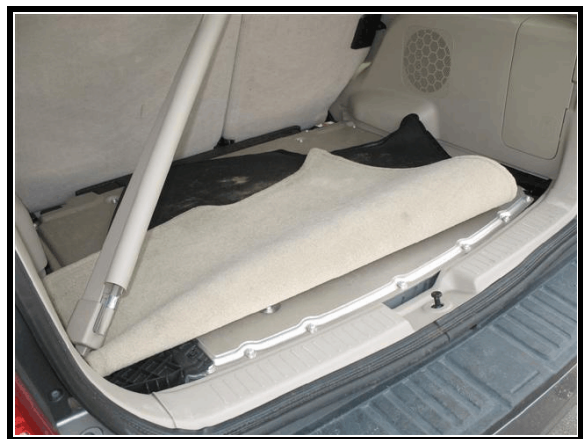
The high-voltage battery pack consists of 50 battery modules with each module comprised of 5 Nickel Metal-Hydrate (NiMH) 1.3-volt batteries welded together. The battery cells contain a base electrolyte consisting of potassium hydroxide as the dominant active ingredient. The total voltage of the battery pack is approximately 300 volts DC. The battery pack is mounted below the rear cargo floor, aft of the second row seat (**Figure 13**). The battery pack was mounted laterally in the vehicle and was concealed and protected by an aluminum cover that was bolted to the rear floor of the vehicle. The battery is electrically isolated from the rest of the vehicle when the key is OFF.

**Figure 13.** Battery location

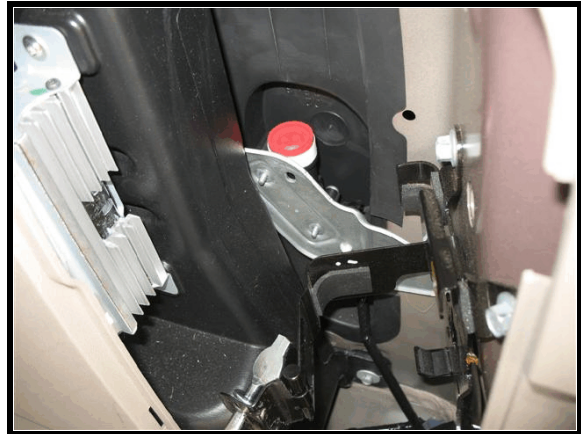
In the event the vehicle receives a substantial physical jolt the high voltage shut-off switch shuts off power from the high voltage battery. The inertia-activated shut-off switch was located in the cargo area on the passenger side of the vehicle in the jack compartment, behind the jack access door (**Figure 14**). The switch is located behind the jack. At the time of the vehicle inspection the switch had opened and disabled the battery. The DSI investigator reset the switch and the vehicle was restarted.

**Figure 14.** High-voltage shut-off switch

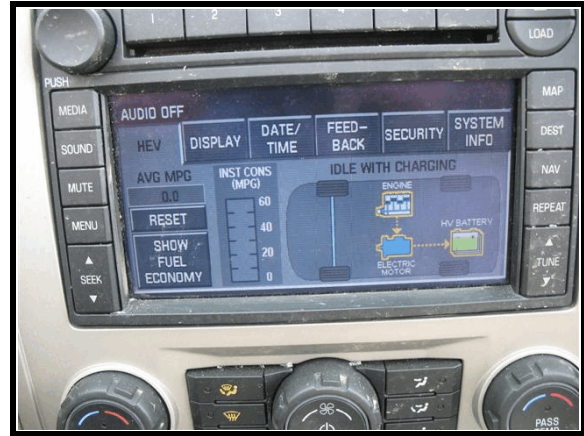
External power was applied to the vehicle service battery and the vehicle was started. The electronic odometer and other controls were illuminated and the power door locks were activated. The center video screen on the IP displayed systems and maintenance details pertaining to the vehicle showing the vehicle running and the HV battery being charged (Figure 15).

**Figure 15.** Center IP display. Vehicle running and HV battery being charged.
