**CALSPAN ON-SITE CERTIFIED ADVANCED 208-COMPLIANT
VEHICLE CRASH INVESTIGATION
SCI CASE NO.: CA10003**

VEHICLE: 2006 HONDA CIVIC Si COUPE

LOCATION: NORTH CAROLINA

CRASH DATE: NOVEMBER 2009

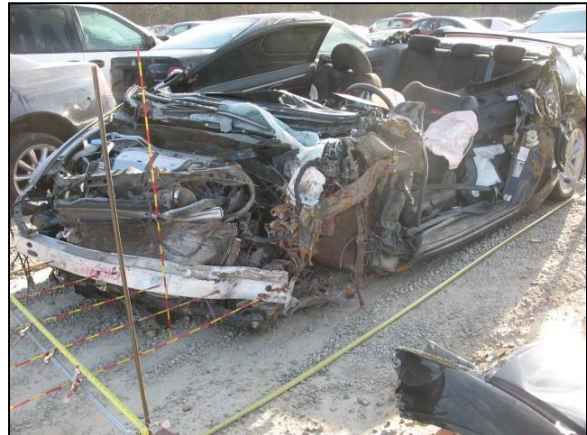
Figure 1: Left front oblique view of the 2006 Honda Civic.

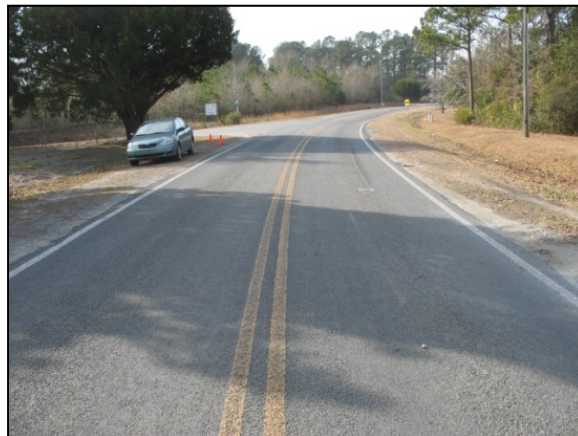
The unrestrained 24-year-old female driver of the Honda was operating the vehicle southbound on the rural roadway at a police-estimated speed of 121 km/h (75 mph). She was en route to her residence and was approximately 4.8 km (3 miles) from her destination. Prior to the crash, she entered the right curve. **Figure 2** depicts the Honda's pre-crash trajectory. The unrestrained 24-year-old male driver of the International was operating the vehicle northbound in the left curve. As the vehicles neared the intersection, the Honda crossed the center line and entered the northbound travel lane. There was no physical evidence at the crash site indicating avoidance actions prior to impact. The front of the Honda approached the front left corner of the International.

Figure 2: Pre-crash southbound trajectory of the Honda.

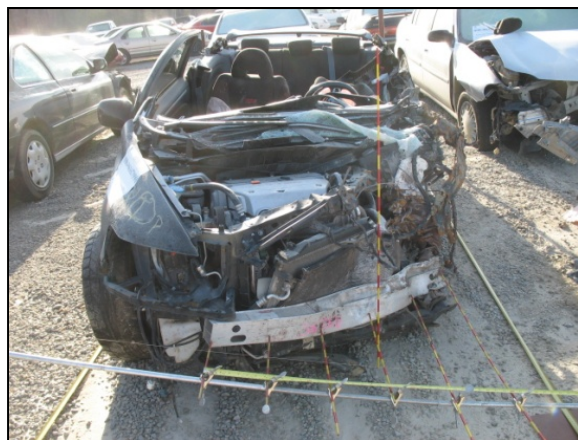
The Honda sustained severe damage in this offset frontal crash to the front and left planes (**Figure 3**). On the front plane, the direct contact damage began 33 cm (13 in) left of the vehicle centerline, and extended left 58 cm (22.8 in) to the front left bumper corner. The front bumper had been displaced to the left 10 cm (3.9 in) by the impact forces. The maximum crush was located at C1, the front left bumper corner and measured 71 cm (28 in). The combined direct and induced damage extended across the entire frontal end-width of the vehicle. A residual crush profile was documented along the bumper reinforcement bar and was as follows: C1 = 71 cm (28 in), C2 = 57 cm (22.4 in), C3 = 43 cm (16.9 in), C4 = 24 cm (9.4 in), C5 = 12 cm (4.7 in), C6 = 0 cm. The impact reduced the left wheelbase 33 cm (13 in); the right wheelbase elongated 7 cm (2.8 in) due to body deformation. The Collision Deformation Classification (CDC) assigned for this impact was 12FYEW4.

Figure 3: Frontal damage to the Honda.

The direct contact damage wrapped around the left front corner and extended along the left plane 278 cm (109.4 in) to the left rear axle area.

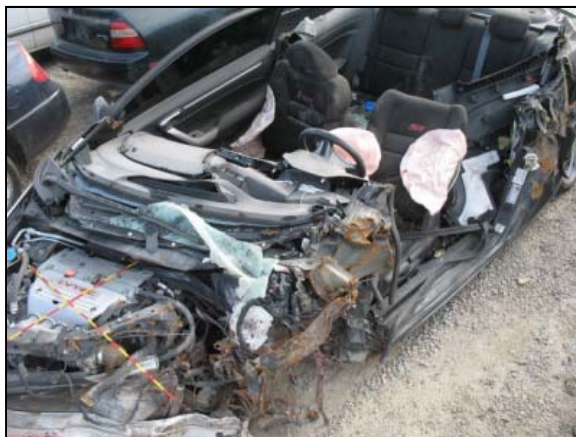
Figure 4 is an overhead oblique view of the damage to the Honda. The left front wheel separated from the suspension and was not available for inspection. The left door was damaged, intruded into the passenger compartment, and was jammed shut post-crash. Emergency personnel cut the left door and roof from the Honda in order to extricate the driver. The maximum lateral deformation from the prolonged engagement was an estimated 15 m (6

Figure 4: Overhead front oblique view of the damage to the Honda.

in). The windshield was completely fractured and had been removed from the Honda by rescue personnel. The left windows, backlight, sunroof right rear window were disintegrated due to impact forces. The front right window was not damaged.

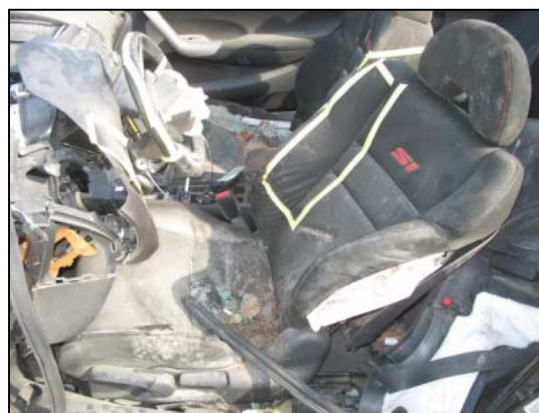
Figure 5 is a left lateral view of the interior damage. **Figures 6 and 7** are interior views of the intrusion into the driver's space and the driver's contacts. The driver loaded the steering wheel rim through the frontal air bag resulting in abrasions to the steering wheel rim at the 6 to the 11 o'clock position. The steering wheel was rotated approximately 70 degrees clockwise (CW) at the time of the SCI inspection. The shear capsules of

Figure 5: Left lateral interior view of the driver's position.

the steering column were inspected and found to have compressed 4 cm (1.6 in) forward due to occupant loading. The lower section of the steering shaft separated due to the intrusion at the location where it passes through the cowl. The left instrument panel, left of the steering assembly, was scuffed by probable contact with the driver's chest. This scuff mark was 11 cm (4.3 in) in width and 22 cm (8.7 cm) in height. There were two contacts attributed to the driver's knees on the left lower instrument panel. The left contact consisted of scuff marks and fractured plastic that measured 8 cm (3.1 in) by 13 cm (5.1 in) and was located 4 cm (1.6 in) left of the steering column. The right contact consisted of scuff marks, measured 11 cm (4.3 in) wide by 10 cm (3.9 in) in height and began under the steering column and extended right. There was a scuff mark on the right side of the front of the driver's seat back. This scuff mark was 12 cm (4.7 in)

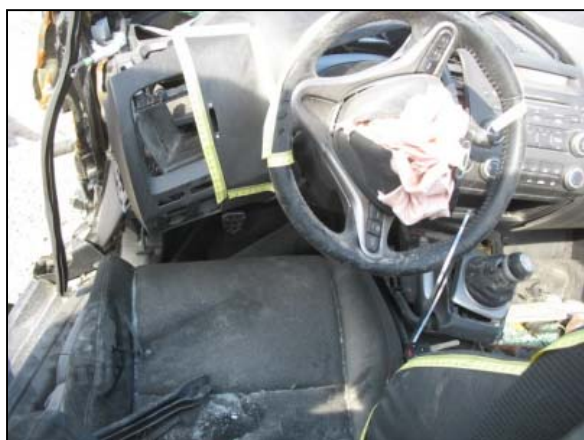
in width and 49 cm (19.3 in) in height and was located on the right side bolster of the driver's seat 5 cm (2 cm) below the top edge of the seat. There was a blood transfer on the inboard aspect of the right seat back that measured 16 x 25 cm (6.3 x 9.8 in) and was located 14 cm (5.5 in) below the top edge of the seat. There was also a localized fracture with body fluid on the windshield which had been removed by rescue personnel. This contact was located at the left aspect of the windshield adjacent to the left A-pillar, at the mid-point of its height. The left front door intruded laterally and compressed the left side of the front left seat back into the second row.

Figure 6: View of the Honda's instrument panel intrusion.

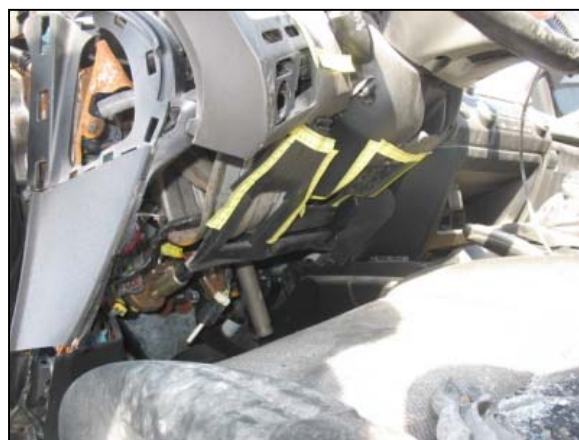
Figure 7: View of the driver's lower extremity contact to the Honda's intruded lower instrument panel.

The driver continued on her forward trajectory towards the front left corner of the Honda. Coincident to this, the left A-pillar, instrument panel and door panel intruded into the driver's space. The driver's lower extremities contacted and loaded the lower instrument panel. This loading resulted in the (indirect) fracture of the left acetabular. The driver's head/face impacted the intruding A-pillar. This impact resulted in the multiple fractures of the face and skull, the multiple brain injuries and soft tissue injuries to the face. The intruding door panel impacted the driver's left flank resulting in the laceration of the spleen, the hip/left buttock contusions and fractures of the left arm and hand.

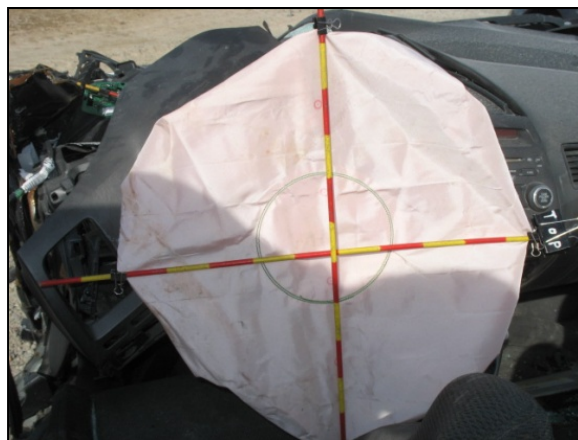
The driver's air bag (**Figure 8**) was concealed within the center hub of a 3-spoke steering wheel by a tri-flap design. The upper flap measured 14 cm (5.5 in) in width at the horizontal tear seam and was 8 cm (3.1 in) in height. The lower flaps were triangular in shape with dimensions that were symmetrical; the upper aspects measuring 7 cm (2.8 in) in width at the horizontal tear seam, the sides measuring 9 cm (3.5 in) in height at the vertical tear seam and the lower aspects measuring 3 cm (1.2 in) horizontally. The driver's air bag measured 60 cm (23.6 in) in diameter in its deflated state.

Figure 8: View of the Honda's frontal driver air bag.

The air bag was vented by two vent ports at the 11 and 1 o'clock positions on the rear aspect of the air bag. The driver's air bag was tethered by two tethers at the 12 and 6 o'clock positions within a 16 cm (6.3 in) circular tether seam sewn to the face of the bag. The lower half of the face of the air bag was covered with blood, and there was a scuff mark that was 11 cm (4.3 in) in height and 8 cm (3.1 in) in width located on the face of the air bag, 4 cm (1.6 in) left of the circular tether seam.

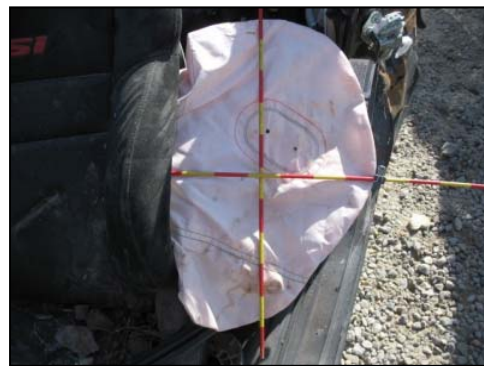
The side impact air bag deployed from a 35 cm (13.8 in) long seam in the upper outboard aspect of the front seat back. The air bag measured 60 cm (23.6 in) in height and 35 cm (13.8 in) in width. The side air bag had one vent port at the bag's forward aspect on the outboard side. The left side impact air bag (**Figure 9**) contained blood evidence located on the inboard side 9 cm (3.5 in) forward of the seat back and extending forward 16 cm (6.3 in). The outboard aspect contained a black plastic deployment transfer located 10-23 cm (3.9-9.1 in) above the lower edge of the air bag and 5-19 cm (2-7.5 in) aft of the front edge. The right side impact air bag was free from occupant contacts. There was a black plastic deployment transfer on the outboard side located 22-29 cm (8.7-11.4 in) aft of the front edge and 15-36 cm (5.9-14.2 in) below the top edge of the air bag.

Figure 9: Left side impact air bag.

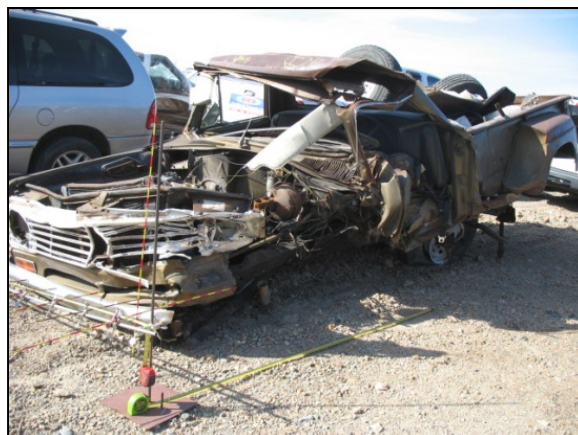
The frontal area of the International sustained moderate severity damage as a result of the impact with the Honda (**Figure 10**), and the top plane sustained minor severity damage in the rollover that occurred subsequent to the initial impact. The direct contact damage began 26 cm (10.2 in) left of the vehicle centerline and extended left 54 cm (21.3 in). The maximum crush was located at C1, the front left bumper corner and measured 57 cm (22.4 in). The combined direct and induced damage (Field L)

Figure 10: Left front oblique view of the damaged International pickup.

extended from the front left bumper corner to the front right bumper corner. A residual crush profile was documented along the full width of the damaged front bumper and was as follows: C1 = 57 cm (22.4 in), C2 = 22 cm (8.7 in), C3 = 13 cm (5.1 in), C4 = 6 cm (2.4 in), C5 = 3 cm (1.2 in), C6 = 0 cm. The CDC assigned for this impact was 12FLEW3. The Honda's engagement continued down the left side to the wheelhouse of the left rear axle. The solid front axle of the International separated from the truck. The front and left planes of the Honda engaged and displaced the left cowl, A-pillar, toe pan, B-pillar and left rear axle.

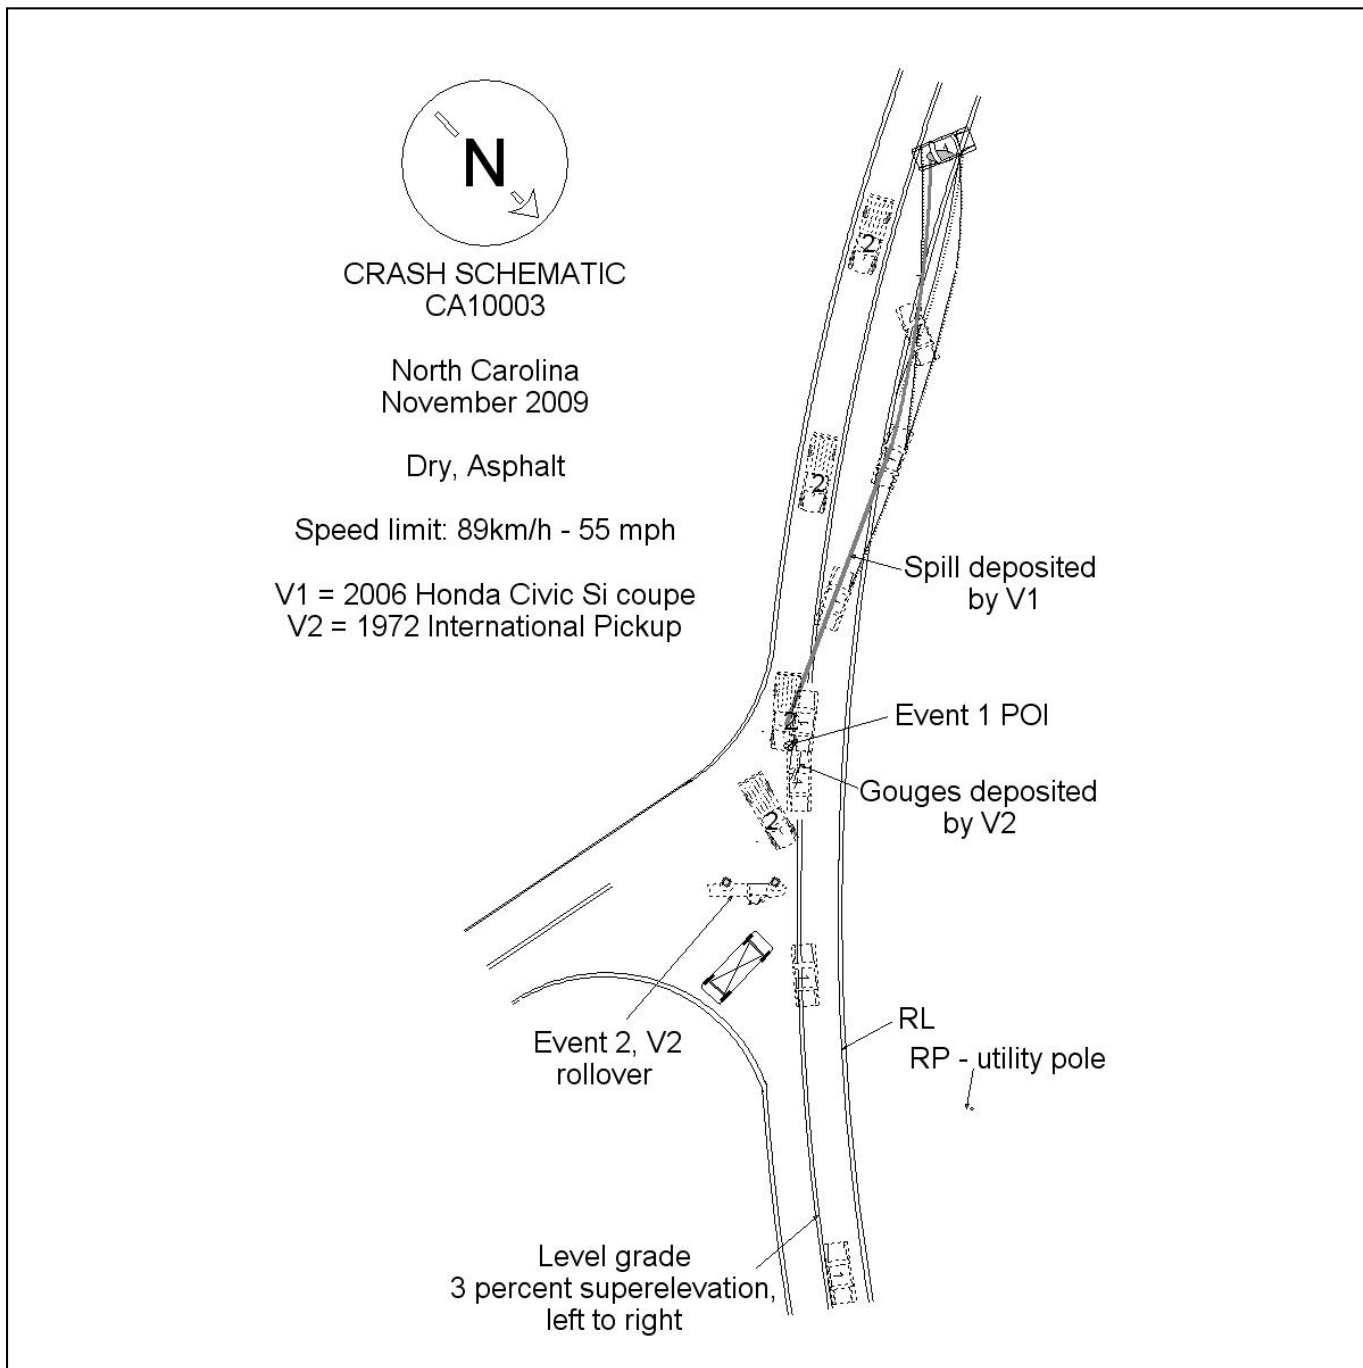
Figure 11: Crash Schematic

This crash occurred during evening hours on a two-lane north/south rural roadway. The environmental conditions were clear, dry and dark at the time of the crash. The roadway consisted of two asphalt surfaced travel lanes. The traffic lanes measured 2.8 m (9.2 ft) in width. The roadway was bordered by narrow asphalt shoulders that were 20 cm (7.9 in) in width. Outboard of the shoulders, the roadsides consisted of grass terrain with embankments that sloped away from the roadway. Adjacent to the west roadside, the grade was negative 1.6 percent for 1.9 m (6.2 ft), transitioning to a negative grade of 29 percent 1.9 m (6.2 ft) west of the road edge into a drainage ditch. In the pre-crash area for the Honda, the roadway had a level grade and included a right curve. The radius of curvature measured 179 m (587 ft). The pre-crash area for the International was also level. The curved section of roadway included a superelevation of 3 percent from east to west. Located near the Point of Impact (POI) was a two-lane roadway that intersected the east side of the main roadway at a 130 degree angle. This intersecting roadway was straight and level and the two travel lanes measured 3 m (9.8 ft) in width. The posted speed limit in the area of the crash was 89 km/h (55 mph). The Crash Schematic is included as **Figure 11** of this report.
