On-Site Rollover Investigation  
Dynamic Science, Inc. (DSI), Case Number DS10005  
2008 Toyota FJ Cruiser  
Arizona  
February 2010

1. Report No. DS10005	2. Government Accession No.	3. Recipient Catalog No.	
4. Title and Subtitle  On-Site Rollover Investigation		5. Report Date  October 1, 2010

14. Sponsoring Agency Code	
15. Supplemental Notes			
16. Abstract  The on-site investigation focused on the rollover dynamics of a 2008 Toyota FJ Cruiser involved in a two-vehicle crash and subsequent rollover. The crash occurred on a two-lane north/south roadway in February 2010 in the state of Arizona. The subject vehicle traveling southbound and was being driven by a restrained 42-year-old male. The other vehicle was a 1995 Ford Mustang that was traveling northbound and was being driven by a 53-year-old female. The Toyota crossed the centerline, entered the northbound lane, and the front end of the Toyota impacted the front end of the Ford in an offset frontal configuration. Following the vehicle-to-vehicle impact, the Toyota initiated a right side leading three quarter-turn trip rollover and came to rest on its left side in the southbound lane. The Toyota was equipped with frontal air

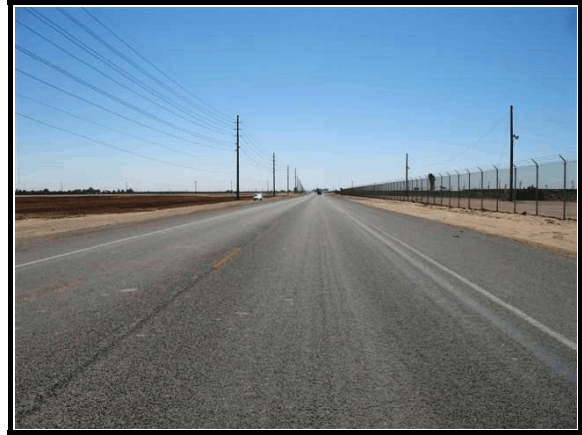
The crash occurred on a north/south two-lane undivided roadway (**Figure 2**) consisting of two lanes measuring 3.6 m (11.8 ft) in width that were straight, level, and composed of asphalt. The travel lanes were delineated by a dashed yellow stripe in the center and solid white fog lines at the paved asphalt shoulders. The east shoulder measured 2.8 m (9.2 ft) and the west shoulder measured 3.3 m (10.8 ft) in width. The posted speed limit at this location was 80 km/h (50 mph). At the time of the crash conditions were dark, clear and dry.

**Figure 2.** Crash site, southbound approach of subject vehicle, 2008 Toyota FJ Cruiser

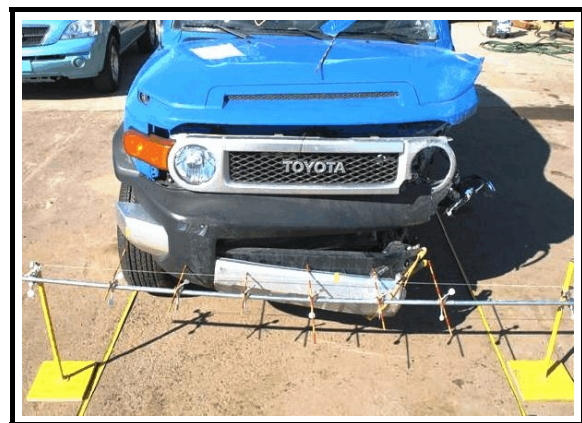
The Toyota sustained direct and induced damage to the front end, left side and undercarriage during the vehicle-to-vehicle impact (Event 1), and left side, right side, and roof during the rollover (Event 2). The left front wheel and tire, 40.0 cm (15.7 in) of the left front bumper fascia, and the roof rack were displaced from the vehicle. For Event 1, direct damage to the front end began at the front left bumper corner and extended 40.0 cm (15.8 in) to the right. The Field L was distributed from bumper corner to bumper corner and measured 132.0 cm (52.0 in) (**Figure 3**). Direct damage down the vehicle's left side began at the left front bumper corner, extended rearward 130.0 cm (51.2 in), and ended at the left A-pillar. Six crush measurements were taken at bumper level as follows:  $C_1 = 11.0$  cm (7.9 in),  $C_2 = 3.0$  cm (1.2 in),  $C_3 = 3.0$  cm (1.2 in),  $C_4 = 2.0$  cm (0.8 in),  $C_5 = 4.0$  cm (1.6 in),  $C_6 = 2.0$  cm (0.8 in). Maximum crush was located at  $C_1$  and the Collision Deformation Classification (CDC) was 12FLEE4.

**Figure 3.** Subject vehicle, front end crush profile measurement

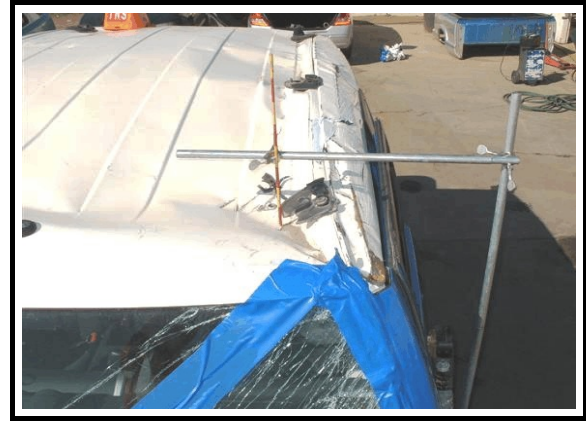
For the rollover, direct damage to the right side consisted of gouges to the rims and scuff marks to the tires resulting from contact with the roadway. Direct damage to the roof was distributed longitudinally beginning at the windshield header, extending rearward 247.0 cm (97.2 in), and ending at the backlight header. Direct damage to the roof was distributed laterally between the roof side rails and measured 121.0 cm (47.6 in). Additionally, the roof rack sustained direct damage to all sides during the rollover. Direct damage to the vehicle's left side began at the left rear bumper corner, extended forward 342.0 cm (134.6 in), and ended at the left front bumper corner. The direct damage was distributed vertically from the sill to the roof side rail and measured 137.0 cm (53.9 in). Maximum vertical roof crush measured 6.0 cm (2.4 in) and was located at 35.0 cm (13.8 in) aft of the windshield header and 10.0 cm (3.9 in) inboard of the left roof side rail (**Figure 4**). Maximum lateral crush to the left roof side rail measured 5.0 cm (2.0 in) and was located above the A-pillar. The CDC for Event 2 was 00TZDO2.

**Figure 4.** Subject vehicle, maximum vertical roof crush measurement

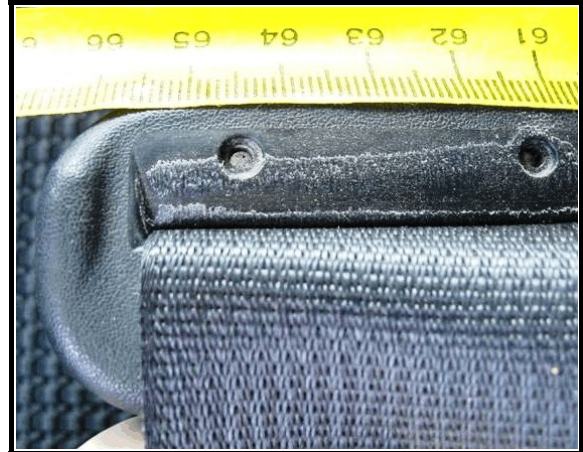
The driver's adjustable D-ring anchorage was in the full-up position and the latch plate was scratched indicating historical usage. The safety belt retractor pretensioner actuated during the crash and the webbing was in the unspooled position. The D-ring showed a scuff mark measuring 1.0 x 5.0 cm (0.4 x 2.0 in) and a transfer from the webbing measuring 1.0 x 1.0 cm (0.4 x 0.4 in). The latch plate showed scuff marks on both sides where the webbing passed through it (**Figure 5**). The safety belt webbing had six scuff or stretch marks. A stretch mark measuring 4.0 cm (1.6 in) was located 21.0 cm (8.3 in) below the stop button; a scuff mark measuring 5.0 x 7.0 cm (2.0 x 2.8 in) was located 28.0 cm (11.0 in) above the stop button and resulted from loading at the latch plate; a 2.0 x 2.0 cm (0.8 x 0.8 in) scuff mark was located 74.0 cm (29.1 in) above the stop button; a 5.0 x 12.0 cm (2.0 x 4.7 in) scuff mark was located 100.0 cm (39.4 in) above the stop button; another scuff mark measuring 5.0 x 12.0 cm (2.0 x 4.7 in) was located 110.0 cm (43.3 in) above the stop button and resulted from loading at the D-ring; and a 5.0 x 8.0 cm (2.0 x 3.1 in) scuff mark was located 139.0 cm (54.7 in) above the stop button. Based on the vehicle inspection it was determined that the safety belt was used to restrain the driver during the crash.

**Figure 5.** Driver's safety belt latch plate showing scuff marks

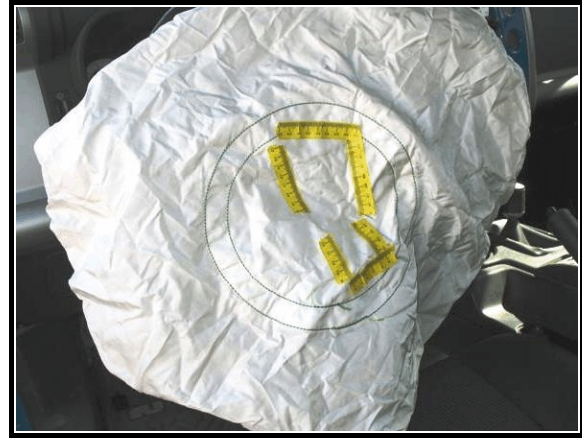
The frontal air bag deployed from the steering wheel hub through module cover flaps that opened at their tear points and were not damaged. Based on the EDR report's Frontal Crash Page 0, the "Time from Pre-Crash TGR"<sup>1</sup> was 0 milliseconds (ms) and the "Frontal AB<sup>2</sup> Deployment Time" and "Pretensioner Deployment Time" were 16 ms. Additionally, "Deployment Stage Driver" indicated "High" for the CAC dual-stage frontal air bag. The air bag measured 60.0 cm (23.6 in) in diameter and was configured with two internal tethers and two vent ports. It showed two scuff marks near the center of the front panel resulting from occupant loading (**Figure 6**). One scuff mark measured 2.0 cm (0.8 in) in length and was located 3.0 cm (1.2 in) from the center of the bag in the upper right quadrant. Another scuff mark measured 2.0 x 2.0 cm (0.8 x 0.8 in) and was located 4.0 cm (1.6 in) from the center of the bag in the lower right quadrant.

**Figure 6.** Frontal air bag showing location of occupant loading

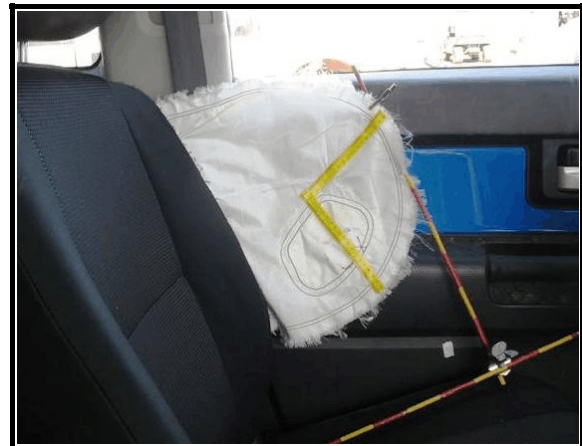
**Figure 7.** Left seat-mounted side air bag showing location of skin oil transfer

The left seat-mounted side air bag deployed from the outboard aspect of the driver's seat back. Based on the EDR report's Side Crash Page 0, the "Time from Pre-Crash TGR" was 5 ms and the "Deployment Time (B-Pillar)" was 26 ms. The air bag was semicircular in shape, measured 34.0 cm (13.4 in) in width and 40.0 cm (15.7 in) in height. The inboard panel of the air bag showed a skin oil transfer (**Figure 7**) measuring 11.0 x 15.0 cm (4.3 x 5.9 in) that was deposited by the driver's left forearm during the crash. The outboard panel of the air bag showed scuff marks measuring 5.0 x 15.0 cm (2.0 x 5.9 in) and 2.0 x 2.0 cm (0.8 x 0.8 in) resulting from contact with the door panel when the seat-mounted side air bag was loaded by the driver.

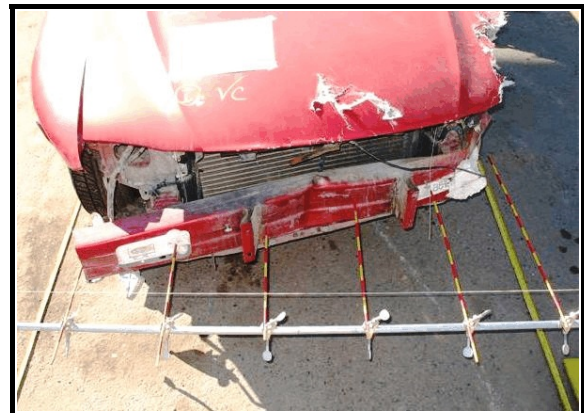
Direct damage to the front end began at the left bumper corner and extended 30.0 cm (11.8 in) to the right resulting in a narrow corner impact. The Field L was distributed from bumper corner to bumper corner and measured 120.0 cm (47.2 in) (Figure 8). Crush down the left side extended from the left front bumper corner to the B-pillar and measured 342.0 cm (134.6 in). Six crush measurements were taken at bumper level as follows:  $C_1 = 43.0$  cm (16.9 in),  $C_2 = 25.0$  cm (3.9 in),  $C_3 = 21.0$  cm (8.3 in),  $C_4 = 13.0$  cm (5.1 in),  $C_5 = 1.0$  cm (0.4 in),  $C_6 = 0$  cm and maximum crush was located at  $C_1$ . For the Ford, the CDC for Event 1 was 11FLEE6.

**Figure 8.** Front end crush profile measurement
