ON-SITE CHARTER BUS ROLLOVER INVESTIGATION

CASE NUMBER - IN10005
LOCATION - FLORIDA
VEHICLE - 2001 KRYSTAL ENTERPRISES
BUS BODY ON A FORD F550 CHASSIS
CRASH DATE - February 2010

Submitted:
August 9, 2010

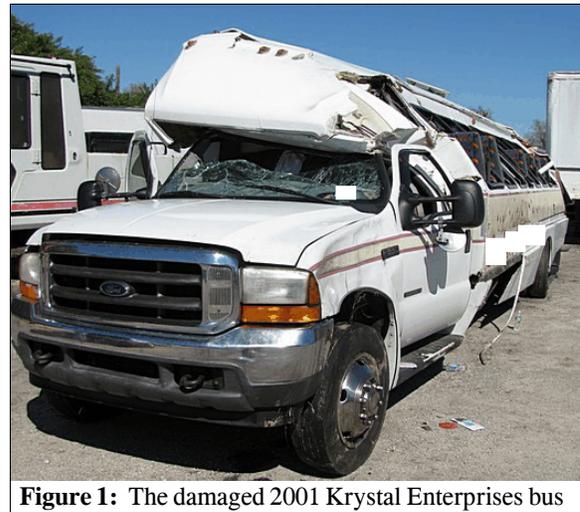
Figure 1: The damaged 2001 Krystal Enterprises bus

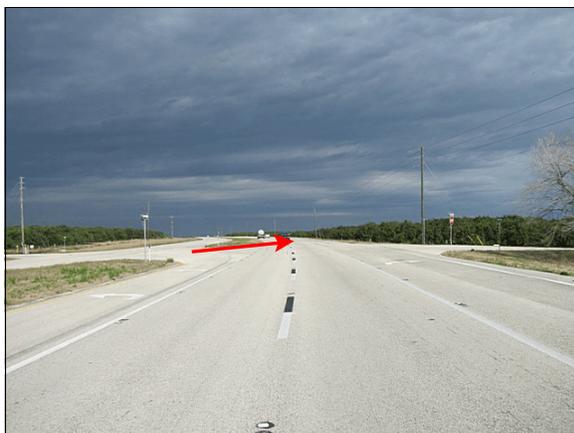
night prior to the crash. He was taking blood pressure and cholesterol medication. On the day of the crash, the driver was returning the group to their hotel following a local tour. He had conducted the tour on previous occasions and was familiar with the roadway. The bus was traveling north on the U.S. highway in the outside through lane (Figure 2). The driver was negotiating a left curve as he approached the 4-leg intersection. The Mercury was traveling east on the rural roadway. According to the police crash report, the driver of the Mercury stopped at the intersection and proceeded through the median opening (Figure 3) and executed a left turn into the path of the bus.

Figure 2: Approach of the bus to impact; photo taken 60 m (197 ft) from center of intersection; arrow shows approach of the Mercury

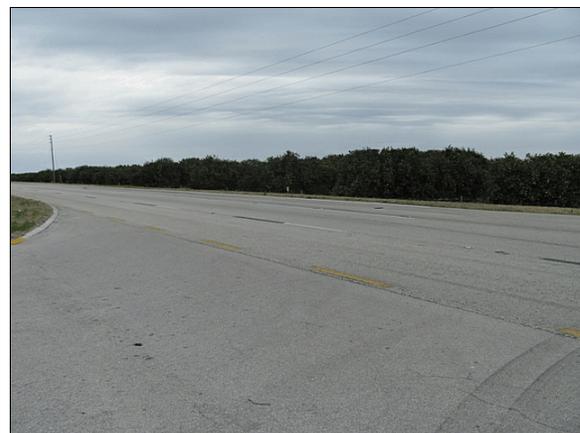
Figure 3: Approach of the Mercury from the median opening to the area of impact

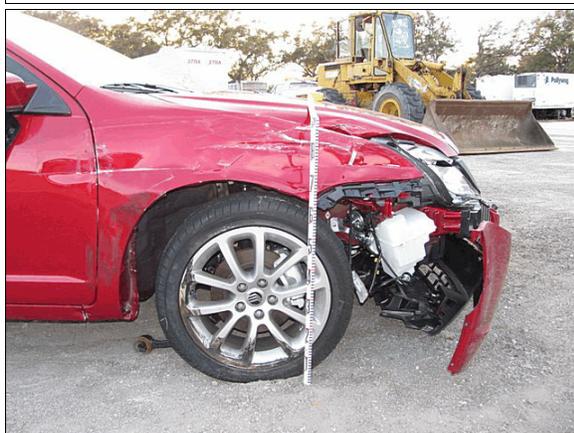
Crash: The right fender of the Mercury (Figure 4) impacted the left side of the bus (Figure 5). The sideswiping type engagement continued down the left side of the bus and the right front wheel of the Mercury (Figure 6) engaged the left rear wheel of the bus (Figure 7). The bus rotated clockwise approximately 50 degrees from its original heading on the roadway and began to roll over left side leading as it departed the east side of the road (Figure 8). The vehicle rolled over 6 quarter turns resulting in the ejection of 8 occupants. The bus came to final rest on its top plane on the east side of the road heading southeast (Figure 9). The Mercury came to final rest in the outside acceleration lane heading north.

Figure 4: Damage on right side of the Mercury from impact with the left side of the Ford; vertical scale in 10th of meter

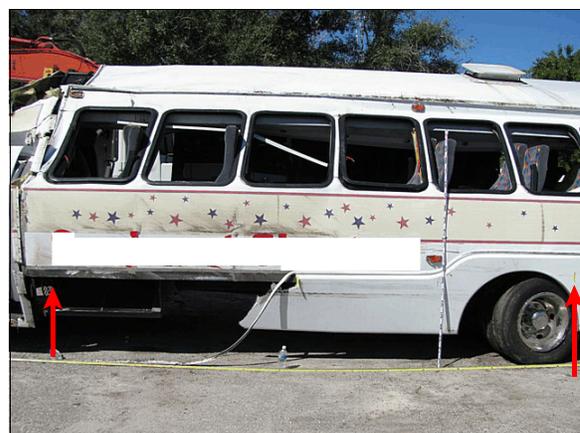
Figure 5: Arrows shows area of contact on left side of the bus from the impact with the Mercury; arrow on right shows extent of red paint transfer

Exterior Damage: The bus sustained left side damage during the impact with the Mercury. The direct damage began 405 cm (159.4 in) rear of the bus’s left front axle and extended rearward 387 cm (152.4 in). The direct damage resided on the fiberglass lower side panel. The damage consisted of scuffs, red paint transfer, and a piece of the side panel 222 cm (87.4 in) in length was broken off the vehicle. The left rear wheel of the bus also engaged the right front wheel of the Mercury. The rim cover was bent and a black rubber transfer approximately 38 cm (15 in) in length was present on the rim cover. The left rear wheel of the bus was displaced rearward 21 cm (8.3 in).

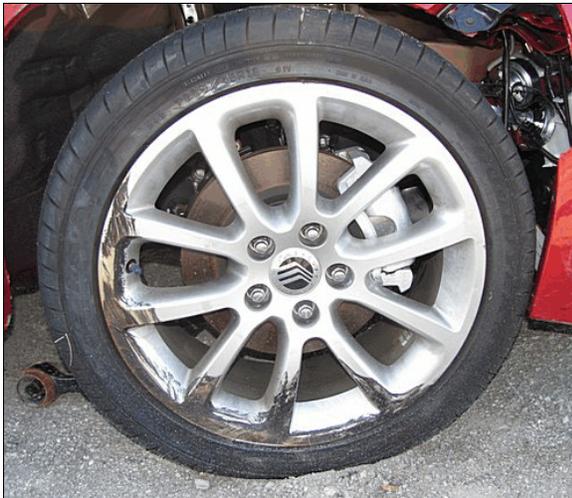
Figure 6: Black rubber transfer on the Mercury's right front wheel from engagement with the left rear wheel of the Ford

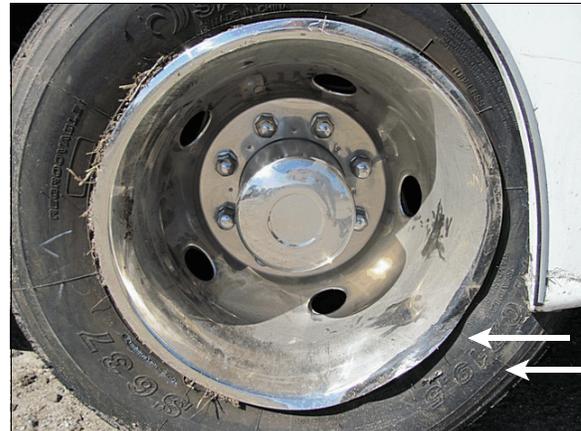
Figure 7: Arrows show black rubber transfer on the rim and contact on the left rear tire of the Ford from engagement with the right front wheel of the Mercury

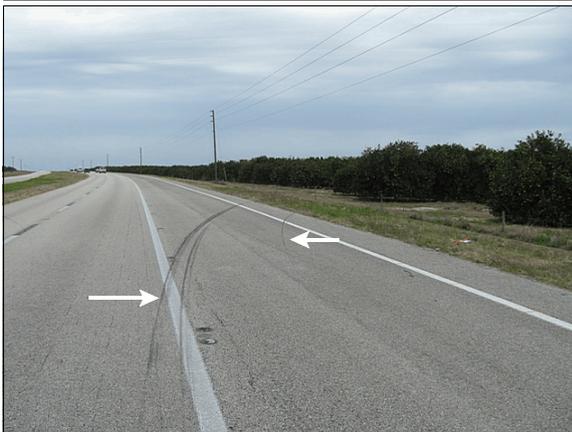
Figure 8: Approach of bus to rollover; tire mark on left is left rear, tire mark on right is left front

The Krystal bus was not equipped with any rollover mitigation features. Following the impact with the Mercury, the bus rotated clockwise as it traveled toward the east side of the roadway. As the vehicle rotated the left rear and left front tires created yaw marks on the roadway (**Figure 8**). The yaw mark from the left rear tires began 36 cm (14.2 in) west of the left lane line of the acceleration lane and extended 32 m (105 ft) northeast where it ended at the outside edge of the shoulder. The tire mark from the inside left rear tire ended approximately in the center of the acceleration lane as the tire began to lift off the pavement (**Figure 10**) indicating the area where

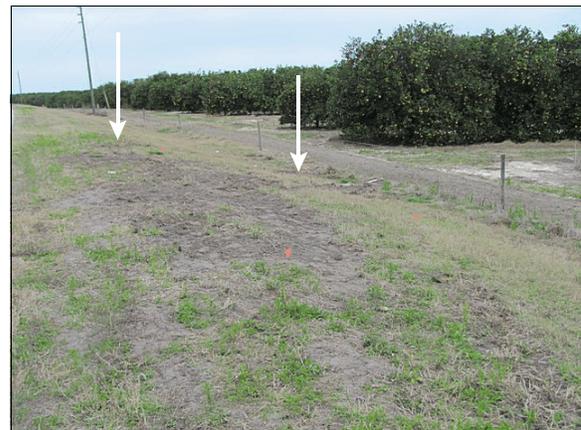
Figure 9: View northeast to path of rollover of the Ford; arrows show area of final rest position of the Ford

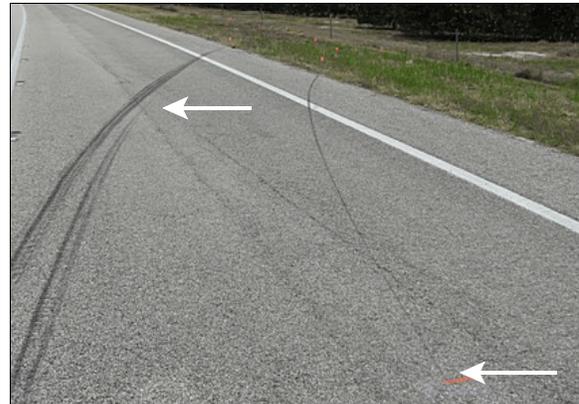
the vehicle was beginning to rollover. The yaw mark from the left front tire began in the approximate center of the acceleration lane (**Figure 10**) and extended 14.4 m (47.2 ft) northeast to the outside edge of the shoulder. At this point the vehicle had rotated clockwise approximately 50 degrees from its original heading on the roadway. The left front tire mark continued an additional 3.3 m (10.8 ft) through the grass and broadened into an irregular shaped furrow that joined with a large ground disturbance. The ground disturbance (**Figure 9**) indicated the area where the left side of vehicle touched down during the first quarter turn of the rollover. The rear portion of the vehicle also contacted the pavement surface during the first quarter turn, which produced scratch marks on the pavement and abraded the vehicle's left roof side rail and roof (**Figure 11**). At this point, the vehicle had rotated clockwise approximately 100 degrees from its original heading on the roadway. The vehicle continued to rollover a total of 6 quarter turns along the negative 16.7% grade of the embankment and came to final rest on its roof heading southeast. The distance traversed during the rollover was approximately 27 m (88.6 ft).

Figure 10: Arrow on left shows area where the inside left rear tire of the bus began to lift off the pavement and the bus began to rollover; arrow on right shows beginning of the yaw mark from the left front tire

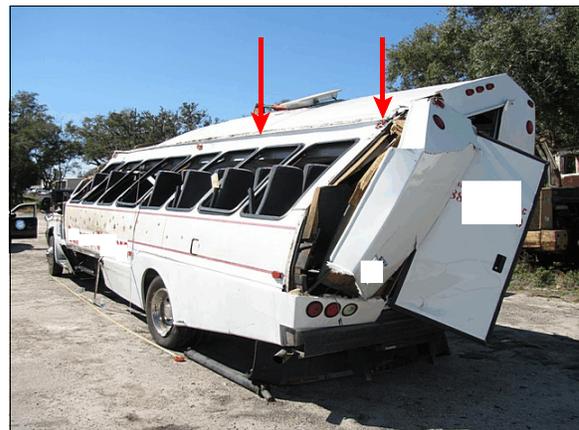
Figure 11: Arrows show location of pavement abrasions on the left roof side rail and roof; grass and dirt were entrapped in the roof side rail forward of this area

The damage from the rollover involved primarily the left side and top of the Bus. The direct damage on the left side began 48 cm (18.9 in) forward of the left front axle and extended the full length and height of the vehicle. Grass and dirt were entrapped in the roof side rail. The abrasions from the contact with the roadway surface began 79 cm (30.7 in) rear of the left rear axle and extended rearward along the edge of the roof and left roof side rail. The left side of the roof was crushed vertically 42 cm (16.5 in) and shifted to the right (Figure 14) 85 cm (33.5 in) as measured at the left roof side rail. The damage on the right side consisted of a dent in the rim cover of the right front wheel with dirt and grass in the rim, and a separated bead on the outboard right rear tire with dirt in the bead. The condition of the right front and right rear wheels indicated that they impacted the ground during rollover.

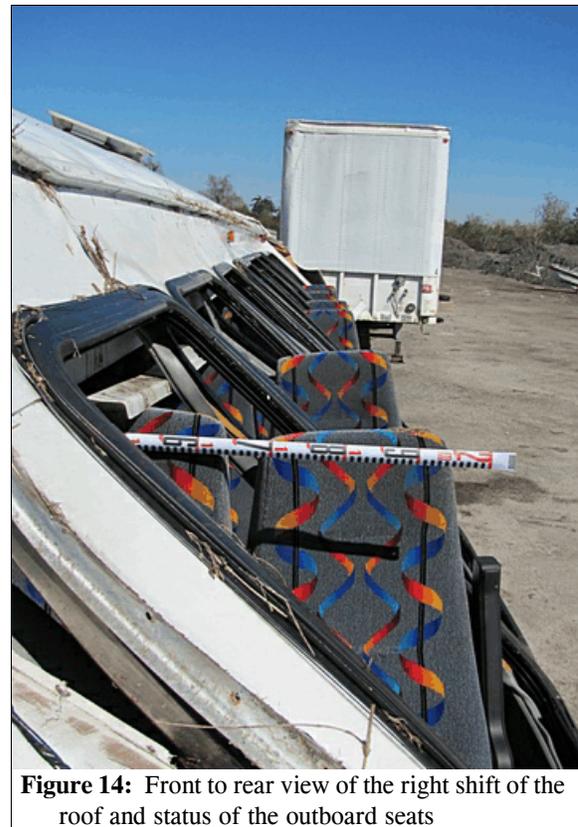
Figure 14: Front to rear view of the right shift of the roof and status of the outboard seats

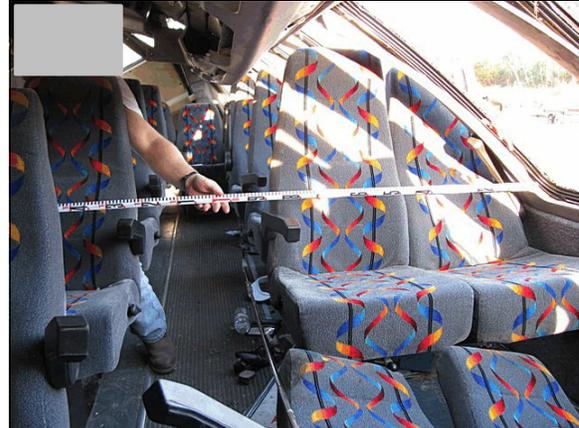
- Top of window frames and window frame pillars (**Figures 17 and 18**): 94 cm (37 in) lateral and 35 cm (13.7 in) vertical intrusion in rows 2-9.
- Overhead open package compartment: displaced laterally 45 cm (17.7 in) and intruded vertically 41 cm (16.1 in) to 53 cm (20.9 in) in rows 2-6, and 49 cm (19.3 in) to 32 cm (12.6 in) in rows 7-9
- Roof inboard of the package compartment: 38 cm (15 in) to 24 cm (9.4 in) vertical intrusion in rows 2-9
- Side panel below windows: 11 cm (4.3 in) lateral intrusion in rows 2-9.

- Lateral distance across the seat cushion from the side of the bus to the inboard edge of the seat cushion (**Figure 17**): 88 cm (34.6 in)
- Lateral distance from the window frame to the inboard edge of the seat back at the top of the seat (**Figure 17**): 0 cm
- Vertical distance from the inboard seat cushion to the top of the window frame (**Figure 18**): 82 cm (32.3 in)
- Vertical distance from the outboard seat cushion to the window frame pillar (**Figure 18**): 30 cm (11.8 in)

Figure 17: Lateral intrusion into left seating rows

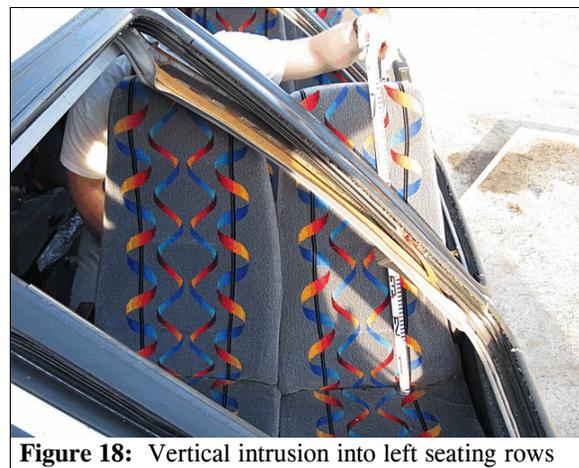
Figure 18: Vertical intrusion into left seating rows

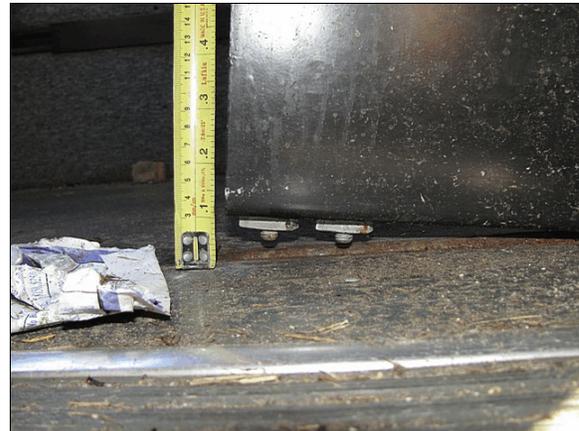
The seats that were located along the sides of the bus were anchored to the floor in a metal channel on the inboard side and to the side of the bus on the outboard side. The seats in rows 3-8 on the left side of the bus were all displaced to the right approximately 6 cm (2.4 in) from the deformation on the left side. All the side anchors on the left side seats remained intact as did all the floor anchors with the exception of seat row 2, where the back anchor was separated from the floor 3 cm (1.2 in) (Figure 19). The front floor anchor remained attached. For the seats located along the right side of the bus, the right shift of the bus body deformed the side anchor plate for each seat (Figure 20) and it pulled away from the side surface 2-3 cm (0.8 in-1.2 in) in each row. All the side and floor anchors for the right side seats remained attached as did the floor anchors for the seats located across the back of the bus.

Figure 19: Separated floor anchor on left row 2 seat

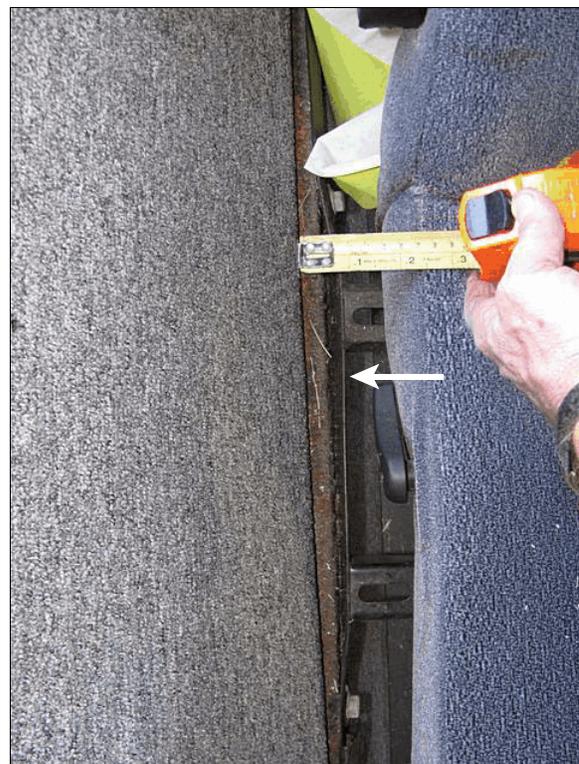
Figure 20: Top view of deformed side anchor plate on right row 8 seat

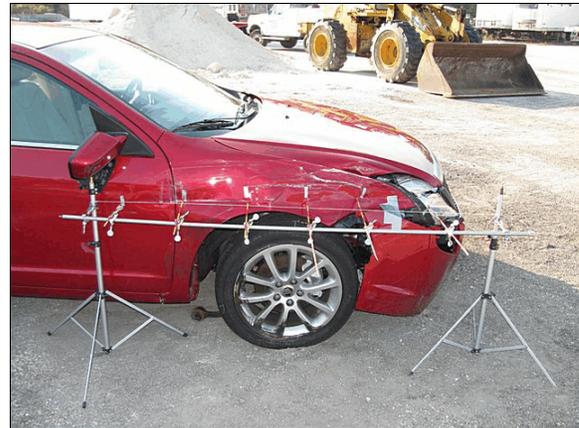
Exterior Damage: The Mercury sustained right side damage during the impact with the bus. The right fender, right front wheel, and front portion of the right front door were directly damaged (Figure 21). The right front wheel of the Mercury engaged the left rear wheel of the bus during the impact, which displaced the Mercury’s right front wheel forward 6 cm (2.4 in) and separated the control arm. The direct damage on the left side plane of the Mercury began 71 cm (28 in) rear of the right front axle and extended 143 cm (56.3 in) forward along the right side. The crush measurements were taken at the upper door level and the residual maximum crush was 12 cm (4.8 in) occurring at C₅ (Figure 22). The table below presents the right side crush profile.

Figure 21: Damage on the right fender and right front wheel of the Mercury from the impact with the left side plane of the Ford

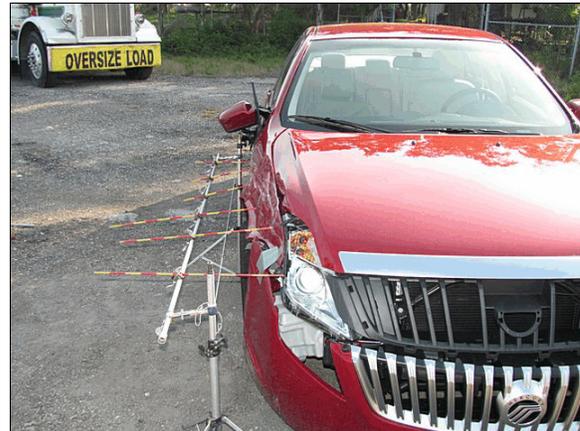
Damage Classification: The CDC for the right side impact 06RYES2 (170 degrees). The WinSMASH program could not be used to calculate a Delta-V for the Mercury since sideswipe impacts and impacts with a bus are out of scope for the program.

Figure 22: Crush on the right fender of the Mercury
