ON-SITE ROLLOVER INVESTIGATION

CASE NUMBER - IN10006

LOCATION - TEXAS

VEHICLE - 2008 NISSAN PATHFINDER LE

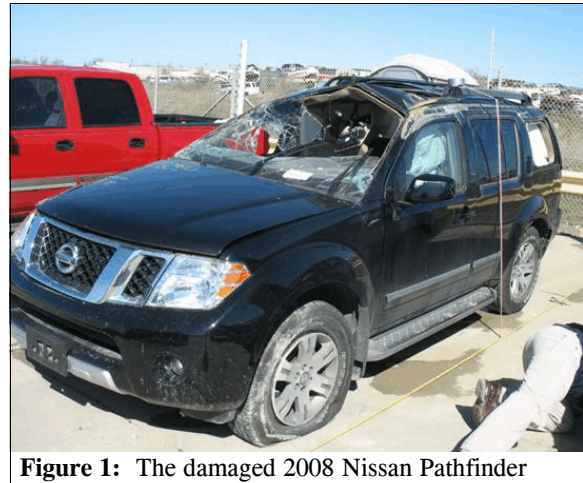
Figure 1: The damaged 2008 Nissan Pathfinder

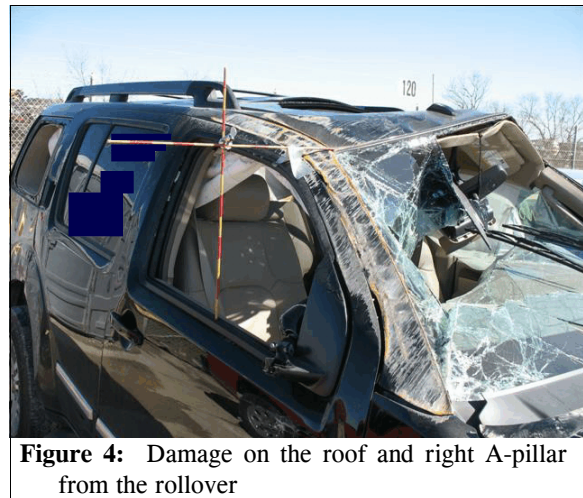
Figure 4: Damage on the roof and right A-pillar from the rollover

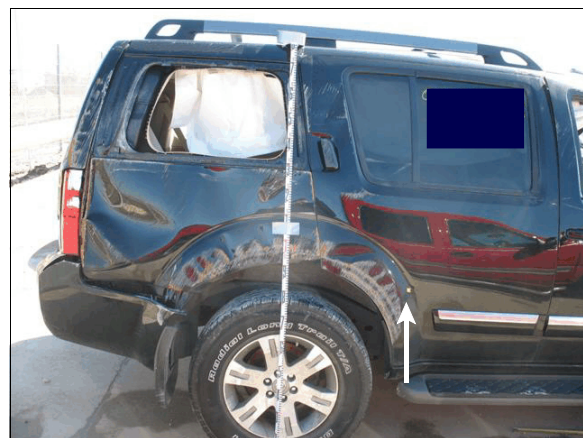
Exterior Damage: The Nissan sustained damage on the right quarter panel and right rear door from the impact with the Mitsubishi. This area also sustained damage from the rollover, which masked any damage that may have occurred from the impact with the Mitsubishi. The only distinguishable damage that may have resulted from the Mitsubishi impact was a longitudinal scratch approximately 4 cm (1.6 in) in length that

Figure 5: Damage on the Nissan from the impact with the Mitsubishi was masked by damage from the rollover; arrow shows location of longitudinal scratch, possibly from impact with the Mitsubishi

began 50 cm (19.7 in) forward of the right rear axle (Figure 5).

Damage Classification: The Collision Deformation Classification (CDC) for the impact on the right quarter panel (event 1) of the Nissan was 03R9999. Columns 4-6 of the CDC were coded unknown since the damage from this impact was masked by the damage from the rollover. The CDC for the rollover (event 2) was 00TDDO2. The severity of the damage from the rollover was minor based on the extent of the roof crush.

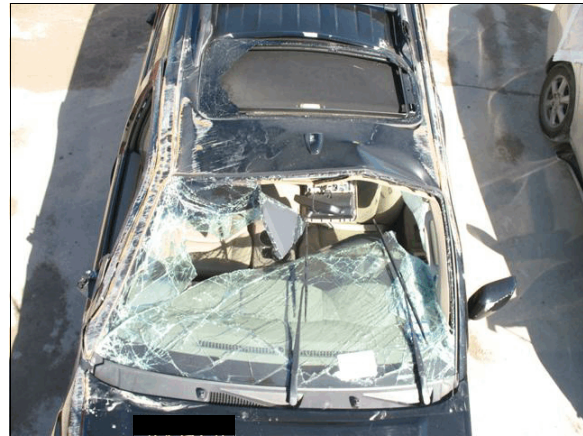
The rollover involved the top and both side planes of the Nissan. The direct damage on the top plane began on the right fender and right portion of the hood. It extended onto the A-pillars and roof (Figure 6). The direct damage on the left side plane began 78 cm (30.7 in) rear of the left front axle and extended along the roof side rail and top of the left side doors and quarter panel ending at the D-pillar. The direct damage on the right side plane began 57 cm (22.4 in) forward of the right front axle and extended rearward along the fender onto the right A-pillar, top of the right front door, right roof side rail, right rear door, and the full height of the right quarter panel. The maximum residual lateral crush was 8 cm (3.1 in) and occurred at the top of the right A-pillar. The maximum residual vertical crush (Figure 7) was 5 cm (2 in) and occurred at the right corner of the windshield header. Both crush points were located 115 cm (45.3 in) rear of the right front axle.

Figure 6: Damage on the roof of the Nissan from the rollover

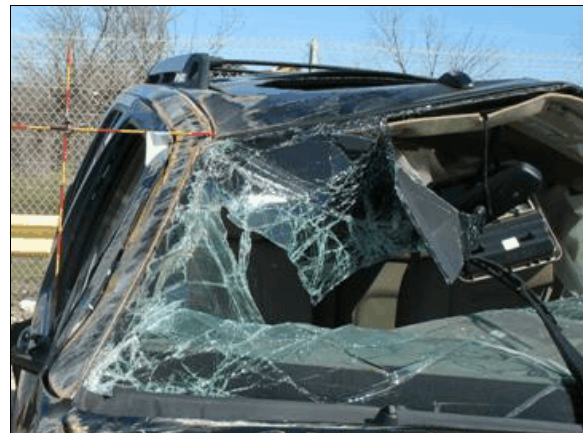
Figure 7: The maximum lateral and vertical crush occurred at the top of the right A-pillar

The vehicle's passenger compartment sustained four intrusions as a result of the rollover, which all occurred in the front passenger area. The most severe intrusions involved the right A-pillar, roof side rail, and windshield header. The right A-pillar and roof side rail intruded laterally 9 cm (3.5 in). The windshield header intruded vertically 5 cm (2 in).

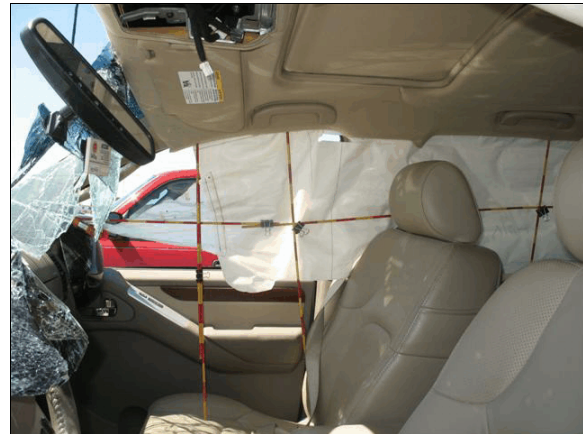
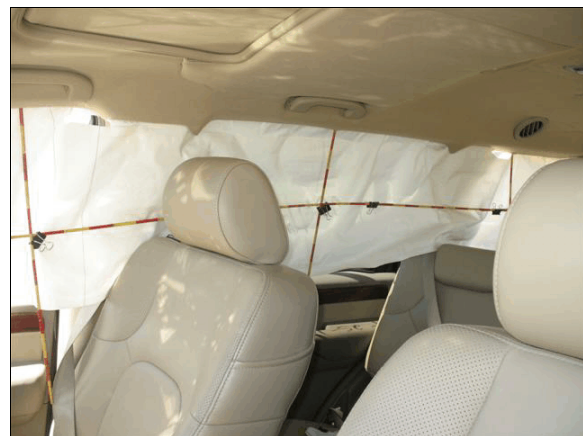
The IC air bags were located along the roof side rails inside the headliner (**Figures 8 and 9**) and extended from the top of the A-pillar to the D-pillar. The deployed IC bags were 220 cm (86.6 in) in width and 40 cm (15.7 in) in height. They were attached at the lower A-pillars by a 32 cm (12.6 in) tether. The IC air bags extended vertically to approximately 1 cm (0.4 in) above the beltline. The gap between the bottom of IC air bag and the A-pillar was approximately 42 cm (16.5 in) in length below the tether and approximately 37 cm (14.6 in) above the tether (**Figure 10**). There was no visible tether at the D-pillar. Inspection of the IC air bags revealed no discernable evidence of occupant contact and no damage.

Figure 8: The front portion of the Nissan's deployed right IC air bag

Figure 9: The back portion of the deployed right IC air bag

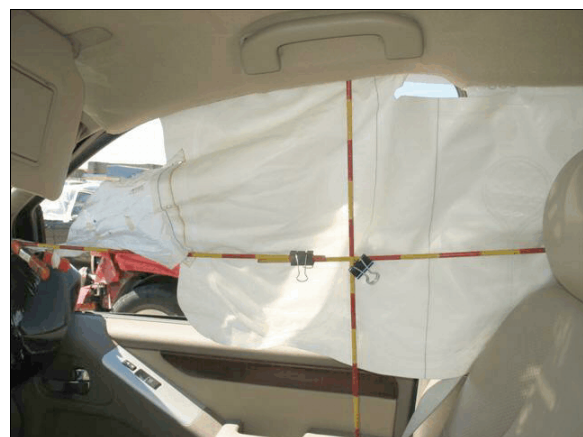
Figure 10: The front of the right IC air bag
