On-Site Motor Coach Rollover Investigation
Dynamic Science, Inc. (DSI), Case Number DS10007
1992 Dina Marcopolo Paradiso Motor Coach
Arizona
March 2010

1. Report No. DS10007		2. Government Accession No.		3. Recipient Catalog No.	
4. Title and Subtitle On-Site Motor Coach Rollover Investigation				5. Report Date March 9, 2011

This on-site investigation focused on a 1992 Dina Marcopolo Paradiso motor coach that was involved in a rollover crash. This crash occurred in March 2010 at 0527 hours in a rural area of Arizona. The crash scene was an east/west two-lane divided interstate highway. The bus was being driven by a 67-year-old male and was traveling westbound. There were 22 occupants on board the bus, including the driver. A 1997 Ford F-150 pickup was traveling in front of the Dina. The pickup was traveling slower than the Dina and was impacted by the front end of the bus. The Dina veered to the left onto the median, overcorrected to the right, crossed both westbound travel lanes, departed the roadway on the right side, overturned, and came to rest off the right side of the roadway (**Figure 1**). A total of nine occupants were ejected from the bus. Six of the ejected occupants,

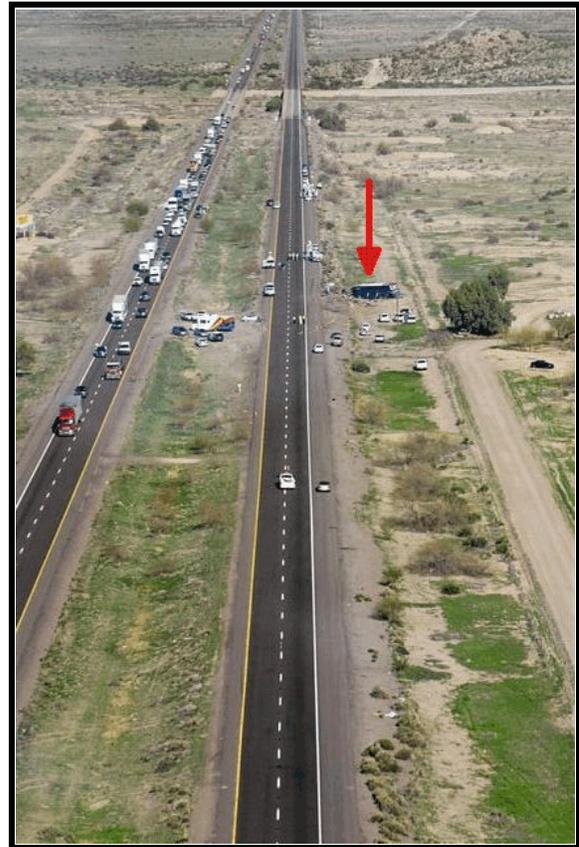
Figure 1. Final rest location of bus - looking west (police photo)

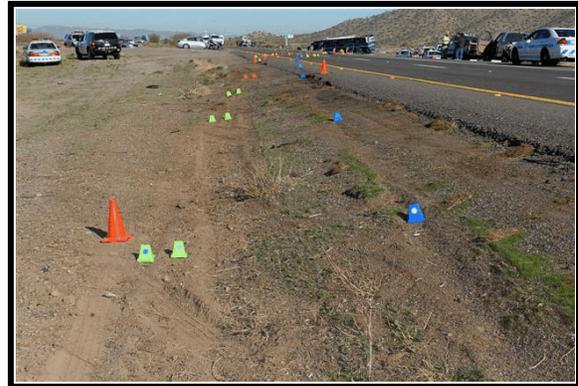
The Dina departed the roadway on the left side and entered the median (**Figure 3**). The driver of the Dina steered to the right, reentered the roadway, and crossed the two travel lanes. The vehicle departed the roadway on the right, the driver steered left to return to the roadway, and the vehicle began a counterclockwise rotation. The rear tires crossed the shoulder onto the embankment (**Figure 4**). The vehicle traveled approximately 51.8 m (170.0 ft) before the tires impacted the embankment surface and the vehicle tripped (**Figure 5**). The bus began a right side leading rollover, rolled 4 quarter-turns, and traveled 34.1 m (112.0 ft) before coming to rest.

Figure 3. Path through median (police photo)

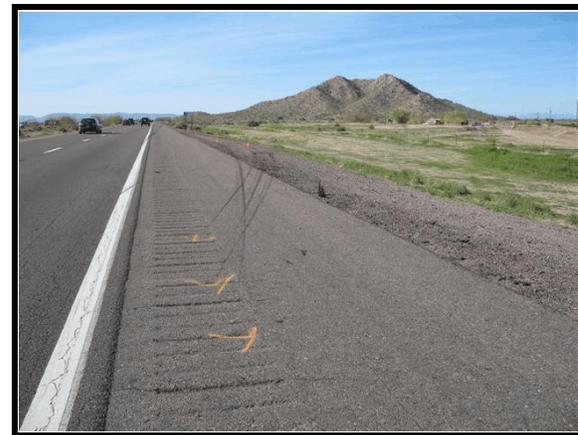
Figure 4. Right side roadway departure for the bus

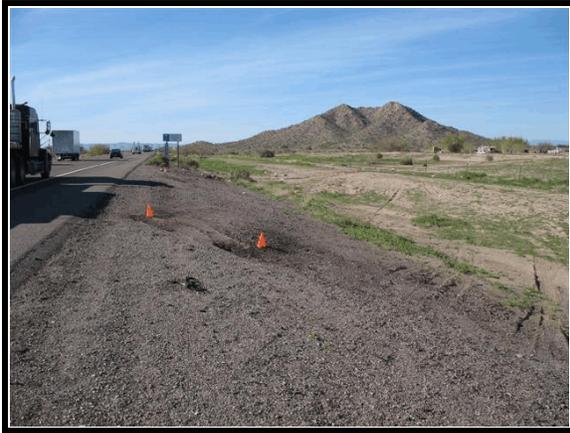
Figure 5. Rear bus tire trip points. Right side road departure.

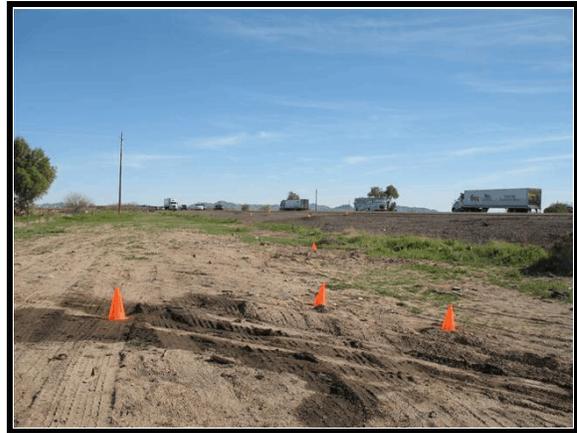
Figure 6. Look back view of bus from beyond final rest

The bus came to rest on its wheels facing southwest (**Figure 6**). All but two of the bus occupants were known to be injured. A total of nine occupants were ejected from the bus. Six of the ejected occupants were fatally injured. The remaining occupants were transported to a variety of trauma centers and hospitals. The police did not list seating positions for all the occupants. An overview of the occupants and their injury status is illustrated in Table 1. A seating diagram for occupants in known seating positions is included as Attachment 2 to this report.

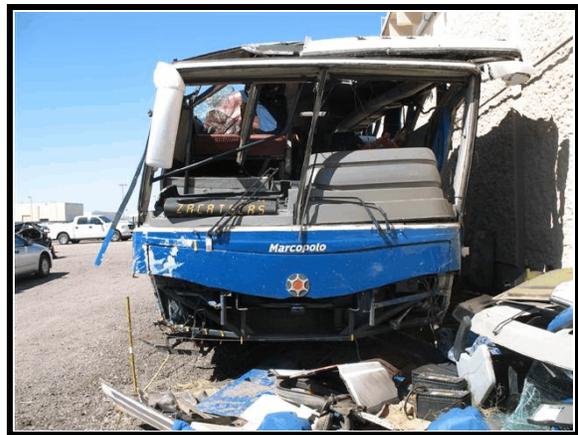
The Dina sustained minor front end damage as a result of the impact with the Ford (**Figure 9**). The direct damage began at the right front bumper corner area and extended 55.0 cm (21.6 in) to the left. The damage extended vertically 131.0 cm (51.5 in) from the ground. Six crush measurements were taken at the bumper level as follows: $C_1 = 0$ cm, $C_2 = 6.0$ cm (2.3 in), $C_3 = 9.0$ cm (3.5 in), $C_4 = 13.0$ cm (5.1 in), $C_5 = 19.0$ cm (7.4 in), $C_6 = 35.0$ cm (13.7 in). The maximum crush was located at C_6 . The bumper was torn away from the vehicle.

Figure 9. Frontal damage

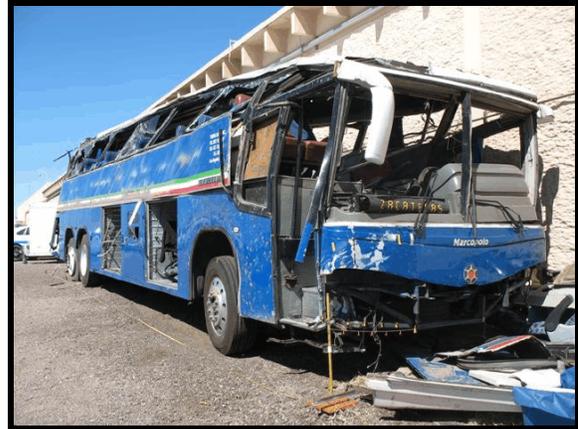
The Dina sustained severe damage as a result of the rollover. There was direct damage to the right side, top, and left side. The damage to the right side began 240.0 cm (94.5 in) aft of the rear axle and extended 1256.0 cm (494.4 in) forward (**Figure 10**). The damage extended vertically from the roof rail downward 170.0 cm (66.9 in) and terminated along the belt line. The lateral crush was documented at three locations as follows:

Location	Crush
Right A-pillar/roof side rail	76.0 cm (29.9 in)
Right roof side rail, 170.0 cm (66.9 in) forward of #3 axle	61.0 cm (24.0 in)
Right roof side rail, 52.0 cm (21.6 in) rearward of #3 axle	52.0 cm (21.6 in)

Figure 10. Right side damage

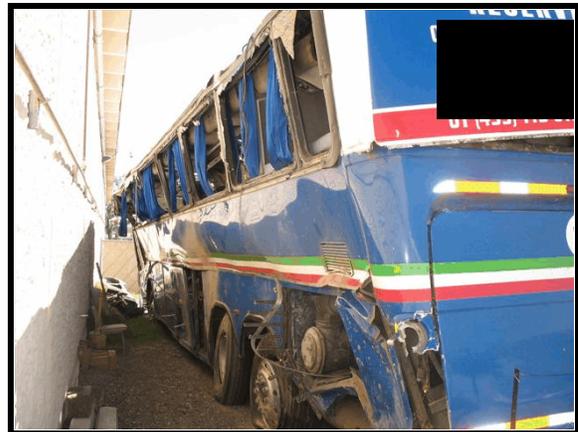
There was scattered damage to the left side that began at the left rear bumper corner and extended forward along the entire length of the bus (**Figure 11**). There was 223.0 cm (87.8 in) of direct damage that extended from the left rear bumper forward to the #3 axle tire. Along this area there was 37.0 cm (14.6 in) of vertical crush along the lower edge of the body. There was direct damage that began at the left front bumper corner and extended 148.0 cm (58.2 in) and terminated 56.0 cm

(22.0 in) forward of the front axle. This area was dented and mud-covered. The maximum lateral crush was located at the left bumper corner and measured 25.0 cm (9.8 in). The greenhouse was shifted to the left by the right side impact with the ground. The shift was measured at two locations; 69.0 cm (27.1 in) at the left A-pillar and 43.0 cm (16.9 in) at the #3 axle.

Figure 11. Left side damage

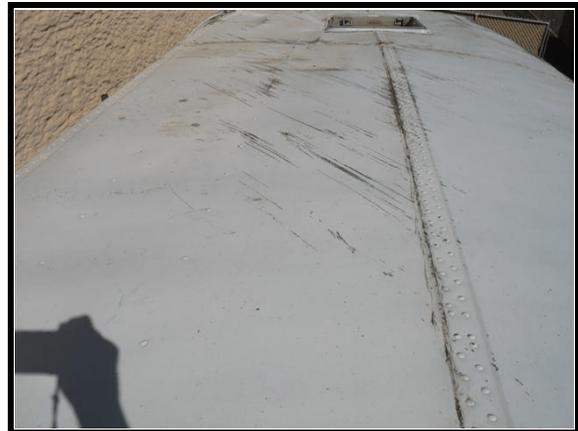
The damage on the roof was distributed laterally from roof side rail to roof side rail and measured 252.0 cm (99.2 in) (**Figure 12**); it was distributed longitudinally along the entire bus length and measured 1141.0 cm (449.2 in). The maximum vertical damage was located at the right A-pillar/roof junction and measured 235.0 cm (92.5 in) from the ground.

Figure 12. Roof damage (looking toward front of bus)

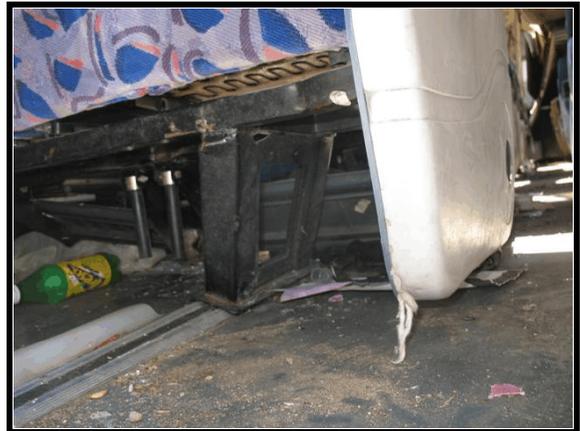
The seats were examined for seat back, seat cushion, armrest, and anchor damage. There were numerous instances of seat shifting, particularly at the inboard legs (**Figure 13**). Outboard arm rests were deformed by intrusion on the right, as well as by occupant contact. The following table describes the damage at each seat position.

Figure 13. Exemplar shifting of inboard seat leg

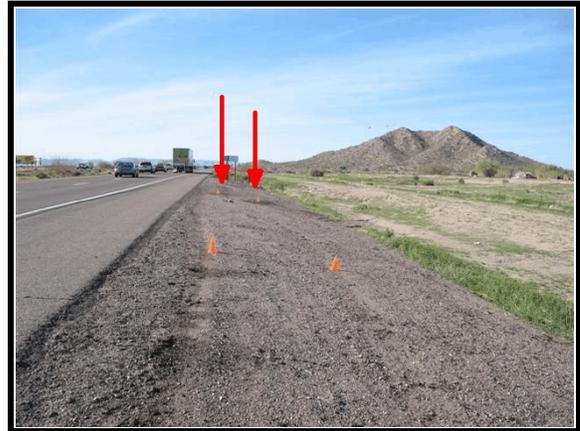
Figure 14. Right side roadway departure. Arrows depict right rear tires trip point.

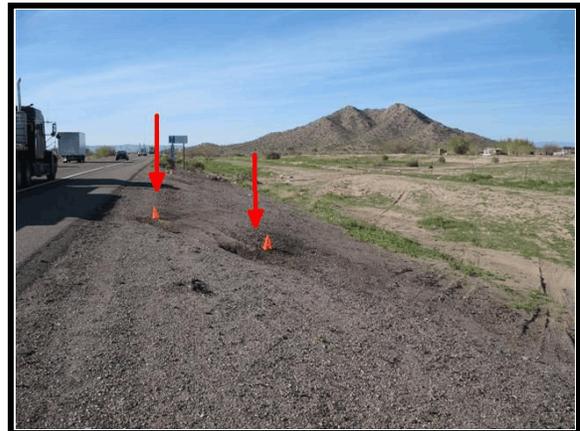
Figure 15. Rear tires trip points

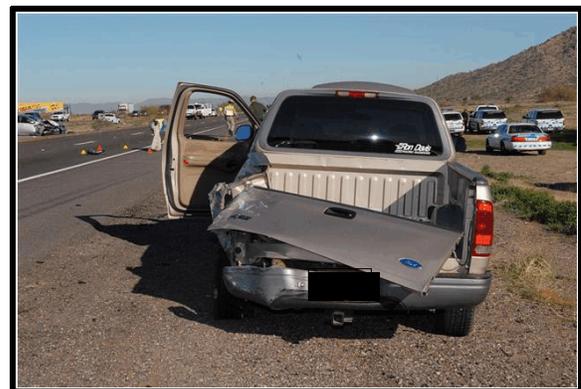
The vehicle sustained moderate damage to the back end during the impact with the front of the Dina (**Figure 16**). The direct damage began at the left rear bumper corner and extended 28.0 cm (11.0 in) to the right. Two crush measurements were documented at the bumper level as follows: C1 = 0 cm, C2 = 31.0 cm (12.0 in). The left side of the bed was deformed 60.0 cm (23.6 in) longitudinally. The Collision Deformation Classification for this impact was 06BLEE2.

Figure 16. Back end damage, other vehicle (police photo)

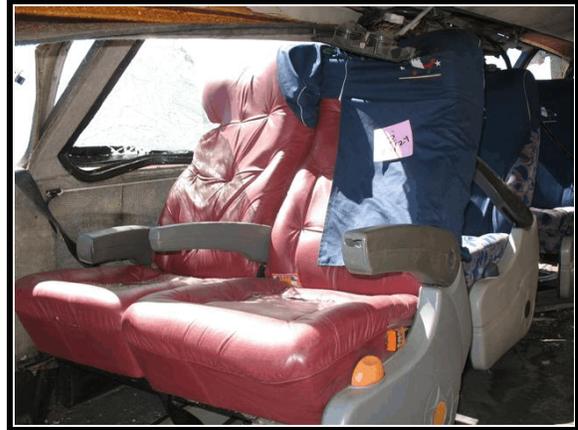
Figure 17. Occupant 03 seating position, seat location 24

Occupant 03, a 67-year-old female, was seated in seat 24 (**Figure 17**). During the first quarter-turn, she was displaced against the side window adjacent to her seat position. The window was fractured/displaced during the initial right side roll. She was ejected from the vehicle through the forward most side window during the fourth quarter-turn and came to rest to the right of the bus.

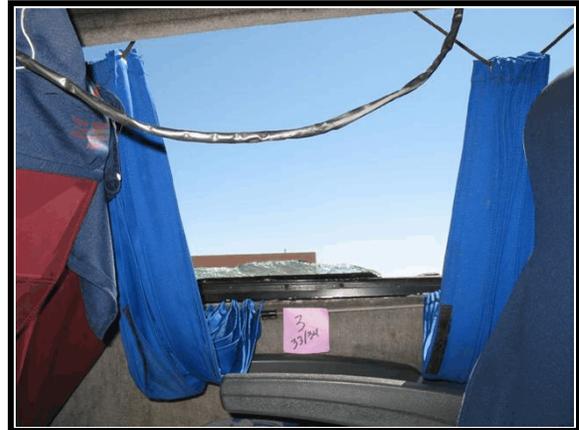
Figure 18. Occupant 07 seating position, seat location 34

Occupant 07, an 81-year-old female, was seated in seat position 34 (**Figure 18**). During initial right side roll, she was displaced from her seat forward and to the right against the adjacent side window. The window was displaced/fractured during the right side impact. She came out of her seat as the vehicle overturned and was then ejected through the side window during the fourth quarter-turn. She came to rest approximately 8.5 m (28.0 ft) to the right of the bus.

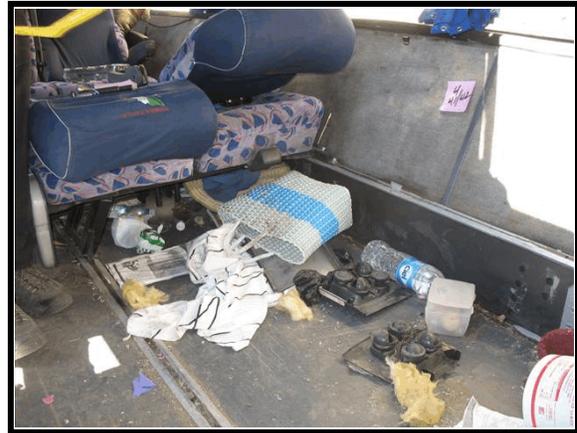
Occupant 08, a 57-year-old female, was seated in seat position 41 (**Figure 19**). During initial right side roll, she was displaced from her seat forward and to the right and was probably near the second set of windows. The seat unit was displaced from its anchorage during the rollover. This occupant was ejected from the vehicle during the fourth quarter- turn and came to rest approximately 1.0 m (3.3 ft) to the right of the bus near the right front axle.

Figure 19. Occupant 08 seating position, seat location 41

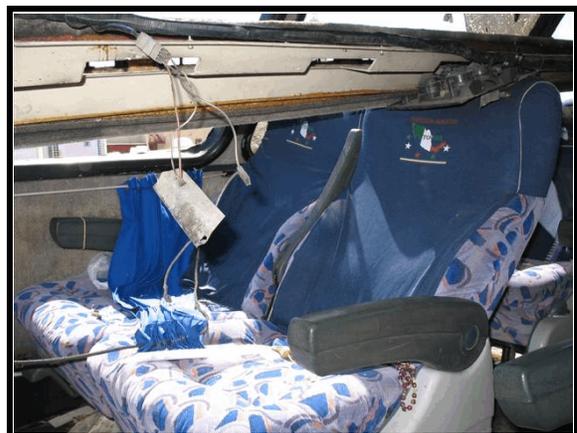
Occupant 12, a 12-year-old male, was seated in seat position 53 (**Figure 20**). He was asleep before the crash. He was ejected at some point during the rollover sequence. The ejection area is not known.

Figure 20. Occupant 12 seating position, seat location 53
