On-Site Rollover Investigation  
Dynamic Science, Inc. (DSI), Case Number DS10009  
2009 BMW 328i  
California  
February 2010

**Dynamic Science, Inc.**  
**Crash Investigation**  
**Case Number: DS10009**

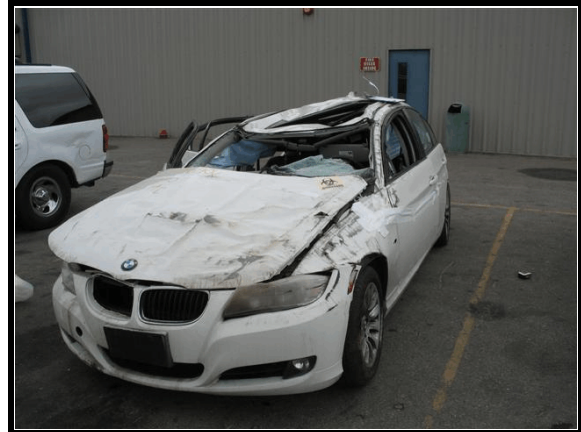
This on-site investigation focused on a 2009 BMW 328i that was involved in a rollover (**Figure 1**). This single vehicle crash occurred in February 2010 at 0700 hours in a rural area of California. The crash site was a two-lane, undivided, east/west state highway. The subject vehicle was being driven eastbound by a restrained 23-year-old male. The front right seat was occupied by a restrained 36-year-old male and the second row right seat was occupied by a 24-year-old male. As the vehicle entered and then exited a sag in the roadway the driver lost control of the vehicle. The vehicle veered to the right onto a gravel shoulder and as the driver steered to the left to return to the roadway the vehicle began a counterclockwise rotation. The vehicle tripped as it reentered the roadway and began a right side leading rollover. The BMW rolled eight quarter-turns as it crossed both travel lanes and departed the roadway on the north side where it came to rest on its wheels facing west. All the occupants exited the vehicle under their own power through the side windows. The driver sustained minor contusions and abrasions, the front right passenger sustained an eye injury, and the second row right passenger sustained a chest contusion. All three occupants visited a walk-in clinic later in the day where they were treated and released. The BMW was towed from the scene due to damage and was declared a total loss by the insurance company.

**Figure 1.** Subject vehicle, 2009 BMW 328i

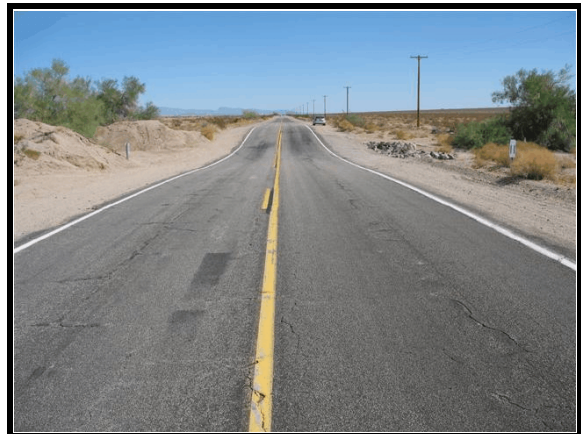
**Figure 2.** Eastbound approach showing sag in roadway

(**Figure 2**). There was a descending 4.0 percent negative grade and the roadway bottomed out 40.5 m (133.0 ft) later. The roadway then began ascending at a positive 6.6 % grade. Just prior to the area where the vehicle went out of control, the roadway was near level with a positive grade of 0.8%. The weather was cloudy, visibility in all directions was good, and the roadway was dry. The posted speed limit for this roadway was 105 km/h (65 mph).

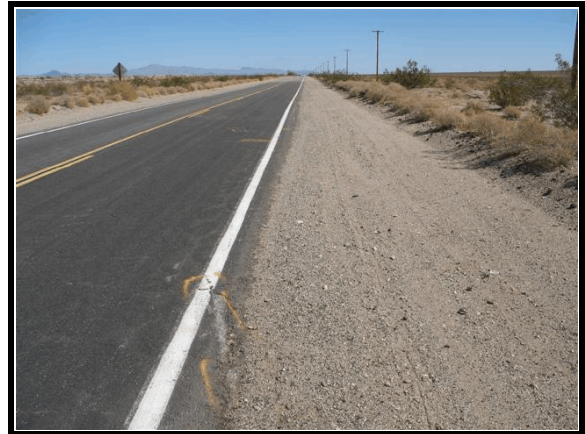
As the vehicle re-entered the roadway it tripped at the junction between the gravel shoulder and asphalt roadway and began a right side leading rollover (**Figure 3**). The vehicle rolled eight quarter-turns on a diagonal across both lanes of travel for 28.3 m (93.0 ft) before departing the roadway and coming rest on its wheels in the open desert.

**Figure 3.** Area vehicle returned to roadway (looking east)

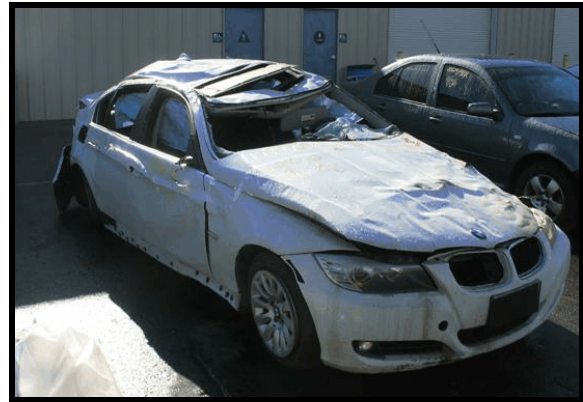
The BMW sustained damage to the left side, right side, back and top during the rollover event (**Figure 4**). The direct damage to the top of the vehicle extended laterally from roof side rail to roof side rail and measured 118.0 cm (46.4 in). The damage extended laterally across the entire hood and measured 131.0 cm (51.5 in). The hood was shifted to the right. The direct damage began 59.0 cm (23.2 in) forward of the front axle and extended rearward to include the entire hood and roof.

**Figure 4.** Rollover damage, 2009 BMW 328i

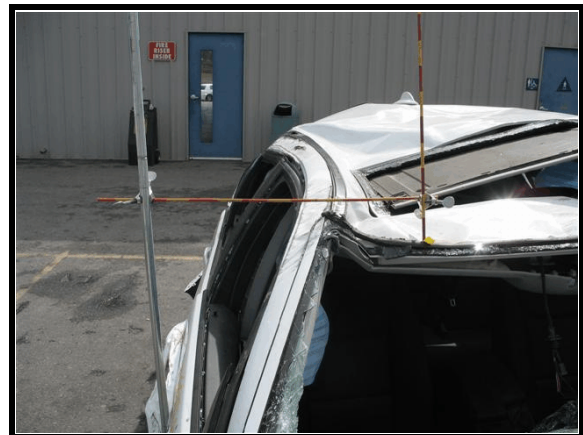
The maximum vertical crush measured 18.0 cm (7.0 in) and was located at the windshield header 20.0 cm (7.8 in) left of the right roof side rail (**Figure 5**). The maximum lateral crush measured 2.0 cm (0.8 in) and was located at the right A-pillar and roof junction. A second vertical crush measurement was taken at the backlight header. The crush measured 9.0 cm (3.5 in) and was located 15.0 cm (5.9 in) right of the left roof side rail. The direct damage to the left side was located 50.0 cm (23.2 in) forward of the front axle and extended 420.0 cm (165.3 in) rearward. There was a 23.0 cm (9.0 in) gap in the direct damage that was located at the second row door. The direct damage to the right side began 85.0 cm (33.4 in)

**Figure 5.** Maximum vertical crush

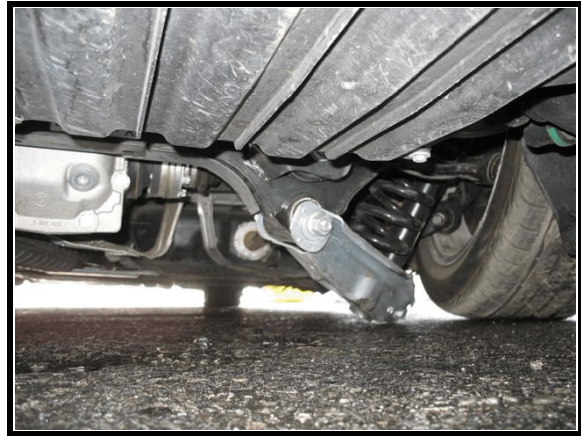
There were scrapes to the left rear, right rear, and right front rims. The right rear wheel was rotated clockwise 10 degrees and canted inboard 9 degrees. The strut was fractured and displaced at the right rear axle (**Figure 6**).

**Figure 6.** Right rear strut displaced

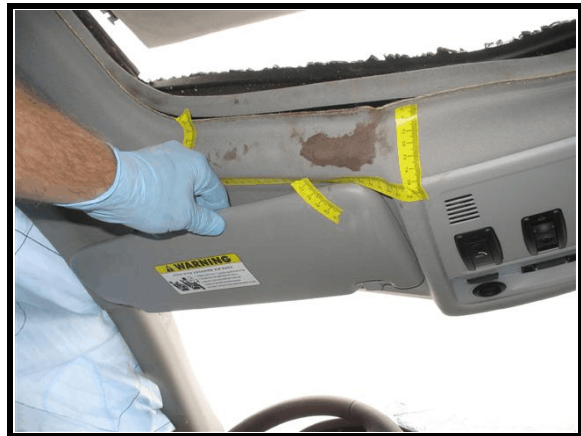
Evidence of occupant loading and contacts were documented to the driver's safety belt, the safety belt latch plate, left roof, and visor (**Figure 7**). The blood evidence to the roof was located 25.0 cm (9.8 in) right of the roof side rail, 25.0 (9.8 in) rearward of the windshield header, and measured 24.0 x 7.0 cm (9.4 x 2.8 in). There was also blood evidence located at the center console and along the right IC air bag module cover.

**Figure 7.** Contact to roof and visor

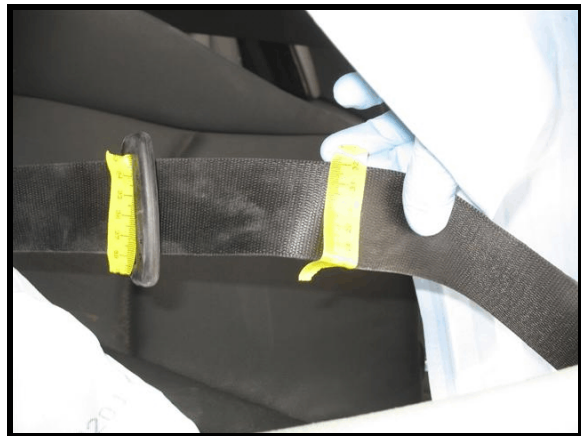
The front row seating positions were equipped with 3-point manual lap and shoulder belts with sliding latch plates and retractor pretensioners. The driver's safety belt had an Emergency Locking Retractor (ELR) and the front right passenger's safety belt had a switchable ELR/Automatic Locking Retractor (ALR). The driver's safety belt latch plate was scratched indicating historical usage. There was an 11.0 cm (4.3 in) area of possible loading to the safety belt webbing located 57.0 cm (22.4 in) from the anchorage (**Figure 8**). Based on the vehicle inspection, the belt was used to restrain the driver during the crash. The front right

**Figure 8.** Driver's safety belt

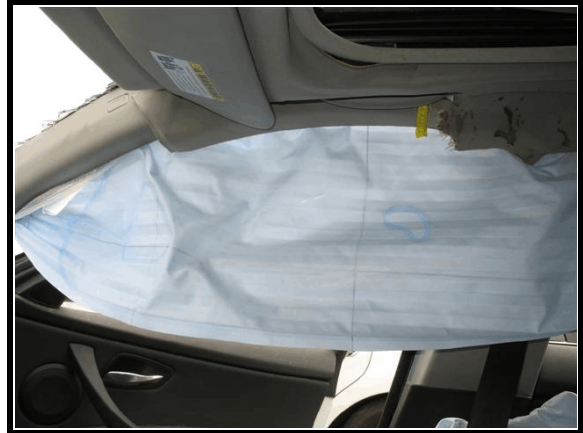
The side IC air bags deployed through the roof rail cladding from a module located at the roof side rail (**Figure 9**). The air bags were generally rectangular and measured 165.0 cm (64.9 in) in length and 32.0 cm (12.6 in) in height. The forward aspects of the bags were attached to the A-pillar by tethers that measured 10.0 cm (3.9 in); the rear aspects were attached to the C-pillar. The longitudinal area of coverage began near the A-pillar and extended to the C-pillar. The bag's vertical coverage began at the roof rail and extended downward below the window frame. There were no indications of loading to the IC air bags.

**Figure 9.** Right IC air bag

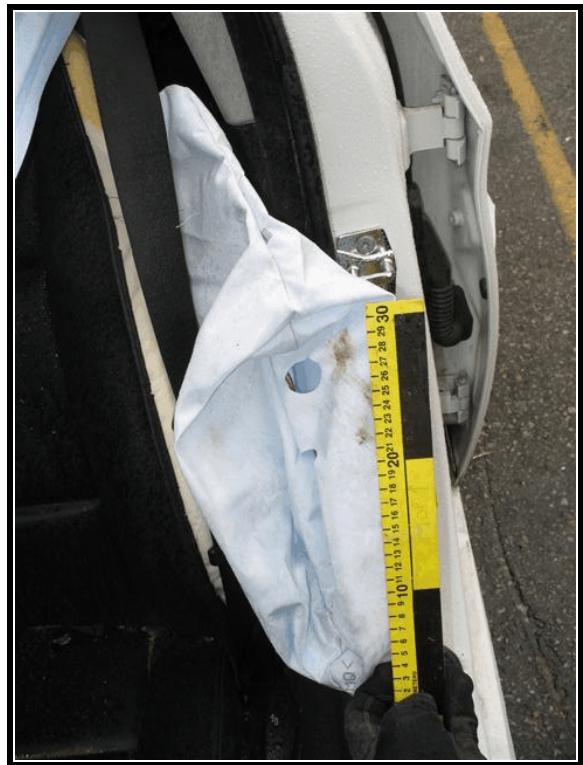
The seat-mounted side air bags deployed longitudinally from the front seat backs (**Figure 10**). The air bags extended 21.0 cm (8.3 in) in length and 30.0 cm (11.8 in) in height. Two 3.0 cm (1.2 in) round vent ports were located at the

**Figure 10.** Driver's seat-mounted side air bag

forward aspects of the air bags. A 16.0 x 5.0 (6.3 x 1.9 in) black scuff was located to the outboard side of the upper vent port on the driver's side air bag. There were no other contacts or damage.

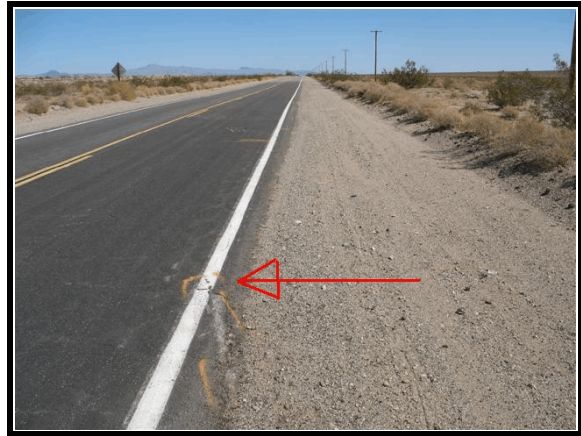
The BMW was traveling at a driver reported speed of 113 km/h (70 mph) when he lost control of the vehicle. The driver was braking and steering as the vehicle entered the right side shoulder. The vehicle traveled 85.9 m (282.0 ft) on the shoulder. At some point the driver steered to the left and the vehicle began a counterclockwise rotation. As the vehicle re-entered the roadway it tripped at the junction between the gravel shoulder and asphalt roadway and began a right side leading rollover (**Figure 11**). The vehicle rolled eight quarter-turns on a diagonal across both lanes of travel before departing the roadway and coming to rest on its roof in the open desert (**Figures 12-13**). The estimated roll distance from the trip point to final rest was 55.8 m (183.3 ft).

**Figure 11.** Trip point at junction of roadway and shoulder

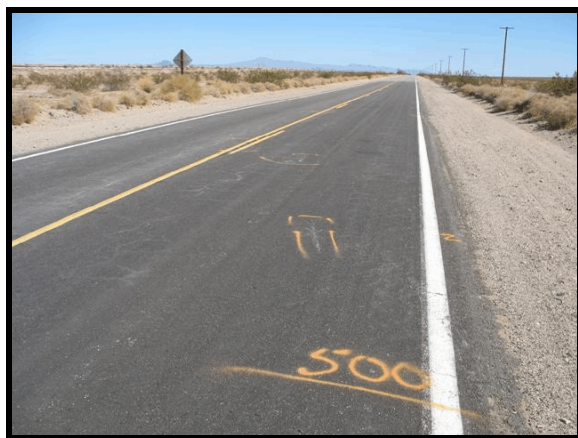
**Figure 12.** Rollover path across roadway

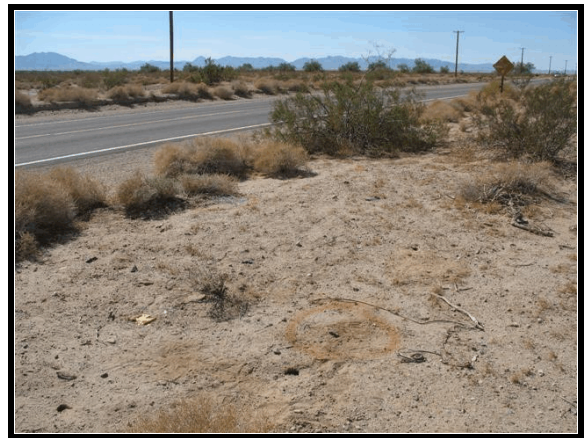
**Figure 13.** Look back view from final rest
