**CALSPAN ON-SITE POTENTIAL UNINTENDED
ACCELERATION CRASH INVESTIGATION
SCI CASE NO.: CA10011
OFFICE OF DEFECTS INVESTIGATION**

VEHICLE: 2008 TOYOTA AVALON

LOCATION: PENNSYLVANIA

CRASH DATE: MARCH, 2010

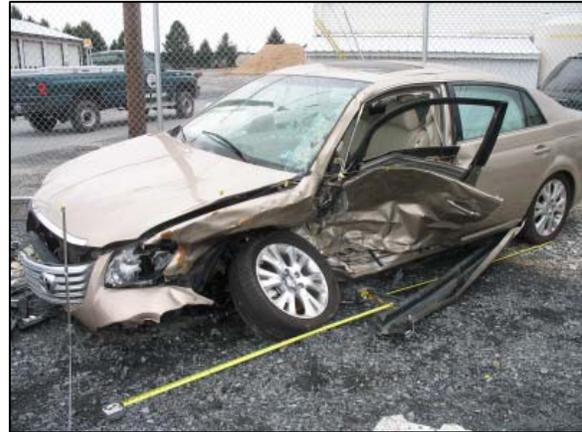
This on-site investigation focused on the alleged Unintended Acceleration (UA) crash that resulted in the death of a 67-year-old male driver of a 2008 Toyota Avalon, **Figure 1**. The Toyota Avalon was included in the recall population for both the Floor Mat Entrapment NHTSA Campaign No. 09V388000 and the Sticky Pedal Recall Campaign No. 10V017000. The Toyota entered a controlled 4-leg intersection and was struck on the left side by a 2005 Honda Pilot sport utility vehicle. The Toyota was equipped with Certified Advanced 208-Compliant frontal

Figure 1: Left front oblique view of the Toyota Avalon.

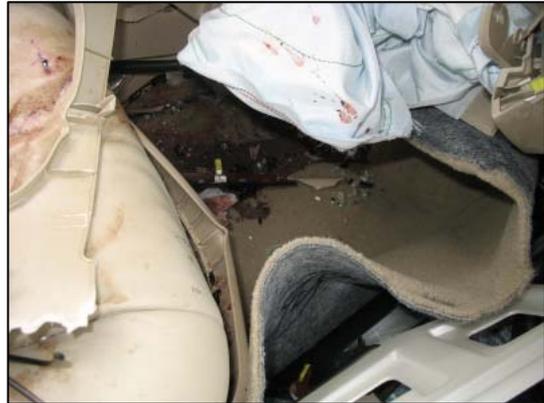
Figure 2: View of the Toyota's driver foot well. No floor mats were located within the foot well.

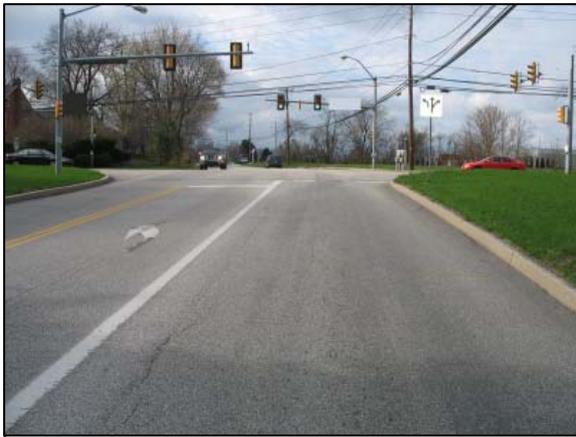
The crash occurred during the daylight hours of March 2010. At the time of the crash, the environmental conditions were reported as heavy rain. The asphalt road surface was wet. The crash occurred at the 4-leg intersection of a 3-lane north/south road and a 3-lane east/west road. **Figure 3** is a northbound trajectory of Toyota. The intersection was controlled by overhead

Figure 3: Northbound trajectory view of the Toyota.

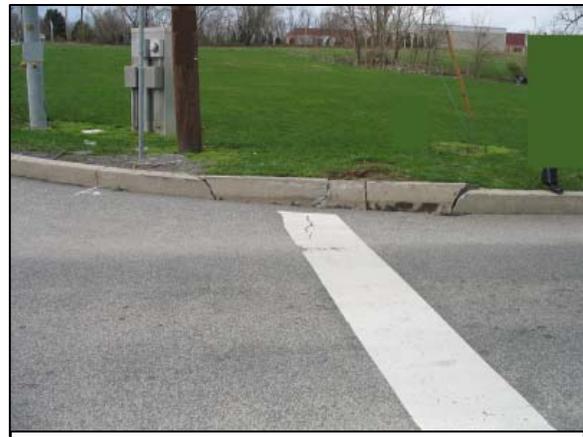
Figure 4: View of the fractured and displaced northeast curb.

The lateral impact redirected the Toyota to the northeast. The Toyota separated from the Honda and traveled 12.5 m (41 ft) where the left front suspension impacted the concrete curb bordering the northeast quadrant of the intersection (Event 2). The force of this impact fractured and displaced the curb, and resulted in the deployment of the vehicle's CAC frontal air bag system and the driver knee bolster air bag. The Toyota overrode the curb and came to rest facing east on the east leg of the intersection, 15.2 m (50 ft) from the initial impact. The Honda separated from the impact with a counterclockwise rotation. The Honda rotated 270 degrees CCW and came to rest facing south within the intersection, 9.4 m (31 ft) east of the impact. Analysis of this event was beyond the scope of WinSMASH.

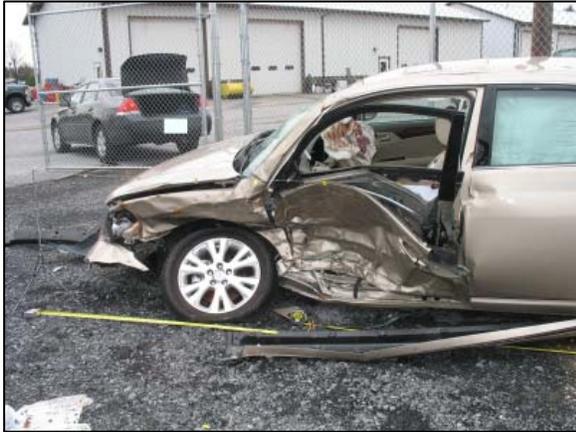
Figure 5 is a left side view depicting the impact damage to the Toyota. The left plane and left front suspension of the Toyota sustained impact damage consistent with the multiple event crash sequence. The direct contact damage to the left plane (Event 1) began at the left front corner and extended rearward onto the left front door panel. Post-crash extrication damage was noted on the left front door panel and window frame. The exterior door panel had separated from the inner door structure at the B-pillar and the panel and window frame had been pulled outboard. This post-crash damage hampered a precise determination of the crush profile and location of the end of the direct and induced impact damage. The end of the direct and induced damage was located on the aft third of the door panel and was estimated to be located at 165 cm (65 in) forward of the left rear axle. The total length of the left side damage measured 196 cm (77.0 in). The residual crush profile measured at the mid-door elevation was as follows: C1 = 0, C2 = 38 cm (14.6 in), C3 = 34 cm (13.4 in), C4 = 17 cm (6.7 in), C5 = 15 cm (5.9 in), C6 = 7 cm (2.8 in). The maximum crush was located on the forward third of the door panel at the C2 crush

Figure 5: Left view of the Toyota Avalon.

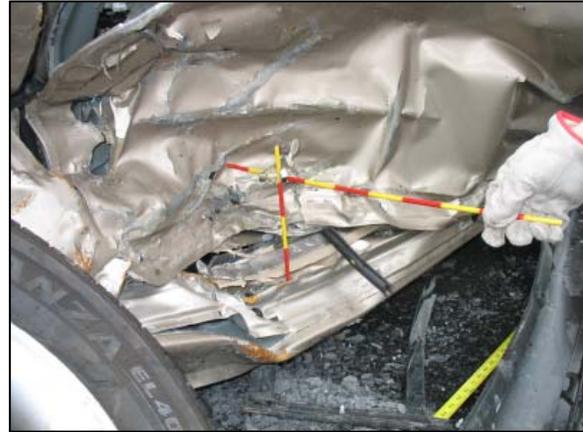
measurement, 198 cm (78.0 in) forward of the left rear axle. The height of the maximum crush location measured 46 cm (18.0 in) above the ground. The Door Sill Differential (DSD) at that location measured 11 cm (4.5 in). Refer to **Figure 6**. The Collision Deformation Classification (CDC) was 10LYEW3.

Figure 6: Close-up view of the maximum crush location and the DSD.

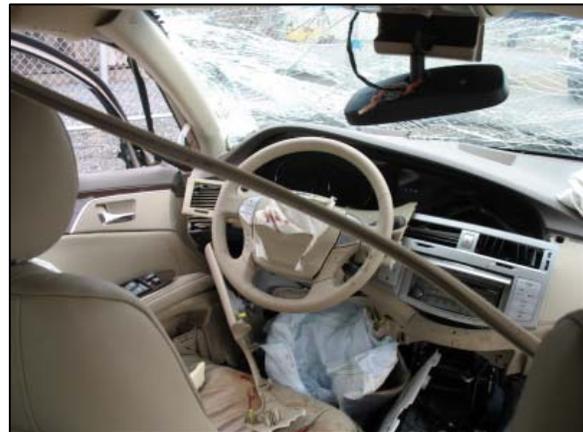
The interior damage to the Toyota consisted of intrusion into the driver's space and deployment of the safety systems. Post-crash body fluid evidence was observed throughout the front interior seats and instrument panel. A 76 cm (30 in) long spatter pattern of body fluid was observed on the head liner. The pattern began at the overhead accessory on the windshield header extending rearward along the centerline of the vehicle. **Figure 7** is a view of the driver's interior. The left A-pillar, left door, and instrument panel intruded into the driver's position. The occupant compartment intrusions are listed in the following table:

Figure 7: View of the left front interior and the intrusion of the Toyota.

Position	Component	Intrusion	Direction
1 st Row Left (Driver)	Left Lower Instrument Panel	8 cm (3.0 in)	Longitudinal
	Door – Forward Lower Quadrant	20 cm (8.0 in)	Lateral
	Left kick Panel	13 cm (5.0 in)	Lateral
	Left A-pillar	3 cm (1.0 in)	Lateral
	Left B-pillar	10 cm (4.0 in)	Lateral
	Sill	10 cm (4.0 in)	Lateral

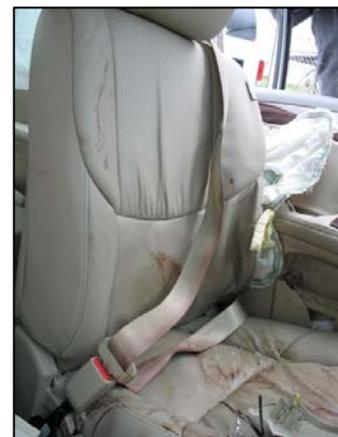
The Toyota Avalon was equipped with 3-point lap and shoulder belts in the five seat positions. The driver's restraint consisted of continuous loop webbing, a sliding latch plate, an adjustable D-ring and an Emergency Locking Retractor (ELR). The driver's D-ring was adjusted to the full-up position. The retractor was equipped with a pretensioner that actuated as a result of the crash. The webbing was extended and the retractor was locked. The length of the exposed webbing measured 160 cm (63 in). **Figure 8** is a view of the driver seat and safety belt. The lap section of the webbing was creased and loaded over a 20 cm (8 in) length. Examination of

Figure 8: View of the Toyota's driver seat and safety belt webbing.

the latch plate revealed a full-width abrasion to the hardware surface. All the evidence observed at the time of the SCI inspection indicated the driver was restrained at the time of the crash.

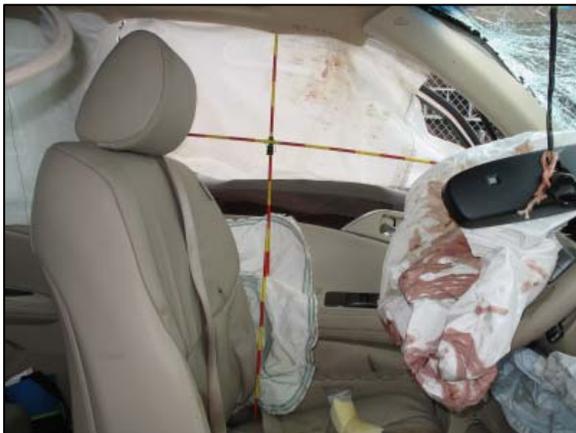
The Toyota's driver seat-mounted side impact air bag and the left IC air bag deployed as a result of the lateral crash event (Event 1). **Figure 9** is a left lateral view across the front row interior. The seat-mounted air bag was elliptical in shape and configured as an inflatable ring with a reinforced fabric center. The air bag measured 43 cm (17 in) in height and extended 18 cm (7.0 in) forward of the seat bolster. The estimated lateral depth of the inflated air bag was 8 cm (3.0 in). There was no residual evidence of direct occupant contact on the air bag.

Figure 9: Left lateral view of the Toyota driver's position and the deployed air bags.

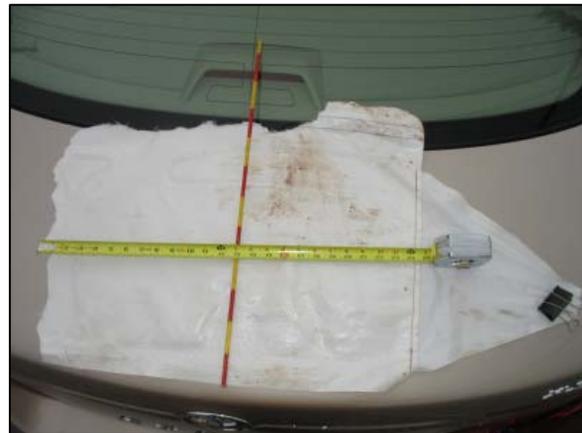
The left IC deployed from the roof side rail and provided coverage from the upper aspect of the A-pillar to the C-pillar. The curtain was rectangular. The overall dimensions of the curtain measured 173 cm x 43 cm (68.0 in x 17.0 in), length by height. A 25 cm x 33 cm (10.0 in x 13.0 in) sail panel was sewn to the forward edge of the curtain and covered the open triangular area formed by the A-pillar and belt line. A large contact area consisting of body fluid was identified on the forward upper aspect of the curtain. The contact was attributed to the driver's head. The section of the IC with the contact area had been cut away from the rest of the curtain prior to SCI involvement. (Note - the section was repositioned during the imaging of Figure 10.) The contact area measured 20 cm x 23 cm (8 in x 9 in), width by height. **Figure 10** is a close-up view of the forward aspect of the IC and the driver head contact.

Figure 10: View of the Toyota's left IC and the driver's head contact.

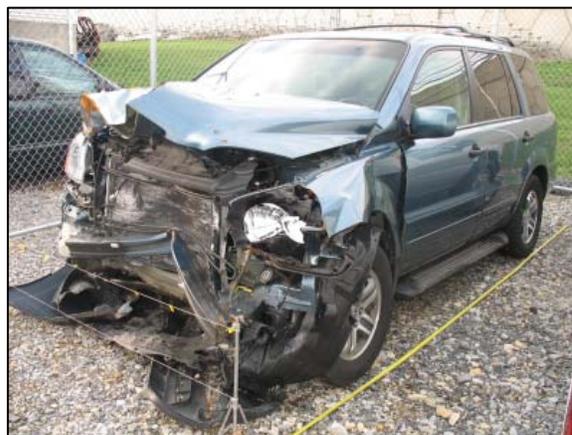
The front plane of the Honda sustained direct contact damage that extended across the entire 163 cm (64.0 in) end width. **Figure 11** is a front left oblique view of the vehicle. The damaged components included the bumper fascia, bumper reinforcement bar, grill, radiator, head lamp assemblies, hood and fenders. The bumper reinforcement deformed into a V-shape and had separated from the frame on the right. The front aspect of the vehicle was deformed to the left approximately 15 cm (6 in) consistent with the 1 o’clock direction of the impact force. The residual crush profile measured along the reinforcement bar was as follows: C1 = 9 cm (3.5 in), C2 = 19 cm (7.5 in), C3 = 35 cm (13.8 in), C4 = 34 cm (13.4 in), C5 = 21 cm (8.3 in), C6 = 10 cm (3.9 in). The maximum crush measured 45 cm (17.7 in) and was located 8 cm (3.1 in) right of C3. The left wheelbase was reduced 8 cm (3.1 in). The right wheelbase dimension was

Figure 11: Front left oblique view of the Honda.

unchanged. The windshield was fractured from the exterior force of the crash. All the doors remained closed during the impact and were operational post-crash. All the side glazing was intact. The CDC was 01FDEW2.
