ON-SITE OFFICE OF DEFECTS INVESTIGATION POTENTIAL UNINTENDED ACCELERATION INVESTIGATION

CASE NUMBER - IN10011

VEHICLE - 2007 LEXUS ES-350

CRASH DATE - June 2008

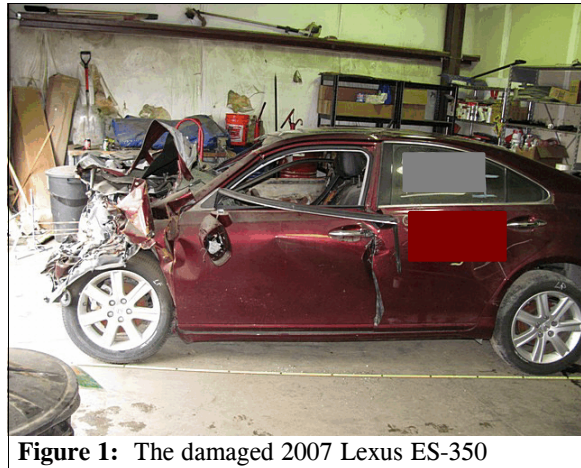
Figure 1: The damaged 2007 Lexus ES-350

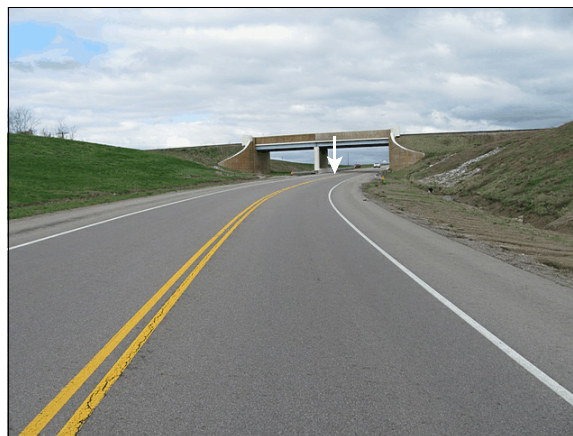
Pre-Crash: The restrained 52-year-old male driver of the Lexus was traveling east negotiating a right curve (**Figure 2**). The vehicle traversed through an area where water was running across the roadway. Based on the police measurements, the area of water was approximately 15 m (49.2 ft) in width and the center of the runoff was approximately 83 m (272 ft) west of the impact area. The Ford was traveling west approaching the curve (**Figure 3**). It was occupied by a restrained 58-year-old male driver, restrained 24-year-old male front right passenger, and an unrestrained 45-year-old male second row center passenger. The vehicle was a correctional institution transport van and was transporting the second row passenger from a medical facility. The crash occurred in the westbound lane as the Ford entered the curve.

Figure 2: Approach of the Lexus; arrow shows area of the impact

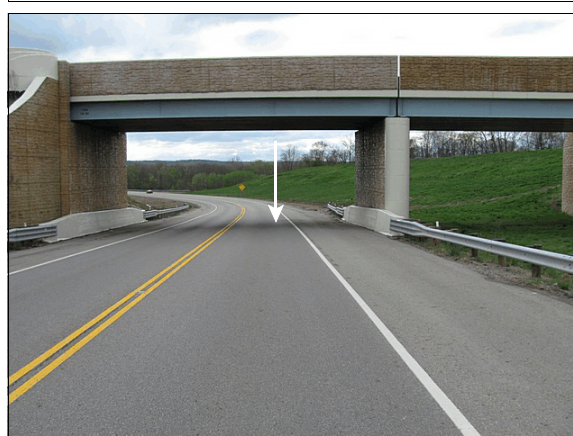
Figure 3: Approach of the Ford; arrow shows area of the impact

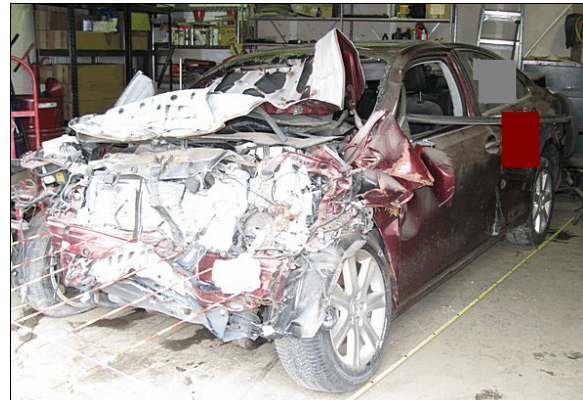
Crash: The front plane of the Lexus (**Figure 4**) impacted the front plane of the Ford (**Figure 5**). Based on the police measurements, the impact occurred in the Ford’s travel lane 3 m (9.8 ft) from the center of the roadway. The force direction on the Lexus was within the 12 o’clock sector and the impact force was sufficient to trigger deployment of the driver’s frontal and knee air bags.

Figure 4: The damage on the front plane of the Lexus from the impact with the front of the Ford

Exterior Damage: The Lexus sustained front plane damage during the impact with the Ford. The front bumper, grille, hood, both headlamp/turn signal assemblies and both fenders were directly damaged. The direct damage involved the full width of the front end, 150 cm (59.1 in). The crush measurements were taken on the front bumper bar and the maximum residual crush was 69 cm (27.2 in) occurring at C₄ (**Figure 7**). The vehicle’s left side wheelbase was reduced 21 cm (8.3 in) while the right side wheelbase was extended 4 cm (1.6 in). The table below presents the front crush profile.

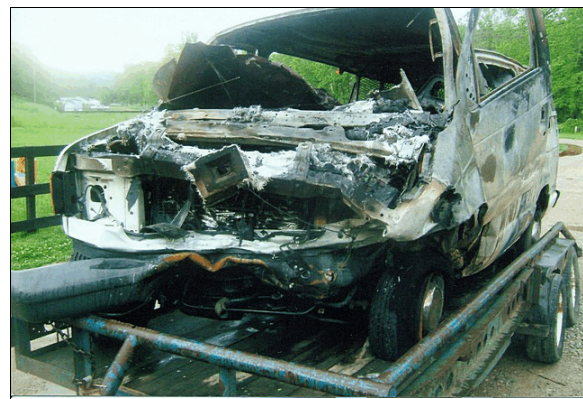
Figure 5: Police photo of the damage on the front of the Ford

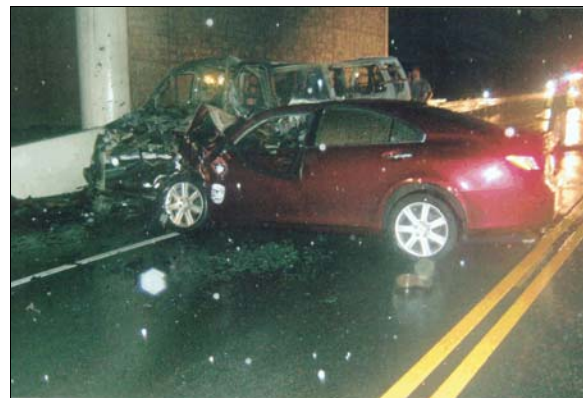
The EDR reported this as a low stage deployment, which occurred 5 ms following the impact trigger. The Lexus rotated counterclockwise 95 degrees and came to final rest across the westbound lane heading north (Figure 6). The Ford came to final rest on the north shoulder heading west.

Figure 6: Police photo of the final rest positions of the Lexus and the Ford

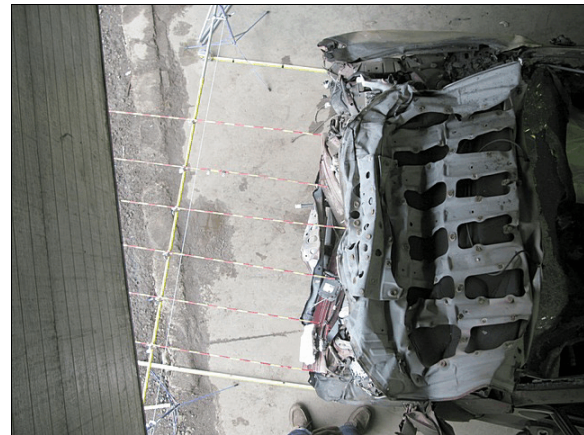
Figure 7: Top view of the front crush on the Lexus; each increment on the rods is 5 cm (2 in)

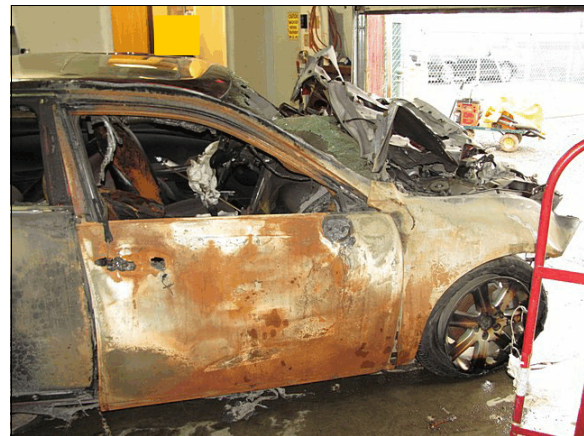
The Lexus sustained fire damage (**Figure 8**) that involved the right fender, right portion of the hood and windshield, right front wheel, right front door, right rear door, and the interior of the vehicle. The fire started within the engine compartment of the Ford and spread to the Lexus. The fire was extinguished by a local fire department approximately 15 minutes following their arrival at the crash scene.

Figure 8: Right side view of the damage on the Lexus from the fire

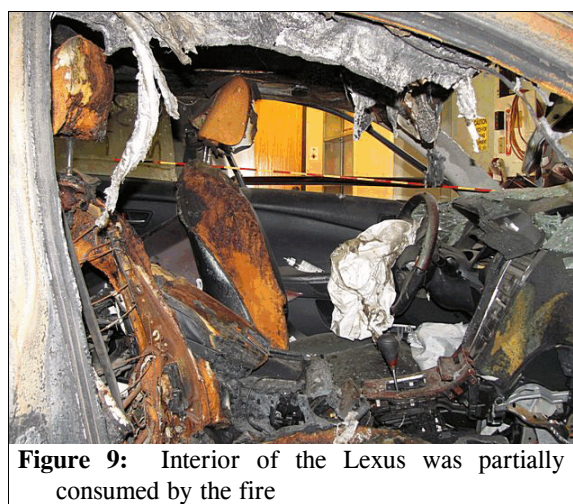
Vehicle Interior: The interior of the Lexus was partially consumed by the fire (**Figure 9**). There was no deformation of the steering wheel rim. The energy absorbing steering column was compressed approximately 3 cm (1.2 in) from loading by the driver.

Figure 9: Interior of the Lexus was partially consumed by the fire

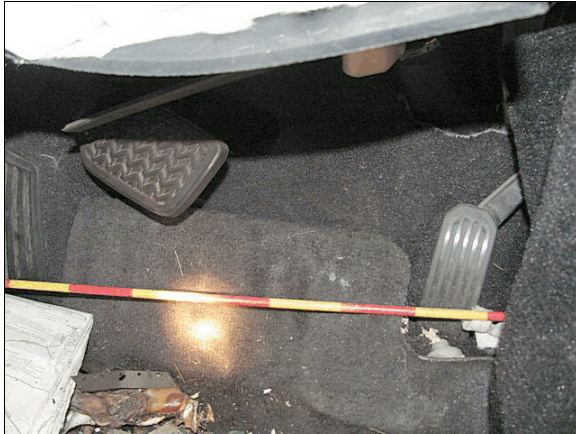
The initial status of the accelerator pedal, brake pedal, and floor mat at the time of the SCI inspection are shown in **Figure 10**. The driver's floor mat was secured by the floor mounted attachments and was partially entrapped under the driver's seat from the damage. The floor mat was not over or in contact with the accelerator pedal. There were no discernable product identification codes on the back of the floor mat. A Lexus logo was present on the front of the floor mat. The intrusion of the driver's toe pan folded the carpet and the end of the accelerator

Figure 10: The initial status of the driver's floor mat, accelerator pedal, and brake pedal at the SCI inspection

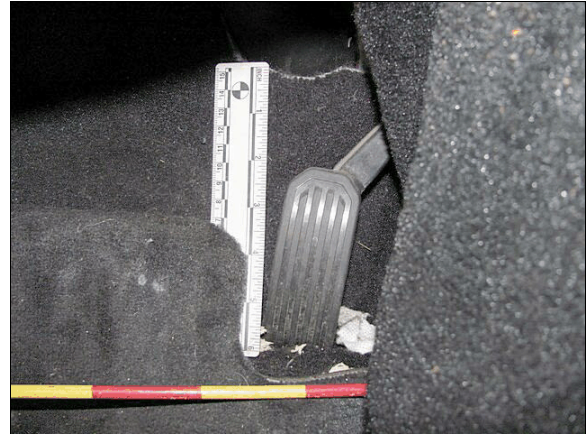
pedal was entrapped in a damaged carpet fold (**Figure 11**). When freed from the carpet fold, the accelerator pedal functioned smoothly and did not bind. **Figure 12** shows the Denso accelerator pedal mechanism housing. Both rear wheels were removed and the brake rotors and brake pads were inspected. They showed no evidence of overheating (**Figures 13 and 14**). Both rotors contained significant rust deposits from prolonged non-use.

Figure 11: The end of the accelerator pedal was entrapped in a fold in the damaged carpet

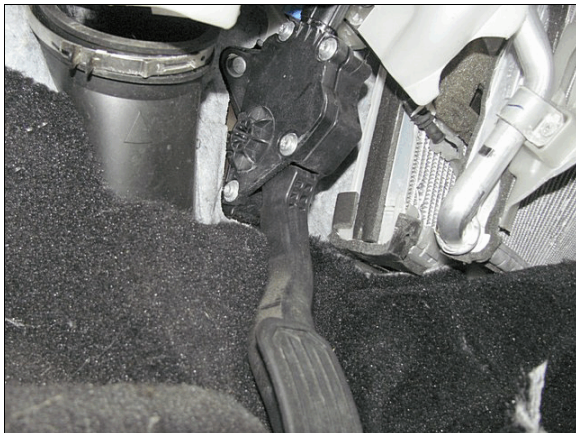
Figure 12: The Denso accelerator mechanism housing

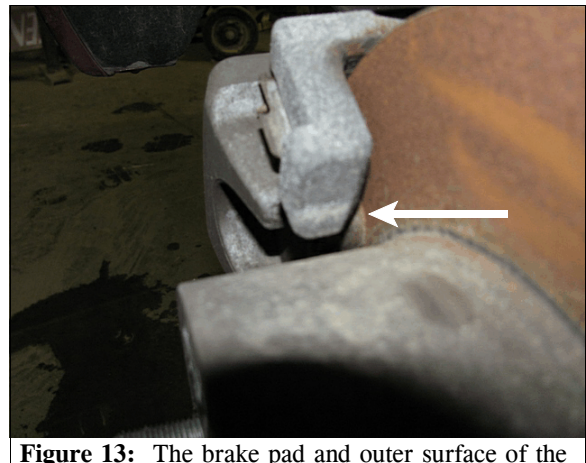
Figure 13: The brake pad and outer surface of the brake rotor on the right rear wheel of the Lexus; arrow shows the brake pad

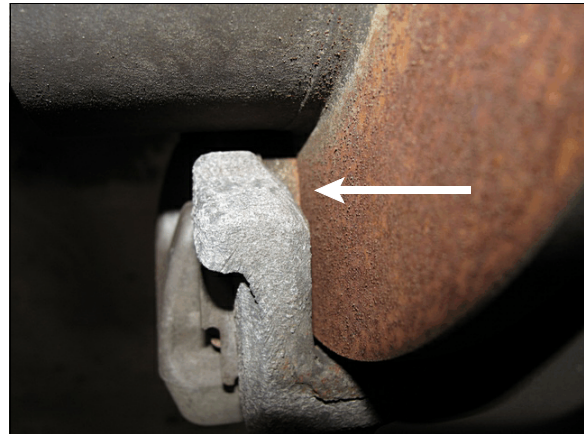
Figure 14: The brake pad and outer surface of the brake rotor on the left rear wheel of the Lexus

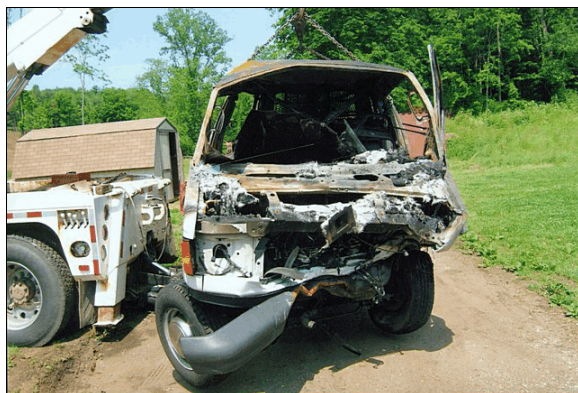
Exterior Damage: The Ford sustained front plane damage (**Figure 15**) during the impact with the Lexus. The direct damage began on the front left bumper corner and involved approximately 55% of the front bumper. A fire started in the front of the vehicle immediately following the crash and involved the whole vehicle (**Figure 16**).

Figure 15: Police photo of the front plane damage on the Ford from the impact with the Lexus

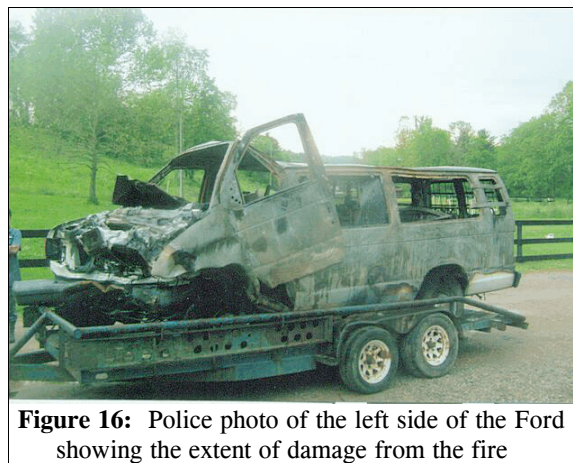
Figure 16: Police photo of the left side of the Ford showing the extent of damage from the fire
