ON-SITE HEAVY TRUCK UNDERRIDE INVESTIGATION

CASE NUMBER - IN10015

VEHICLE - 2008 WABASH NATIONAL SEMI-TRAILER

CRASH DATE - March 2010

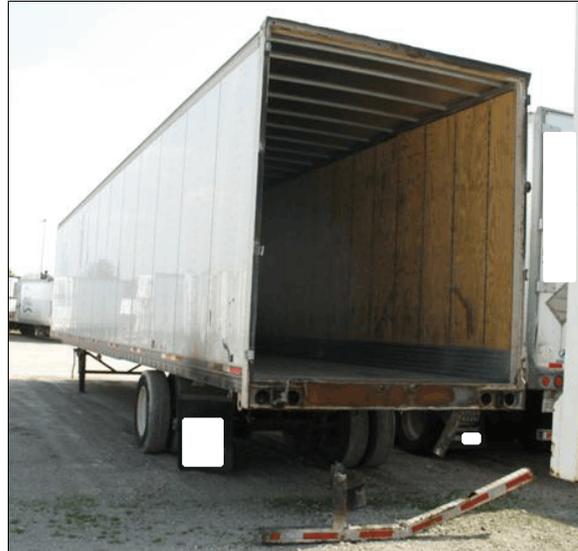
Figure 1: The damaged 2008 Wabash National semi-trailer and its damaged rear impact guard

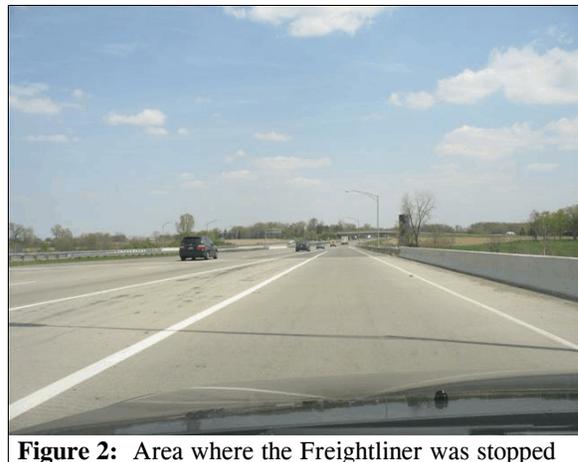
Figure 2: Area where the Freightliner was stopped

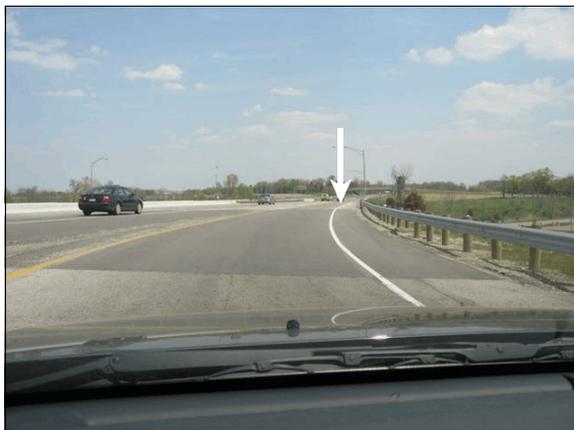
Figure 3: Approach of the Ford entering the entrance ramp lane; arrow shows area of impact

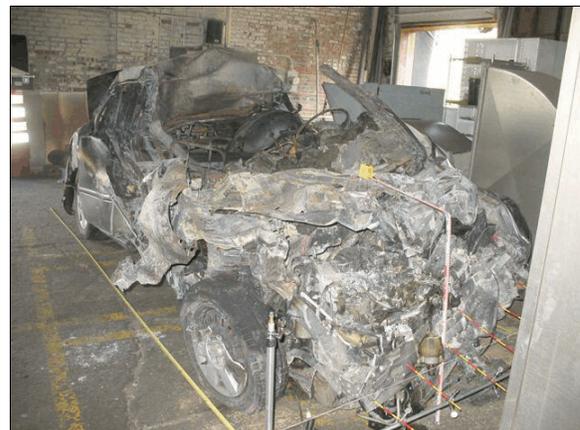
Crash: The front plane of the Ford (**Figure 4**) impacted the impact guard (event 1) and underrode the back of the semi-trailer (**Figure 5**). A fire ignited in the Ford's engine compartment (event 2). The impact guard engagement on the Ford began at the front left bumper corner. The direct contact on the impact guard began at the left corner and extended approximately 160 cm (62.9 in) to the right. The crash separated the impact guard from the semi-trailer. The Ford penetrated under the semi-trailer and contacted the mud flap bracket, air reservoir tank, slack adjusters, and back axle (**Figure 6**). The tandem wheels on the semi-trailer were adjusted forward. The distances from the back of the semi-trailer to the back tires and back axle were 222 cm (87 in) and 271 cm (106.7 in), respectively. The A-pillars and roof of the Ford engaged the back of the semi-trailer, and the roof was crushed rearward 77 cm (30.3 in). Both vehicles came to final rest in the entrance ramp merge lane heading east.

Figure 4: Damage on the Ford from underriding the semi-trailer and from the fire

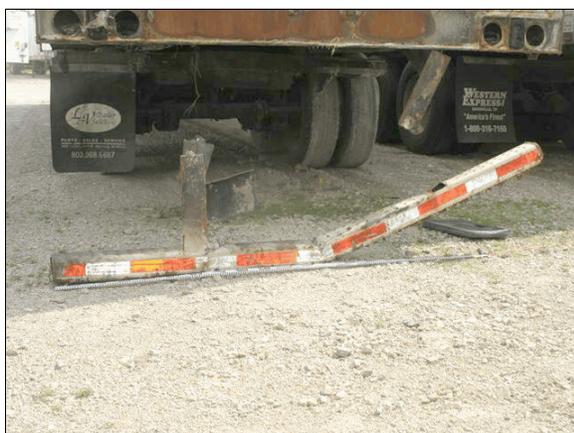
Figure 5: The back of the semi-trailer and damaged impact guard

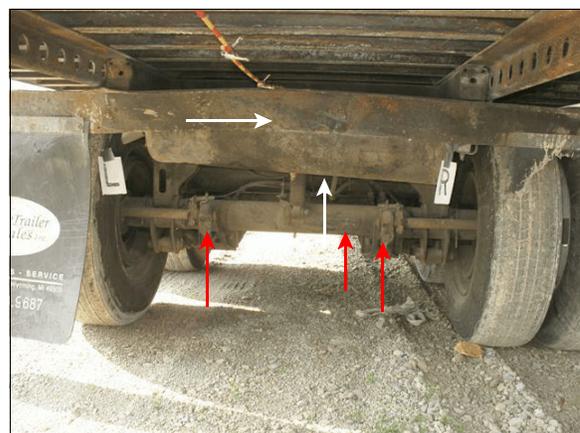
Figure 6: The Ford contacted the mud flap bracket, air reservoir tank, slack adjusters, and the axle

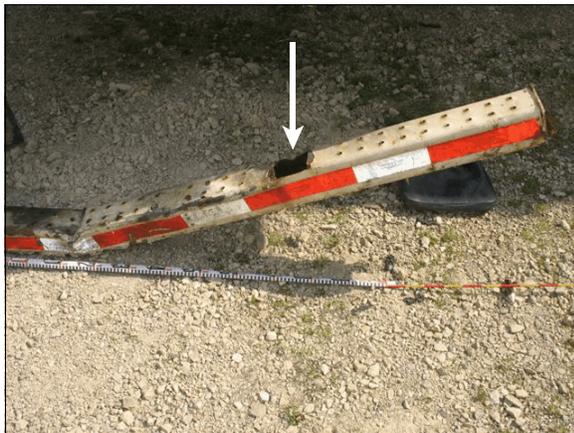
One identification placard was found on the impact guard but the fire had rendered it unreadable. The impact guard's right vertical support broke at the weld on the horizontal member of the impact guard (**Figures 7 and 8**). The left vertical support broke at the frame rail on the semi-trailer (**Figures 9 and 10**). The schematic on the following page presents the post-crash measurements of the semi-trailer and impact guard.

Figure 7: The right vertical support broke at the weld on the impact guard

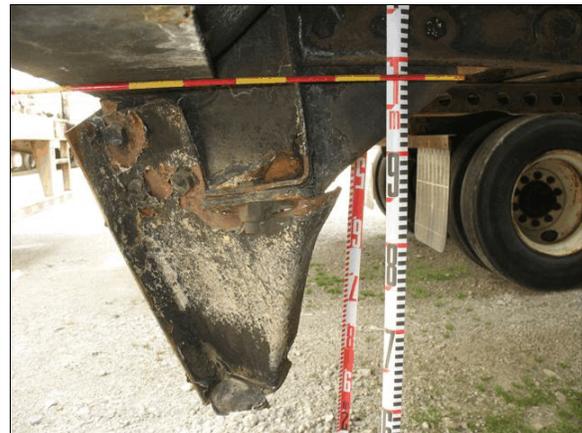
Figure 8: Right side view of the right vertical support for the impact guard on the semi-trailer

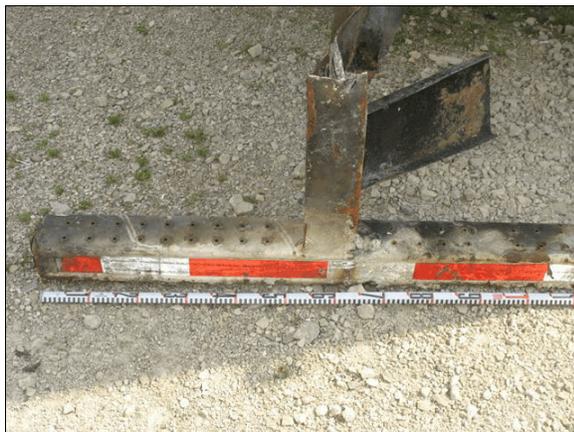
Figure 9: The broken left vertical support on the impact guard

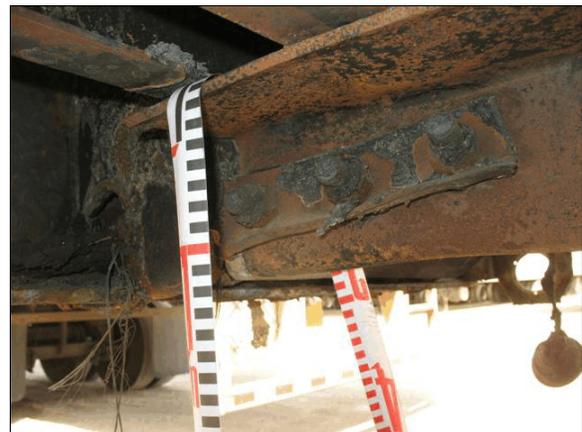
Figure 10: The broken impact guard vertical support bracket on the left frame rail of the semi-trailer

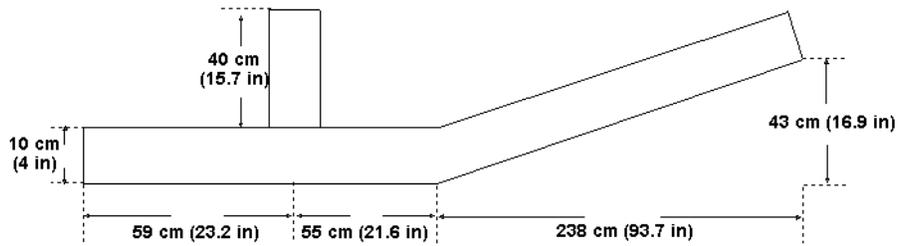
Back View of Damaged Rear Impact Guard

Length of horizontal member as measured along damage contour was 246.4 cm (97 in)

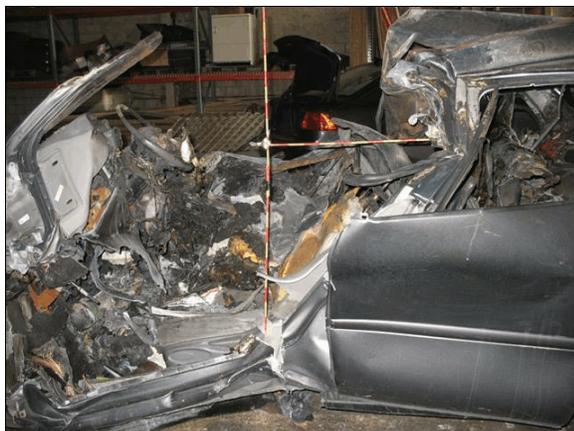
Exterior Damage: The Ford sustained damage on the front plane that extended to the A-pillars and roof. The direct damage involved the front bumper, grille, both headlamp/turn signal assemblies, hood, windshield, both A-pillars, roof and both B-pillars. The direct damage began at the front left bumper corner and extended 124 cm (48.8 in) across the bumper. The A-pillars and roof engaged the back of the semi-trailer and the roof was crushed rearward 77 cm (30.3 in, **Figure 11**). The B-pillars also engaged the back of the semi-trailer and the left B-pillar was crushed rearward 33 cm (13 in), while the right B-pillar was crushed 30 cm (11.8 in). A front crush profile was taken at the bumper level and the maximum residual crush was 56 cm (22 in) occurring at C₂ (**Figure 12**). The table below presents the front crush profile.

Figure 11: Left side view of the roof and A-pillar crush on the Ford

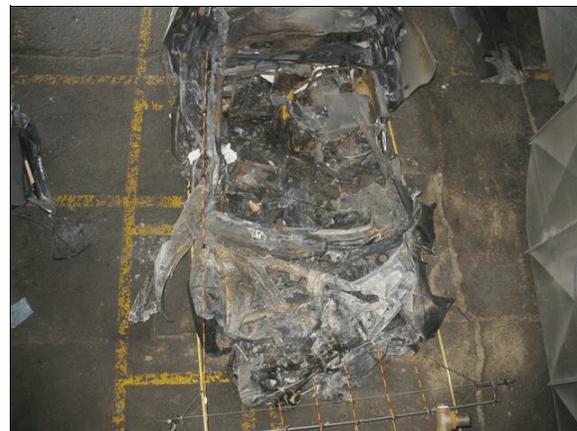
Figure 12: Top view of the crush on the Ford
