# INDIANA UNIVERSITY

## TRANSPORTATION RESEARCH CENTER

## ON-SITE CHILD RESTRAINT SYSTEM INVESTIGATION

CASE NUMBER - IN10016  
LOCATION - ALABAMA  
VEHICLE - 1995 PONTIAC GRAND AM GT  
CRASH DATE - May 2010

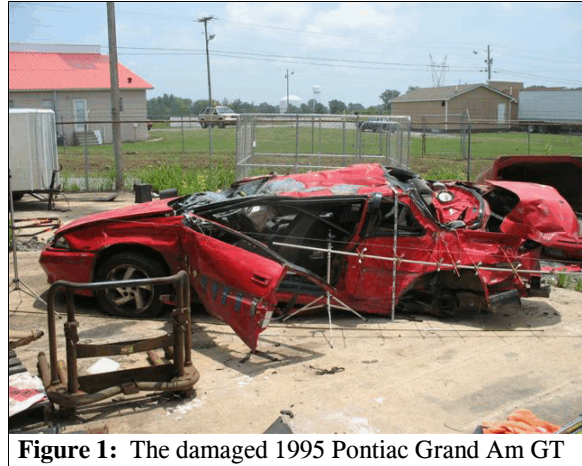
**Figure 1:** The damaged 1995 Pontiac Grand Am GT

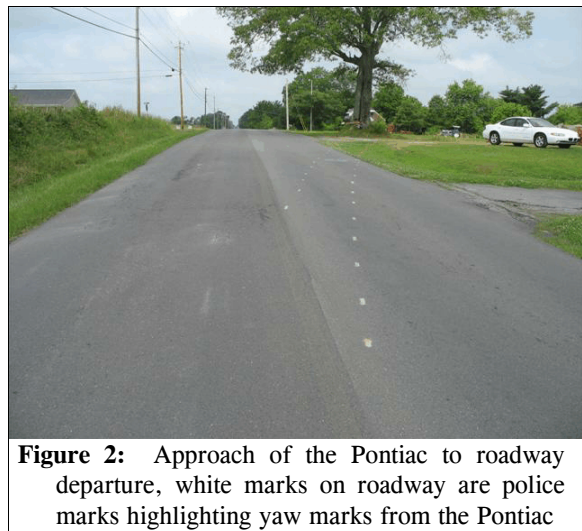
**Figure 2:** Approach of the Pontiac to roadway departure, white marks on roadway are police marks highlighting yaw marks from the Pontiac

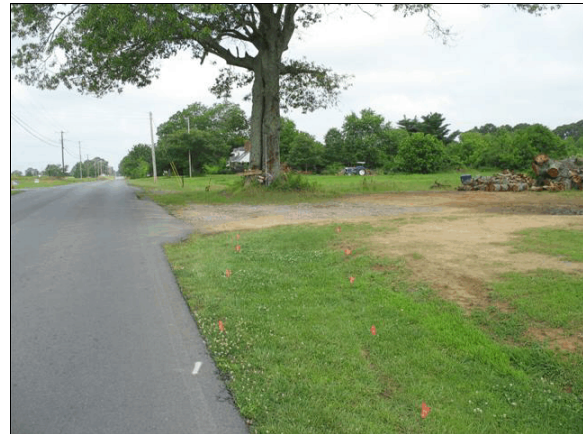
**Figure 3:** Approach to impact with the tree; orange flags show yaw marks in the grass; yaw mark on left is left rear tire; yaw mark on right is left front tire

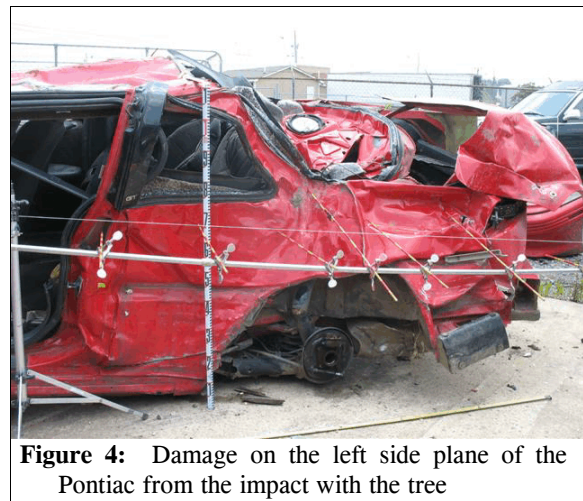
**Crash:** The vehicle was airborne a distance of 14 m (46 ft) when the left side plane (**Figure 4**) impacted a 104 cm (41 in) diameter tree (**Figure 5**, event 1). The vehicle rotated counterclockwise off the tree and rolled over (event 2) with the right side leading 6 quarter turns. The driver's door came open during the rollover and the unrestrained driver was ejected. The driver's frontal air bag deployed during the crash. The Pontiac came to final rest on its top heading west 22 m (72.2 ft) northwest of the impacted tree.

**Figure 4:** Damage on the left side plane of the Pontiac from the impact with the tree

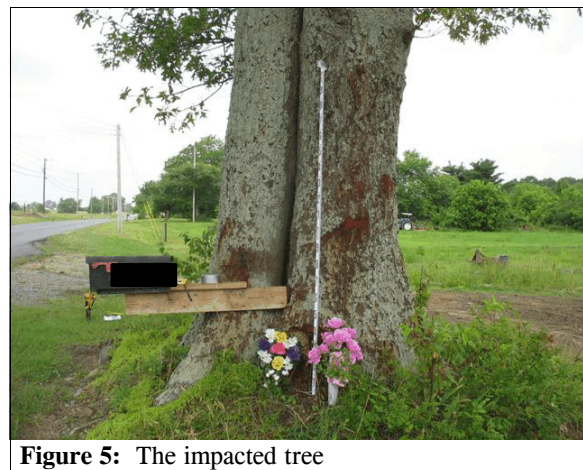
**Figure 5:** The impacted tree

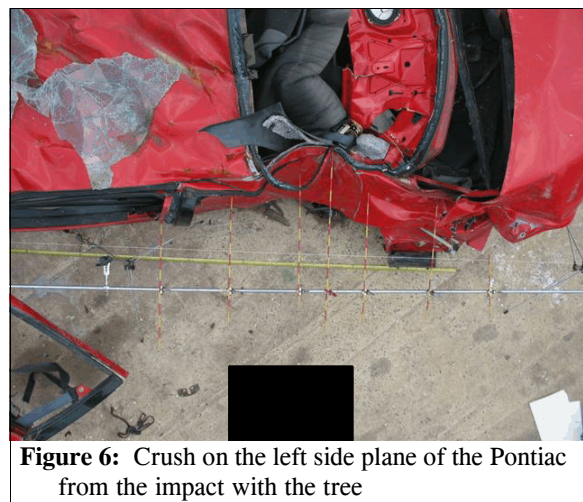
**Exterior Damage Event 1:** The vehicle sustained direct damage on the rear edge of the left front door, quarter panel, B- and C-pillars, trunk lid, and left rear wheel during the impact with the tree. The left rear axle was broken and the wheel was separated from the axle. The direct damage began 131 cm (51.6 in) rear of the left front axle and extended rearward 155 cm (61 in). The crush measurements were taken at the upper-door level and the maximum residual crush was 35 cm (13.8 in), occurring 16 cm (6.3 in) to the left of C<sub>3</sub> (Figure 6). The left side wheelbase was extended 10 cm (5 in), while the right side wheelbase was extended 5 cm (2 in). The quarter panel, trunk lid, and roof sustained indirect damage. The table below presents the left side plane crush profile.

**Figure 6:** Crush on the left side plane of the Pontiac from the impact with the tree

**Damage Classification Event 1:** The Collision Deformation Classification was 00LZAW3 for the tree impact. A non-horizontal principal direction of force was assigned since the vehicle was airborne when it impacted the tree. The WinSMASH program could not be used since non-

horizontal impacts are out of scope for the program. Based on the extent of the crush on the left side plane, the severity of the damage was moderate.

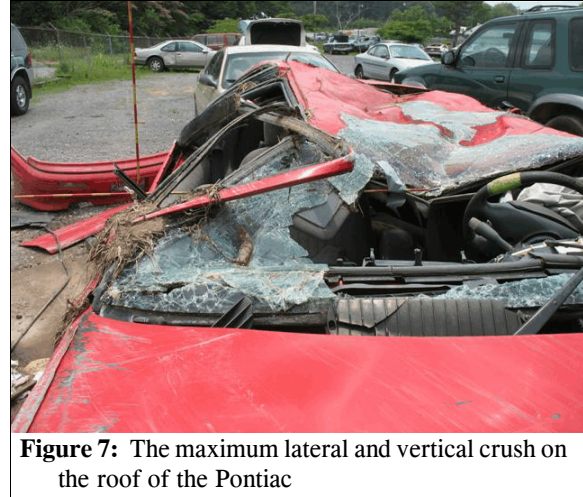
**Figure 7:** The maximum lateral and vertical crush on the roof of the Pontiac

on the hood and the right portion of the roof. The direct damage on the right side plane began at the front of the fender, 76 cm forward of the right front axle, and extended 290 cm (114 in) rearward along the right side. The maximum residual vertical crush (**Figure 7**) was 43 cm (16.9 in) and occurred at the center left windshield header, 103 cm (40.6 in) rear of the right front axle. The maximum lateral crush (**Figure 7**) was 37 cm (14.6 in) and occurred at the top of the right A-pillar, 73 cm (28.7 in) rear of the right front axle.

**Damage Classification Event 2:** The CDC for the rollover (event 2) was 00TDDO5. The WinSMASH program could not be used since a rollover is out of scope for the program. Based on the extent of the crush on the roof, the severity of the damage from the rollover was severe.

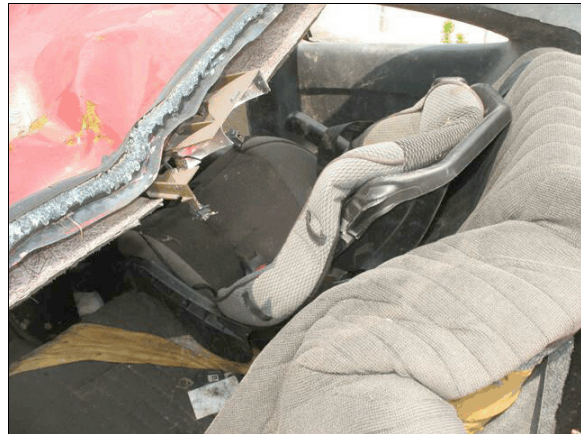
At the SCI inspection, the second row right passenger's CRS was found secured in the vehicle (**Figure 8**) by the lap-and-shoulder safety belt. The safety belt webbing was routed through the forward facing belt path on the back of the CRS and the belt was buckled. No locking clip was present and there was no evidence that one had been used on the safety belt. The belt webbing was not snug, which allowed approximately 10 cm (2 in) of lateral and 5 cm (1 in) of longitudinal movement of the CRS on the seat.

**Figure 8:** The CRS was found secured in the second row right seating position of the Pontiac at the SCI inspection

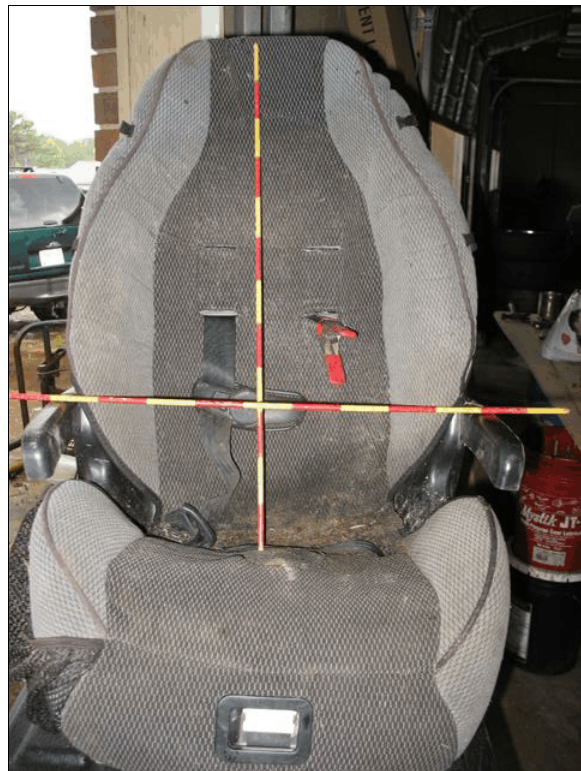
The Pontiac's second row right passenger [23-month-old female, 76 cm (30 in) and 16 kg (35 lbs)] was seated in a Cosco/Dorel High Back Booster CRS (**Figure 9**). There were no labels on the CRS that identified the date of manufacture or the model number. The CRS's weight and height restrictions when the 5-point harness was in use were 9-18 kg (20-40 lbs) and 86 cm-109 cm (34-43 in), respectively. A warning was molded into the plastic shell, which stated that the CRS should not be used after December 2009.

**Figure 9:** The Cosco/Dorel High Back Booster CRS

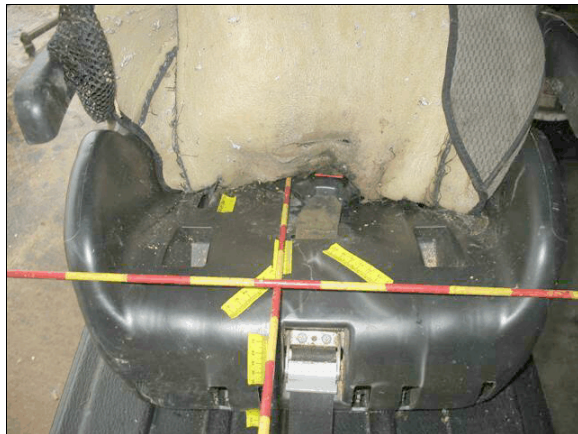
The inspection of the CRS revealed a crack 23 cm (9 in) in length on the bottom of the shell immediately to the right of the harness strap adjuster (**Figure 10**). Stress marks on the shell were also present near the crack. A crack 15 cm (5.9 in) in length was present on the left portion of the upper shell. There were corresponding stress marks, 28 cm (11 in) in length, that joined to the crack and curved up to the top right portion of the shell (**Figure 11**). Heavy abrasions were also present on the top left of the shell (**Figure 12**). The crack and curved stress marks

**Figure 10:** Yellow tape highlights crack and stress marks in shell of CRS

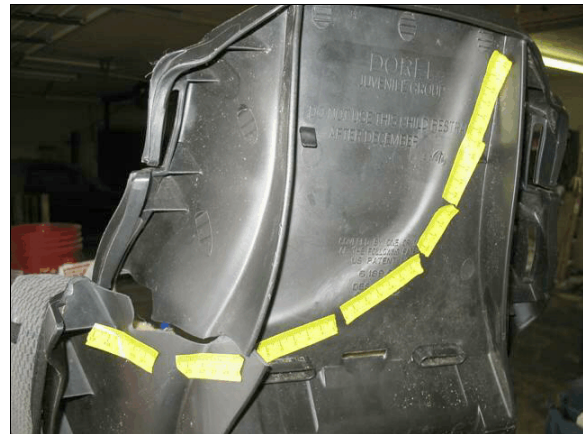
**Figure 11:** Crack and stress mark on upper left portion of the shell of the CRS

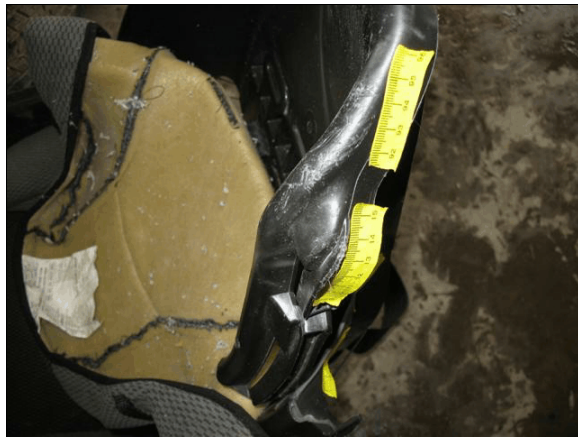
**Figure 12:** Abrasions on the top left portion of the shell of the CRS

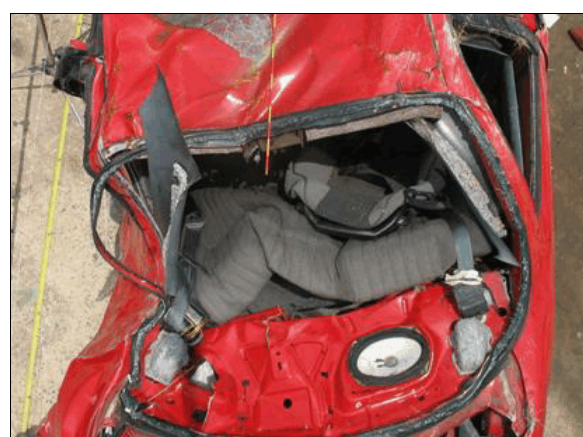
corresponded with the intruded shape of the second row seat back (**Figure 13**). The left harness strap had been cut at the crash scene.

**Figure 13:** CRS and deformed second row seat back of the Pontiac

The Pontiac’s left side impact with the tree displaced the child to the left within the CRS. The second row seat back was buckled by the impact and deformed the back of the CRS. There was no discernable evidence of occupant contact on the CRS. As the vehicle rolled over and the roof was crushed, the CRS and the child were redirected toward the roof. The deposits of body fluid on the roof above the child’s seating position indicated that the child contacted her head on the roof. The police crash report stated that the child sustained a severe head injury, which was caused by contact with the intruding roof during the rollover. The child was declared deceased at the crash scene.
