CALSPAN ON-SITE MOTORCOACH FIRE INVESTIGATION

SCI CASE NO.: CA10016

VEHICLE: 1995 MCI MODEL 102-DL3

INCIDENT DATE: APRIL 2010

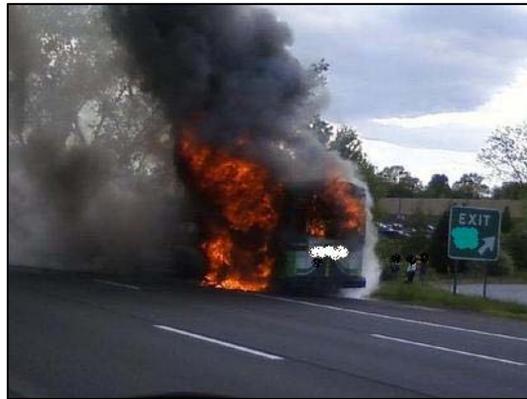
Figure 1. On-scene view of the motorcoach fire prior to the arrival of the fire department. (Image obtained from an Internet news site.)

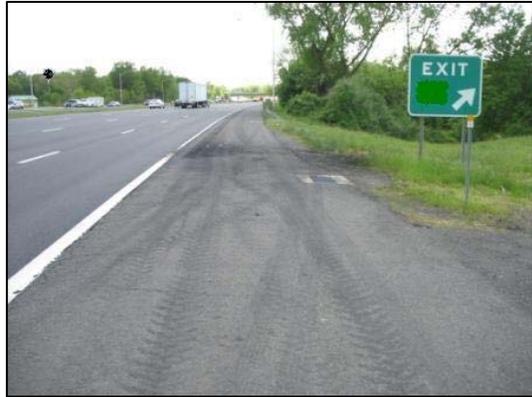
Figure 3. Area of the fire on the right shoulder of the interstate.

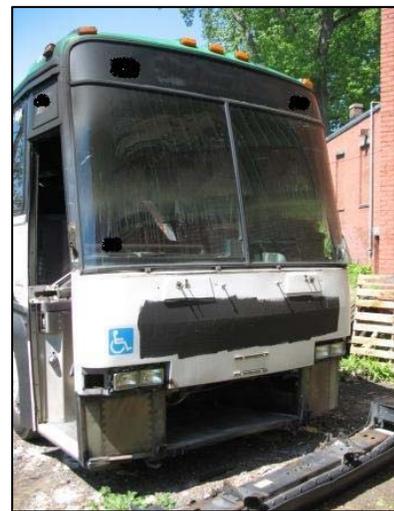
Fire damage to the front of the motorcoach was confined to components above the beltline. The left windshield glazing was fractured and cracked at the lower aspect with two large cracks that radiated upward approximately three-quarters of the height of the glazing from the lower left corner. The right windshield glazing was intact. Both windshield glazing panels were soot and smoke stained on the interior surfaces, with the heaviest evident at the upper aspects. The windshield header was intact on the exterior, but displayed similar smoke staining on its interior aspect as well.

The frontal exterior below the level of the beltline was not damaged by the fire. The windshield wipers and bumper system were removed from the motorcoach prior to inspection. The spare tire was new and was located behind the bumper system. The spare tire was not damaged by the fire. **Figure 4** is a frontal view of the motorcoach.

Figure 4. Frontal view of the motorcoach.

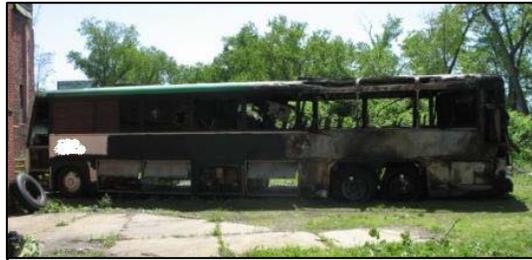
Figure 5. Left side view of the fire damage to the motorcoach.

began 170 cm (67 in) forward of the left drive axle. Progressing rearward from this point, the body panels and paint showed increasing heat damage, primarily blistering of the painted surfaces. High heat oxidation of the sheet metal body panels between the floor and the beltline was located 43-104 cm (17-41 in) forward of the left drive axle and were warped from the heat. The paint was burned off of the lower body panel forward of the left drive axle. The body paneling directly above the left drive and tag axle positions was heavily blackened from smoke and heat damage. There was an area of high heat oxidation 18-147 cm (7-58 in) aft of the tag axle with warping of the sheet metal. **Figure 5** is an overall view of the fire damage to the left side of the motorcoach.

The fire extended directly upward over the left rear axle positions into the three rear side glazing panels. Evidence of high heat was present on the left H- and I-pillars with the same evidence extending along the roof side rail from the G-pillar to the midpoint of the I- and J-pillar location.

The paint was burned off the lower body panel aft of the tag axle and the side access door to the engine compartment. The fiberglass corner panel at the left rear corner was melted, with damage extending full height to the roof area. The rubber splash shield over the rear axles was completely consumed by the fire.

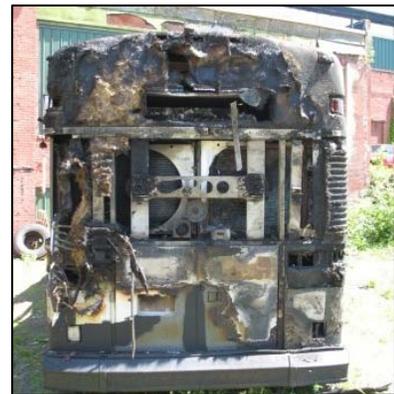
The fire damage to the back plane of the motorcoach was extensive (**Figure 6**). The rear bumper fascia was charred, but intact with no burn-through. The center closing sheet metal doors to the engine compartment were closed with areas of isolated heat blistering, smoke staining, and paint charring. High heat evidence was located on the upper aspect of the left and right doors. These doors could not be opened due to heat induced body distortion. The louvered fiberglass radiator fan shroud that was located above the engine compartment was fully consumed by the fire. The copper core dual radiators were intact. The left radiator was not damaged,

Figure 6. Fire damage to the back of the motorcoach.

although the right sustained core damage from water pressure by the firefighters during the extinguishment activities. Both cooling fans were melted and the fire consumed the

drive belt. The fiberglass enclosure above the radiators was burned full-thickness in the lower middle area, with melted fiberglass remnants at the side and upper aspects. The left taillight assembly was fully consumed by the fire. The right taillight was moderately melted, though the assembly itself remained in place.

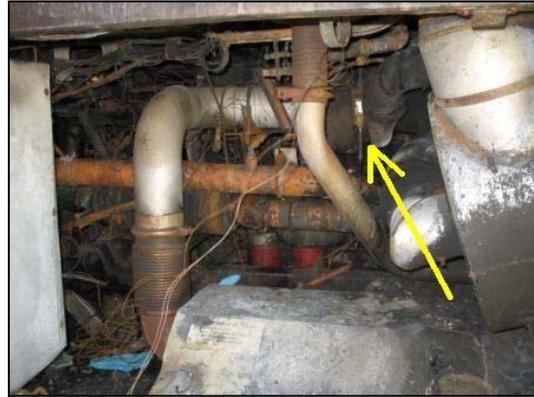
The SCI investigator could not access the engine compartment through the center closing rear doors. The painted surface of the doors was burned and the doors were jammed closed due to heat-related deformation of the door and surrounding structure. The engine compartment was viewed through the left side access door. This door provided access to the turbocharger and the exhaust system (**Figure 7**). The exhaust system and the turbocharger were intact. The turbocharger and the surrounding area did not display evidence of high heat commonly associated with fire origin. The cold air intake at the aft side of the left side mounted turbocharger was dislodged as the silicone connector burned from the intake tube. The fire spread rearward into the engine compartment and consumed the flammable insulation of the wiring and the rubber connectors for plumbing of coolant and air flow.

Figure 7. Left side of the engine compartment and the turbocharger (arrow).

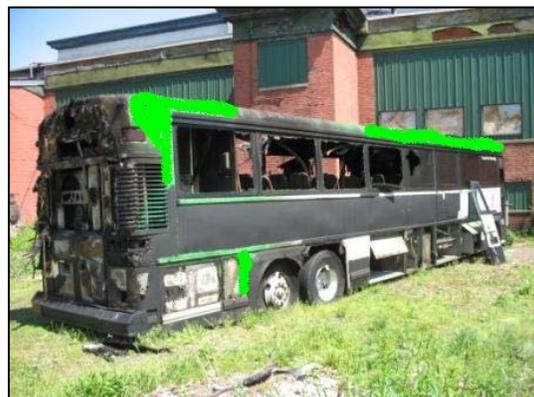
The right side of the motorcoach was burned to a lesser extent than the left side with the entire midsection between the floor and the beltline intact; inclusive of paint and body panels (**Figure 8**). The paint on the roof side rail at pillar locations G- through I- was smoke stained with minimal heat blistering. The paint on the lower rear compartment door, aft of the tag axle, was burned and blistered. The rear half of the rubber splash shield above the rear axles was intact with heat warp. The forward half of this shield was consumed by the fire. The remaining lower luggage compartment doors were removed pre-inspection and were not damaged. The batteries were undamaged and were salvaged from the motorcoach. The master switch was in the Off-position, and the battery equalizer was removed.

Figure 8. Right side fire damage to the motorcoach.

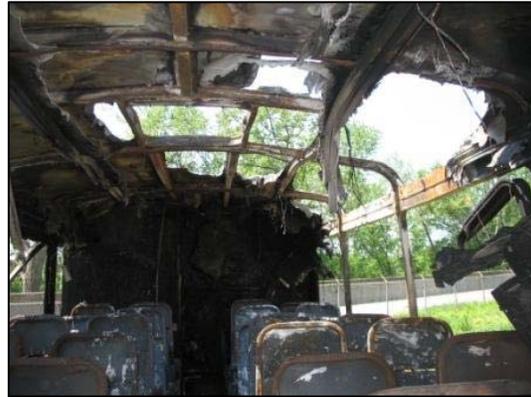
The roof of the motorcoach was constructed of a grid pattern of square stock tubing and surfaced on the outside with overlapping aluminum panels that spanned the pillar locations. The fire spread into the roof from the high fuel source of the left side drive and

tag axle tires. The roof was completely burned through at the left G- to I-pillar locations. The burn-through extended laterally from the side rail to the midline of the roof. The heat of the fire caused the roof structure to sag 5 cm (2 in) over left seating rows 9-11, at pillar locations G- to I. The right longitudinal roof rail was heat sagged approximately 3 cm (1.25 in) adjacent to the right G- to I- pillars. The right side of the roof and roof side rail was not involved and the forward aspect of the left roof (A- to F-pillars) was not involved. The fire spread forward through the interior overhead compartments and the headliner. **Figure 9** is a view of the fire and heat-related damage to the roof of the motorcoach.

Figure 9. Burn-through and sag of the roof and roof structure of the motorcoach.

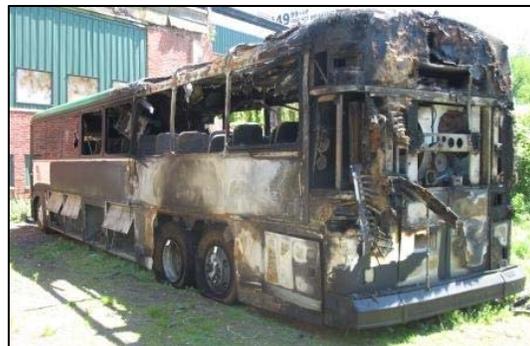
The firefighters used a pike pole to penetrate and remove the rear side glazing panels in an effort to ventilate the fire and gain access to the interior for water and fire suppression foam. The glazing panels between the left A- and B-pillars, adjacent to the driver's position, were removed by the motorcoach company post-event. The two forward glazing panels for the passenger compartment were intact with smoke and soot staining. The firefighters holed the third glazing panel located between the D- and E-pillars. This glazing panel remained in place with smoke and soot staining present on the inside surface. The last five glazing panels were completely removed from the motorcoach. Glass fragments remained in the aluminum framing at the E- to F, F- to G, and the I- to J-pillar locations. This was indicative of removal by the firefighters. The glazing panels and the aluminum frames over and aft of the drive and tag axle locations were presumably consumed by the fire as the fire was intense at this location prior to the arrival of the fire department.

Figure 10. Glazing damage to the left side of the motorcoach.

These glazing areas served as a portal for the fire to spread into the ceiling and roof area of the motorcoach. **Figure 10** is a view of the left side glazing damage.

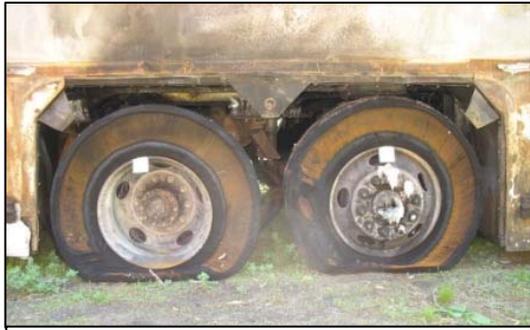
The left outer drive axle tire was heavily burned by the fire. The inner and outer sidewalls were burned full-thickness with the steel cords of the sidewalls fully exposed. The only remaining sidewall was located at the bottom of the tire at the 5-8 o'clock positions. The rim bead and shoulder area of the tread were burned but intact. The tire tread was burned smooth with the exception of the tire patch that remained intact with the ground.

The left tag axle tire was burned in a pattern similar to the outer drive axle tire. The sidewalls were burned full-thickness and the tread was burned smooth. The tire had rotated during the towing process. The bottom aspect of the tire that sustained the least amount of fire damage was rotated to the 6:30 - 9 o'clock position. The steel cord of the sidewall retained the shape of the tire. **Figure 11** is a view of the left drive and tag axle tire damage. **Figure 12** is a view of the remains of the left inner drive axle tire.

Figure 11. Fire damage to the left drive and tag axle tires.

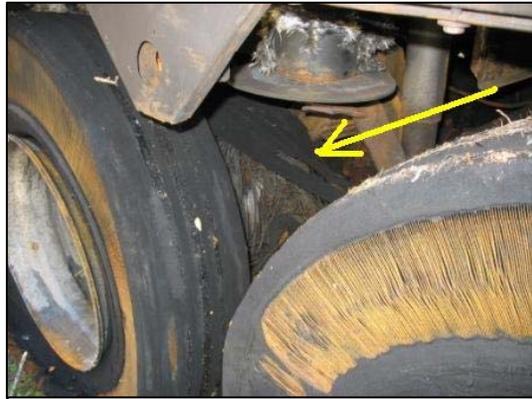
The inner drive axle tire was severely burned with fragments of the tread remaining, held only in place by the steel belts. The steel bead and the sidewall wires were entangled around the axle area. The upper tread and sidewalls of the tire were completely consumed. The bottom tire patch that remained intact was rotated to the upper position post-event.

Figure 12. Remains of the left inner drive axle tire (arrow).

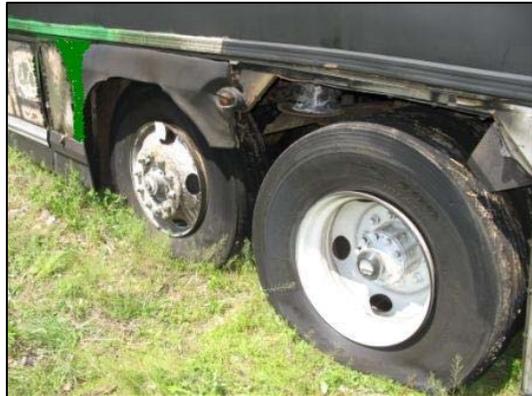
The sidewalls and the tread of the right outer drive axle tire were burned at the upper areas. The fire damage was minor; however, the tire was flat and de-beaded from the steel wheel. This tire rotated approximately 90 degrees clockwise (when viewed from right side) from its position at the time of the fire to its position at the time of the inspection.

The inner sidewall and tread surfaces of the right inner drive axle tire were burned from the 12-4 o'clock positions; indicative of tire rotation post-event. The burn pattern was superficial although the tire was flat and de-beaded at the time of the SCI inspection.

Figure 13. Right drive and tag axle tire damage.

The right tag axle tire was flat and de-beaded with the tread and inner sidewall burned. The outer sidewall was burned superficially at the upper half of the tire. **Figure 13** is a view of the right drive and tag axle tire damage.

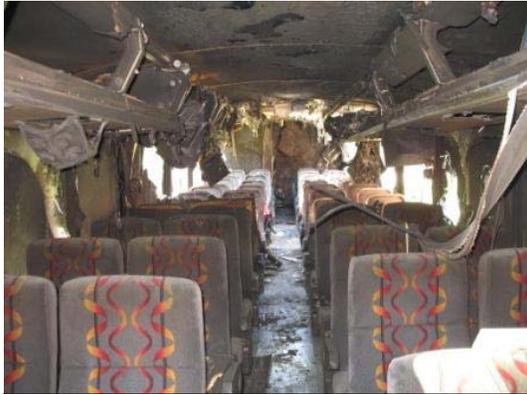
The fire spread into the ceiling and roof of the motorcoach. The interior and exterior panels were completely burned from left pillars G- to J, extending from the left roof side rail to right of the centerline at the rear roof emergency exit. The remaining interior ceiling was charred and blistered from the G-pillar forward. **Figures 14 and 15** are interior views looking rearward.

Figure 14. Interior view of the motorcoach looking front to back.

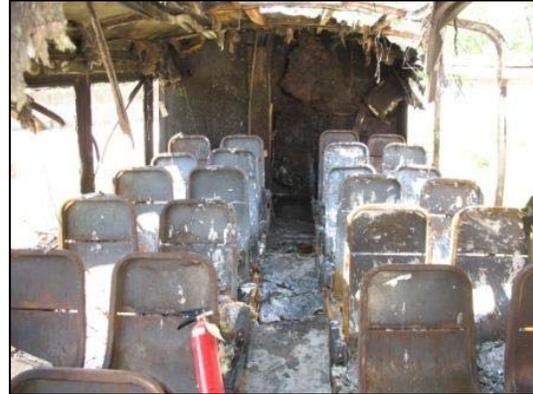
Figure 15. Interior view looking rearward from seating row 8.

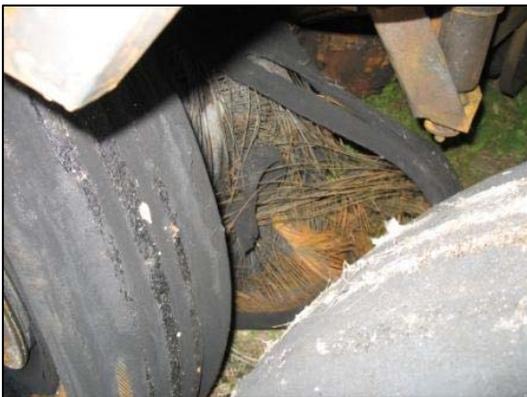
The origin for this motorcoach fire was at the left inboard drive axle tire position. Passengers onboard the motorcoach heard a loud bang followed by a popping sound. The initial sound was believed to be a blow-out of the inboard drive axle tire followed by a rotational sound caused by a possible tread or sidewall flap. The driver continued to travel on the interstate at highway speeds with the aired out tire. This travel on the dry asphalt road surface generated frictional heat buildup within the tire from the wheel rotating against the bead of the tire, the tread and sidewall possibly engaging the outboard tire sidewall, and the flat tire remaining in contact with the pavement surface. As a result, the tire self-combusted and the fire ensued. **Figure 16** is a view of the remains of the left inner drive axle tire.

Figure 16. Remains of the left inner drive axle tire.

Determination of Cause: In evaluating the left side drive axle, it is apparent that the largest amount of damage is to the inner tire which has been completely consumed with the steel cords wrapped around the wheel. The left outer drive tire and tag axle tire were also severely burned, but not to the extent of the inner drive tire. The wheel bearings in the hub and the foundation brake components at the wheel end were not inspected. The cause of this fire is consistent with an inner drive tire blow-out. However, the influence the brakes and bearing had on this blow-out could not be evaluated.

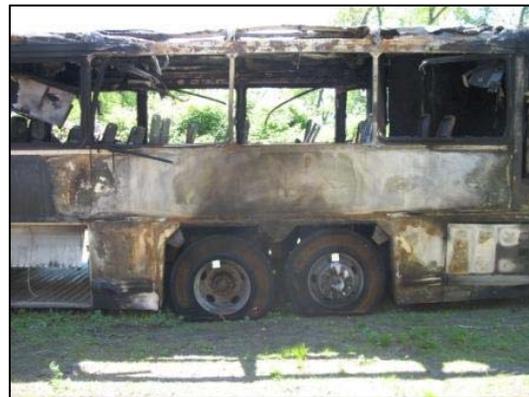
The tire became a significant source of fuel for the fire as it spread to the adjacent drive and tag axle tires. The fire continued to spread through the undercarriage and minimally involved the right side tires. The fire subsequently burned through the plywood floor over the rear axle positions and spread to the interior of the motorcoach through the left rear glazing and roof areas. The fire spread forward throughout the interior and burned through the roof of the motorcoach. The high heat burn pattern was vertically oriented over the left rear axle area, indicative of a left side origin in the axle area fueled by the tires (**Figure 17**). The fire damage resulted in a total loss of the motorcoach.

Figure 17. High heat damage above the left drive and tag axle locations.
