CALSPAN ON-SITE ROLLOVER CRASH INVESTIGATION

SCI CASE NO.: CA10021

VEHICLE: 1997 TOYOTA T100 PICKUP TRUCK

CRASH DATE: MAY 2010

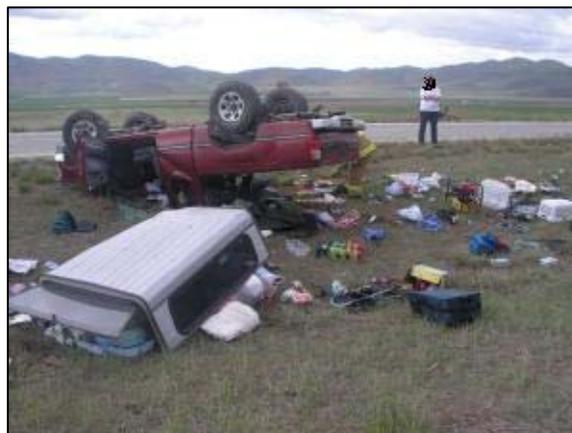
Figure 1: Overall view of the crash site and the final rest position of the Toyota. (Image obtained through an internet news site).

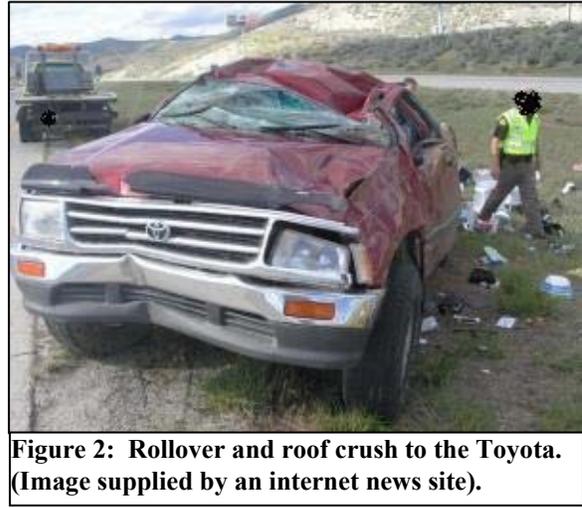
Figure 2: Rollover and roof crush to the Toyota. (Image supplied by an internet news site).

The laminated windshield was bonded to the Toyota and was fractured full height and width. The bond and laminate remained intact post-crash as evident in the on-scene image (**Figure 2 above**). At the time of the SCI inspection, the majority of the windshield glazing was sagged into the interior of the vehicle due to heat exposure of the plastic laminate. The left and right side glazing was disintegrated at the four outboard positions. The front door windows were closed pre-crash. This was determined by the position of the window tracks and fragments of tempered glass remaining in the window frames. The rear glazing panels were presumed to be closed pre-crash as these windows were wing-type with forward-mounted hinges. The backlight glazing was gasket-mounted and was disintegrated. The Toyota was not equipped with roof glazing.

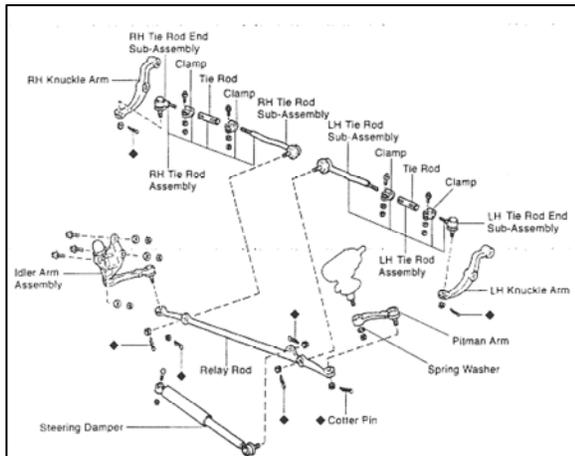
The Toyota's steering system (**Figure 3**) consisted of a recirculating ball system utilizing a cast iron steering box that was mounted to the left frame rail. A pitman arm connected to the left outboard aspect of the relay rod transferred steering inputs from the steering box to the relay rod (center link). An idler arm was mounted to the outboard end of the right frame rail. The inner tie rods were connected to the relay rod, inboard of the pitman arm and the idler arm. A hydraulic steering damper was connected to the inboard aspect of the left inner tie rod. The outer tie rods were mounted to the steering knuckle arms that were bolted to the spindle assemblies.

Figure 3: Mechanical illustration of the Toyota's steering system. Illustration supplied by ODI.

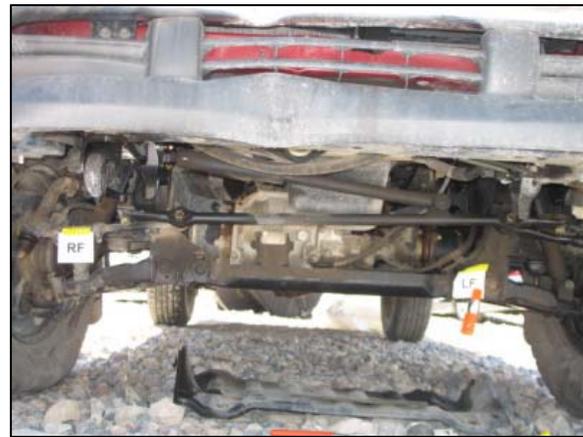
The undercarriage engine cover (skid plate/splash shield) was removed from the front undercarriage of the Toyota to facilitate a thorough inspection of the steering components. The SCI inspection of the steering system revealed that all linkage and associated components were intact and tight post-crash. There was no separation or looseness in the tie rods, pitman arm, idler arm or the relay rod. All rubber boots on the steering components were intact and free of damage (**Figure 4**).

There was slight deformation of the front suspension/steering system that resulted in a differential of the toe adjustment of the front tires. This damage was related to the rollover event and was not a pre-crash condition. With the steering wheel positioned in a near 12 o'clock position, the lateral distance between the outboard edges of the front tires at the forward position measured 172 cm (67.75 in) while the same measurement at the aft edge of the tires was 150 cm (59.25 in). The physical evidence at the crash site also indicated that the driver retained steering

Figure 4: Overall view of the Toyota's steering linkage.

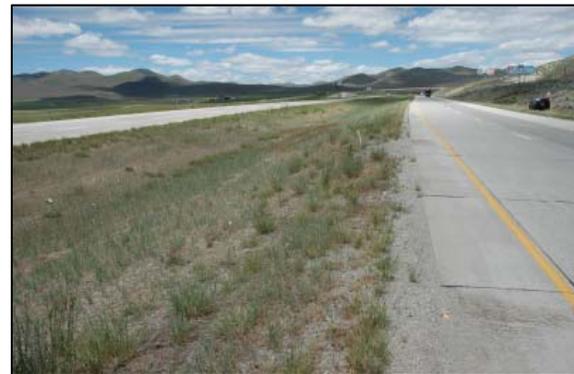
The driver was en-route to a destination in an adjacent state and was traveling in a northerly direction on the divided interstate in the 121 km/h (75 mph) speed zone. She was traveling with her three children who were restrained in CRS's secured in the rear seat of the Toyota. As the driver was exiting the right curve, the Toyota drifted to the left and departed the inboard shoulder of the grass median in a tracking attitude, **Figure 5**.

Figure 5: Northbound trajectory view of the Toyota in the area of the initial road departure.

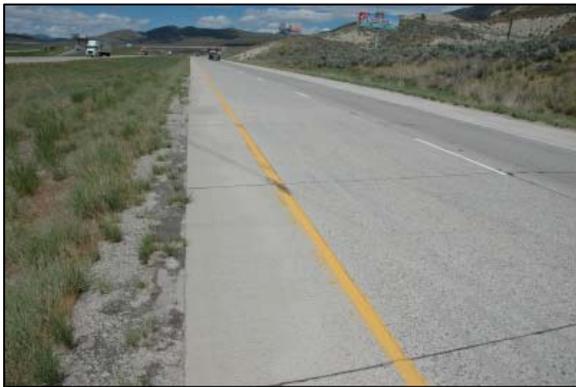
The Toyota subsequently departed the left inboard travel lane and shoulder in a CCW yaw (**Figure 6**). The Toyota had rotated approximately 35-40 degrees CCW as it reentered the median. The Toyota traveled approximately 15 m (50 ft) in a northerly direction in the median. The right side tires furrowed into the dirt surface and tripped the Toyota into a right side leading rollover. The initial contact involved the upper aspect of the right side of the vehicle's body. Contact evidence and crush damage was minimal. The Toyota continued to overturn and impacted the median surface with the left roof side rail area between the second and third-quarter turn. This contact resulted in the severe damage to the roof of the Toyota and separated the aluminum cap from the cargo bed.

Figure 6: Northbound trajectory view of the yaw trajectory of the Toyota at the second left roadside departure.

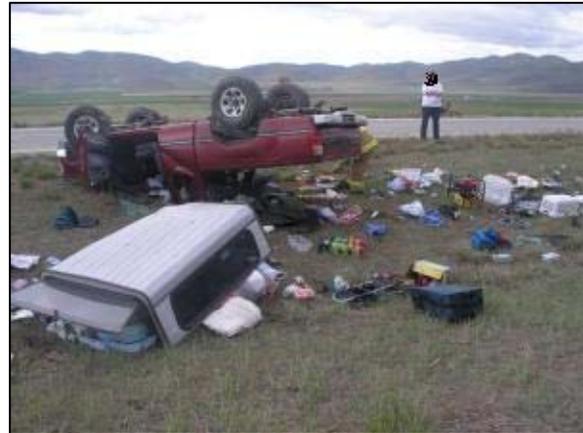
The Toyota rolled an additional four-quarter turns to the right through the median before coming to rest on its roof with the front of the vehicle adjacent to the inboard shoulder of the southbound travel lanes. The Toyota completed six-quarter turns and rolled a distance of approximately 15 m (50 ft) from the trip point to final rest. **Figure 7** is a view of the Toyota's final rest location.

Figure 7: Final rest position of the Toyota looking to the northwest. Image obtained through an Internet news site.

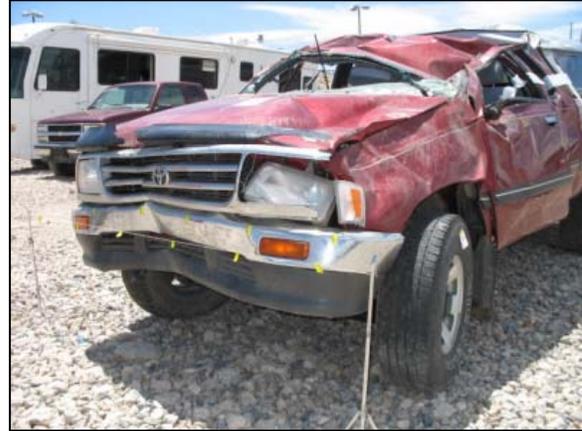
The delineator post impact (**Figure 8**) was located right of the Toyota's frontal centerline and was diagonally oriented, representative of the negative slope of the median. The direct contact damage on the chrome bumper face was located 13–18 cm (5-7.25 in) right of center and 18–23 cm (7-9 in) right of center of the hood face. The yielding object impact produced crush resulting in deformation to the full width of the bumper. The combined induced and direct contact damage was 172 cm (67.75 in) and extended from bumper corner to bumper corner. Maximum crush was 16 cm (6.2 in), located 14 cm (5.5 in) right of the centerline. The residual crush profile at bumper level was as follows: C1 = 0 cm, C2 = 1 cm (0.25 in), C3 = 7 cm (2.6 in), C4 = 11 cm (4.5 in), C5 = 3 cm (1.2 in), C6 = 2 cm (0.6 in). The Collision Deformation Classification (CDC) for this impact event was 12FCEN1.

Figure 8: Left front oblique view of the Toyota.

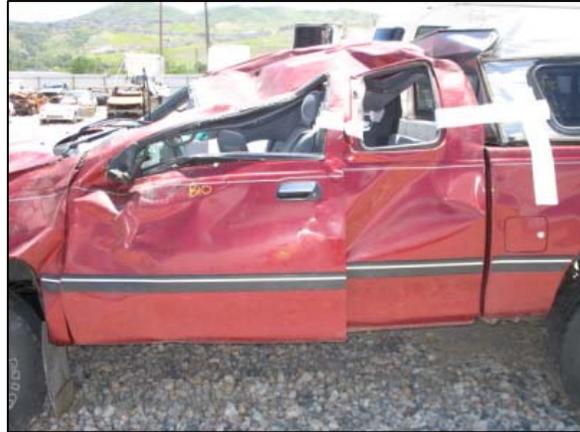
The greenhouse area of the Toyota sustained the majority of the damage from the rollover (**Figure 9**). The contact damage from the first and fifth-quarter turns was located at the right

upper C-pillar and the right roof side rail. The abrasion pattern to the roof was diagonally oriented front-to-back and left-to-right and involved the majority of the roof panel's surface. The third-quarter turn resulted in severe damage to the roof, the left side upper pillars, and the windshield header. The lateral right displacement of the left roof side rail and the vertical displacement of the windshield header buckled the roof over the driver's position. The maximum roof crush at this location was 57 cm (22.6 in). The maximum lateral roof crush measured 20 cm (7.75 in) and was located at the left roof side rail between the adjoining pillars.

Figure 9: Left view depicting the greenhouse deformation of the Toyota.

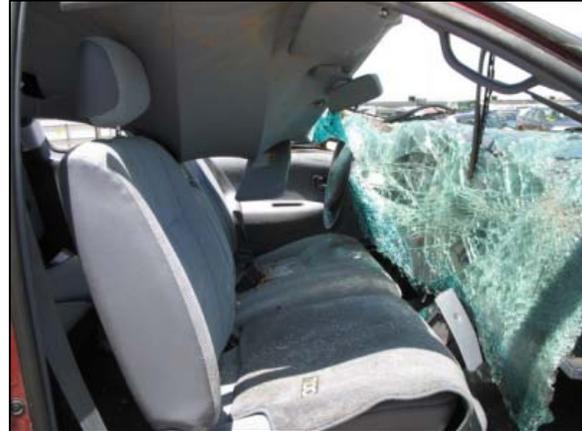
The maximum intrusion occurred at the driver’s position and involved 57 cm (22.6 in) of vertical displacement of the roof. The roof was crushed by the rollover; however, the magnitude of intrusion was amplified by the buckling that resulted from lateral displacement of the left roof side rail and adjacent pillars, and the vertical displacement of the windshield header. The interior view of the driver’s position (**Figure 10**) documents a greater extent of crush, showing the headliner intruding beyond the level of the driver’s seat back. The headliner remained buckled post-crash; therefore this headliner intrusion of 60.3 cm (23.75 in) was not structural. The headliner also buckled and intruded into the rear center position, with a non-structural intrusion value of 43 cm (17 in). At both documented headliner locations, the headliner could be pushed up against the intruding roof. The interior intrusions are documented by position, component, magnitude and direction in the following table:

Figure 10: Right interior view across the front seat depicting the roof/headliner intrusion.
