On-Site Rollover Investigation  
Dynamic Science, Inc. (DSI), Case Number DS10026  
2010 Scion xD  
California  
September 2010

14. Sponsoring Agency Code	
15. Supplemental Notes This on-site investigation focused on the rollover dynamics of a 2010 Scion xD involved in a vehicle-to-vehicle crash with a Toyota Prius and subsequent rollover, and the injuries sustained by the adult male driver of the Scion.

**Dynamic Science, Inc.**  
**Crash Investigation**  
**Case Number: DS10026**

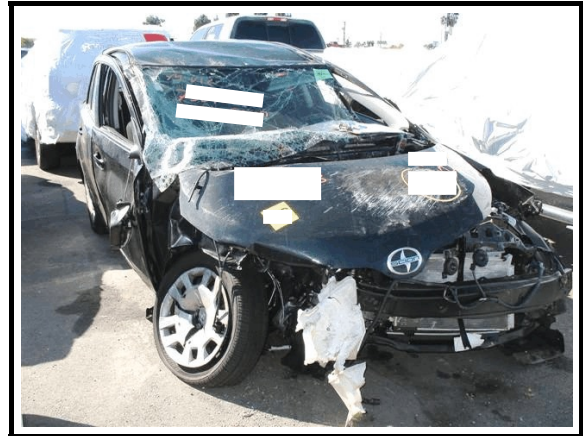
**Figure 1.** 2010 Scion xD

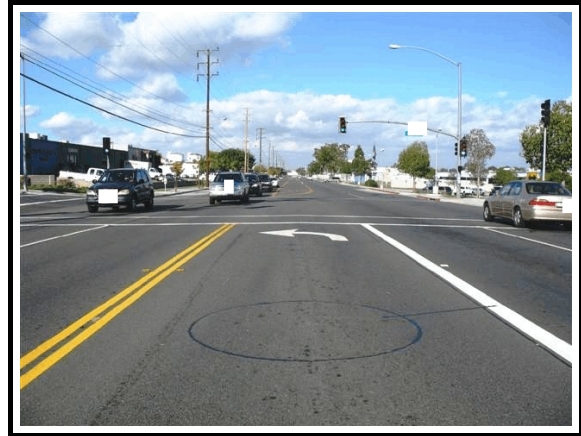
**Figure 2.** Crash site, looking north from left turn lane

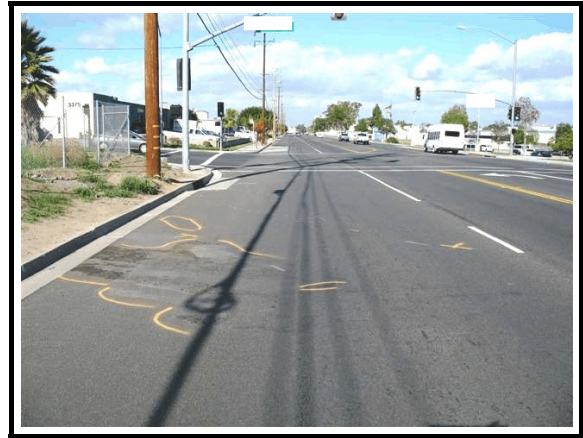
from the right. Following the impact, the Scion rotated counterclockwise and initiated a left side leading trip rollover (Event 2) and after rolling two quarter-turns came to rest on its roof in the first southbound lane from the right (**Figure 3**). Evidence of the trip included a fracture to the Scion's left front rim and scuff marks to the tire indicating contact with the roadway. A scrape mark on the roadway deposited by the Scion during the rollover measured 30.0 cm (12.0 in) in length and was located 20.7 m (69.9 ft) south of the area of the first impact. The roll distance was estimated to be 21.0 m (69.0 ft).

**Figure 3.** Look back from final rest to rollover and impact, 2010 Scion xD

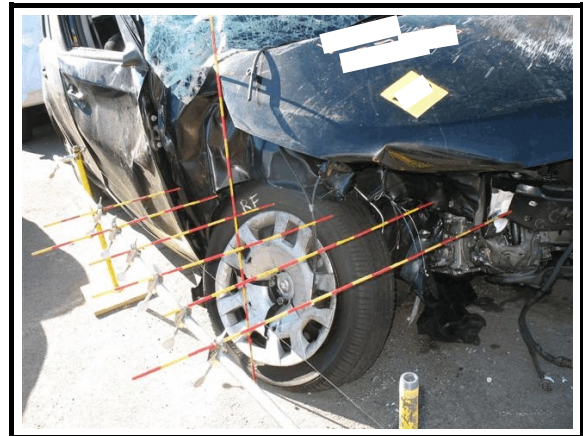
The Scion sustained direct and induced damage to the right side and induced damage to the front, left, and top planes during the vehicle-to-vehicle impact (Event 1). The front right rim was canted inboard, the front right tire was flattened, and the front bumper fascia and grille were displaced from the vehicle. The direct damage to the right side began at the right A-pillar, 207.0 cm (81.5 in) forward of the rear axle and extended 79.0 cm (31.1 in) forward to the right edge of the front bumper backing bar. The Field L also measured 79.0 cm (31.1 in). Six crush measurements were taken at lower-door level as follows:  $C_1 = 7.0$  cm (2.8 in),  $C_2 = 12.0$  cm (4.7 in),  $C_3 = 34.0$  cm (13.4 in),  $C_4 = 44.0$  cm (17.3 in),  $C_5 = 61.0$  cm (24.0 in),  $C_6 = 63.0$  cm (24.8 in) (**Figure 4**). Maximum crush was located at  $C_6$ . The Collision Deformation Classification (CDC) for Event 1 was 01RFEW4. Based on the CDC, the damage severity to the Scion in Event 1 was severe.

**Figure 4.** Right side crush measurement, 2010 Scion xD

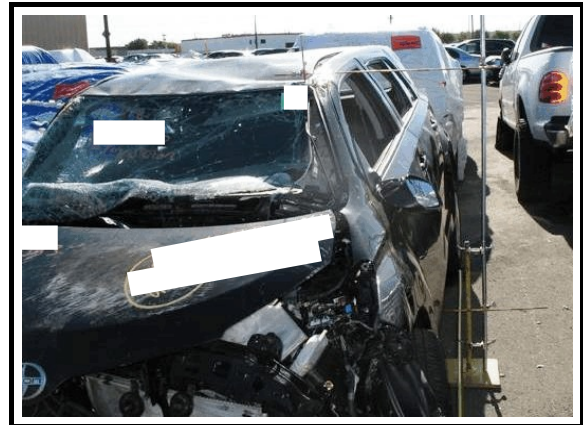
Maximum vertical crush to the greenhouse was located on the left windshield header at 5.0 cm (2.0 in) right of the left roof side rail and measured 9.0 cm (3.5 in) (**Figure 5**). Maximum lateral crush to the greenhouse was located on the left roof side rail at 160.0 cm (63.0 in) forward of the rear axle and measured 17.0 cm (6.7 in). The CDC for Event 2 was 00TDDO2.

**Figure 5.** Roof crush measurement, 2010 Scion xD

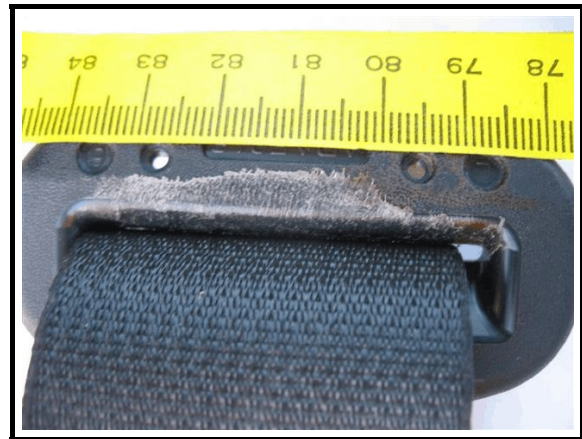
**Figure 6.** Driver's safety belt showing load marks, 2010 Scion xD

The driver's safety belt D-ring anchorage was set to the full-up position and the latch plate was scratched indicating historical usage. The vehicle's EDR report indicated the retractor pretensioner actuated during the crash at the time of the frontal air bag deployment. At the time of the vehicle inspection the retractor was functional and not locked. The D-ring, latch plate (**Figure 6**), and webbing showed scuff marks from occupant loading, and the stop button was displaced from the webbing at 55.0 cm (21.6 in) above the lower anchorage. Scuff marks and stretch marks on the webbing measuring 59.0 cm (23.2 in) in length began 50.0 cm (19.7 in) above the lower anchorage and extended upward,; a blood deposit measuring 14.0 cm (5.5 in) in length began 105.0 cm (41.3 in) above the lower anchorage and extended upward, and another scuff mark measuring 30.0 cm (11.8 in) began 159.0 cm (62.6 in) above the lower anchorage and extended upward to the D-ring. Based on the vehicle inspection, the front left safety belt was used to restrain the driver during the crash.

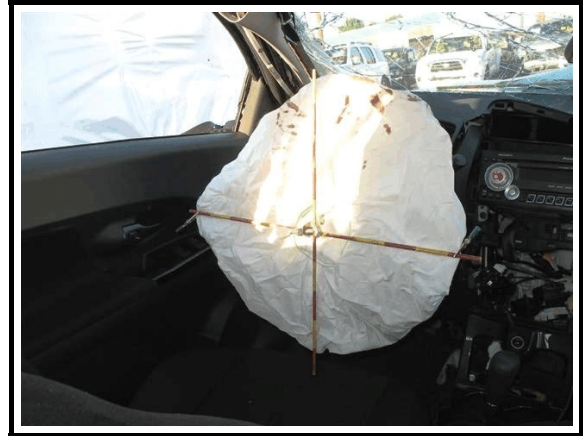
It was circular and measured 55.0 cm (21.7 in) in diameter in its post-inflated state. The air bag was configured with two internal tethers and two vent ports. It was not damaged but did show blood deposited by the driver in the lower quadrants (**Figure 7**).

**Figure 7.** Driver's deployed frontal air bag, 2010 Scion xD

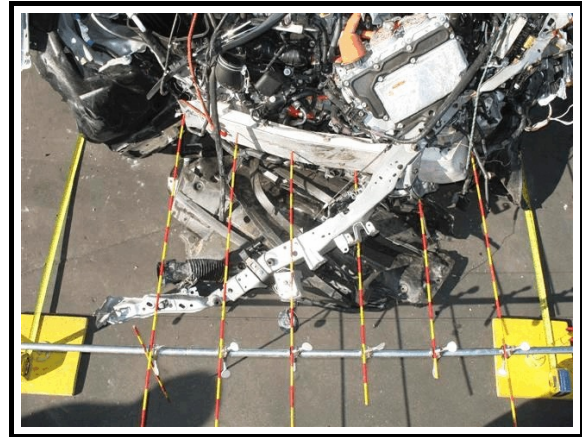
The Toyota sustained direct and induced damage to the front end and induced damage to the left, right, and top planes. The left front tire was displaced rearward by 21.0 cm (8.3 in) and was restricted. The right front tire was displaced rearward by 25.0 cm (9.8 in) and was restricted. The front bumper fascia and bumper backing bar were displaced from the vehicle. The direct damage to the front end was distributed from bumper corner to bumper corner and measured 156.0 cm (61.4 in). The Field L measured 90.0 cm (35.0 in). Six crush measurements were taken at bumper level (**Figure 8**) as follows:  $C_1 = 45.0$  cm (17.7 in),  $C_2 = 38.0$  cm (15.0 in),  $C_3 = 44.0$  cm (17.3 in),  $C_4 = 50.0$  cm (19.7 in),  $C_5 = 58.0$  cm (22.8 in),  $C_6 = 60.0$  cm (23.6 in). Maximum crush was located at C6. The CDC for Event 1 was 12FDEW4. Based on the CDC for the Toyota in Event 1, the damage severity was severe.

**Figure 8.** Front end crush measurement, 2010 Toyota Prius
