ON-SITE HYBRID VEHICLE INVESTIGATION

CASE NUMBER - IN10035

VEHICLE - 2002 TOYOTA PRIUS HYBRID

CRASH DATE - October 2010

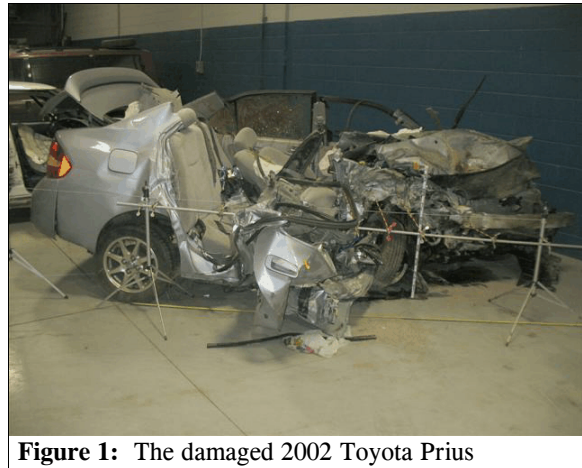
Figure 1: The damaged 2002 Toyota Prius

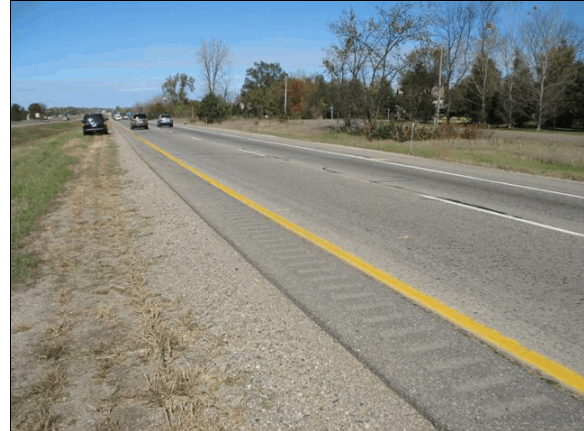
Figure 2: Northbound approach of the Toyota to the area of roadway departure into the median

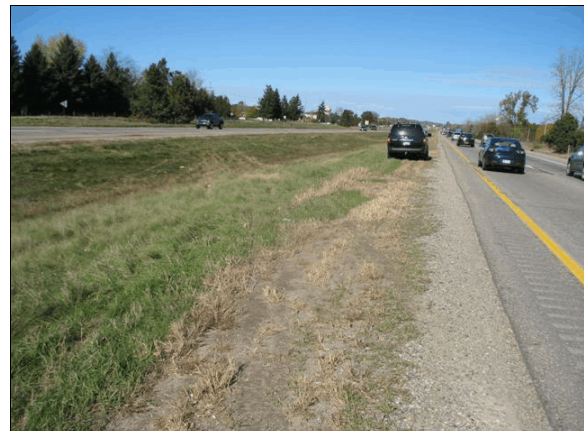
Figure 3: Path of travel of the Toyota northwest through the median to impact in the inside southbound lane

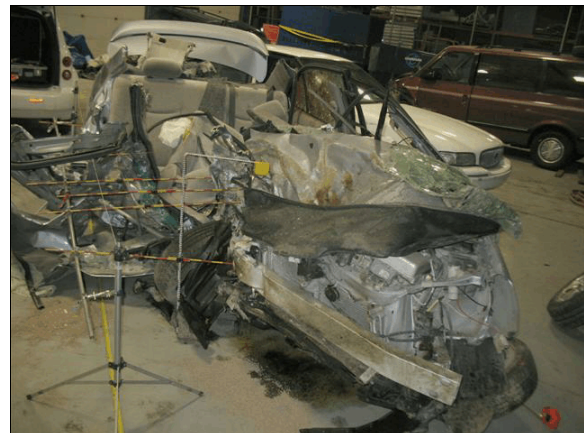
Figure 4: Damage on the front and right side planes of the Prius from the impact with the Chevrolet; crush measurement were documented on both front and side planes

Exterior Damage Event 1: The Toyota sustained front plane and right side plane damage during the impact with the Chevrolet. The front bumper, fender, and hood were directly damaged. The direct damage also extended onto the right side plane and involved the right A-pillar and right front door. The direct damage on the front plane began at the front right bumper corner and extended 55 cm (21.7 in) across the bumper. The maximum residual crush was 103 cm (40.6 in) and occurred at C₆. The direct damage on the right side began 227 cm (89.4 cm) forward of the rear axle and extended 184 cm (72.4 in) forward along the side of the vehicle. A second set of crush measurements was taken at the mid-door level to document the crush to the right side plane. The residual maximum crush was 79 cm (31.1 in) and occurred 20 cm (7.9 in) right of C₄. The Toyota's left side wheelbase was reduced 7 cm (2.8 in) and the right side wheelbase was reduced 92 cm (36 in). There was induced damage to the left fender, right rear door, right quarter panel, right rear wheel, and trunk lid. The table below presents the Toyota's front plane crush profile.

Damage Classification Event 1: The Collision Deformation Classification (CDC) for the Toyota's front impact was 12FZEW6 (10 degrees). The WinSMASH damage only algorithm calculated the total Delta V for this impact as 122 km/h (75.8 mph). The longitudinal and lateral velocity changes were -120 km/h (-74.6 mph) and -21 km/h (-13 mph), respectively. The results appeared high.

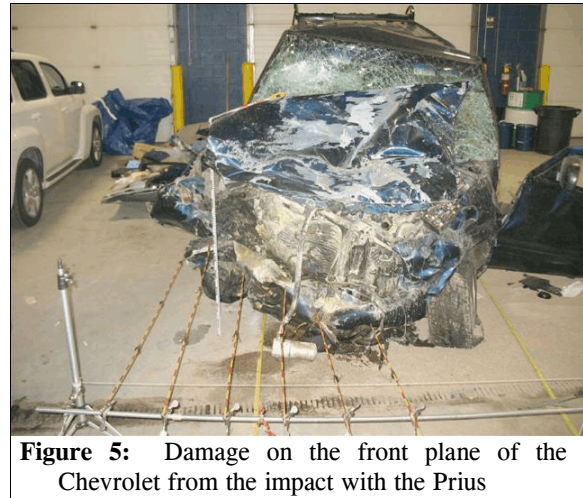
Figure 5: Damage on the front plane of the Chevrolet from the impact with the Prius

Exterior Damage: The Chevrolet sustained front plane damage from the impact with the Toyota. The front bumper, grille, hood, both fenders, and both headlamp/turn signal assemblies were directly damaged. The direct damage began at the front right bumper corner and involved the full front plane of the vehicle. The crush measurements were taken at the bumper level and the maximum residual crush was 156 cm (61.4 in) occurring at C₆. The table below presents the Chevrolet’s front crush profile.

Damage Classification: The CDC for the Chevrolet was 11FDEW6 (340 degrees). The Damage algorithm of the WinSMASH program calculated the Chevrolet’s total Delta-V as 88 km/h (54.7 mph). The longitudinal and lateral velocity changes were -83 km/h (-51.6 mph) and 30 km/h (18.6 mph), respectively. The results appeared high.

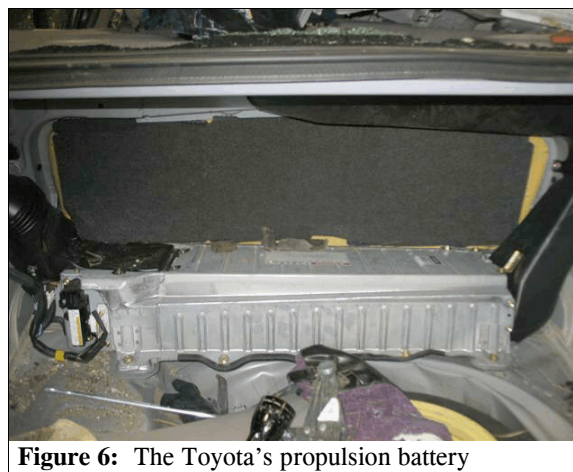
The Toyota's propulsion battery (**Figure 6**) was located in the back cargo area immediately rear of the second row seat. The battery pack consisted of 38, 7.2 volt NiMH modules connected in series in a water resistant stainless steel case. The battery cells contain an alkaline of potassium and sodium hydroxide, which is absorbed into the battery cell plates and will form a gel. The gel will not normally leak in the event of a crash³. Inspection of the propulsion battery revealed no evidence of movement or leakage. The mounting flange on the back of the battery (**Figure 7**) was slightly deformed due to the induced deformation of the floor of the trunk.

Figure 6: The Toyota's propulsion battery

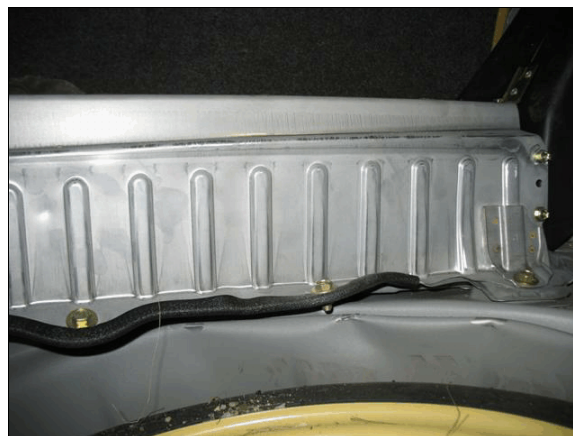
The battery was equipped with a high voltage service disconnect switch, which was located on the back left corner the battery. The switch was in the locked position. The high voltage wiring that was accessible for inspection was not damaged. There was no evidence of electrical arcing at the visible electrical connections on the battery. The voltage inverter and associated wiring and connectors could not be inspected since the hood was jammed shut from damage. An electrical isolation test was not conducted.

Figure 7: Minor deformation of the mounting flange on the back of the Toyota's propulsion battery

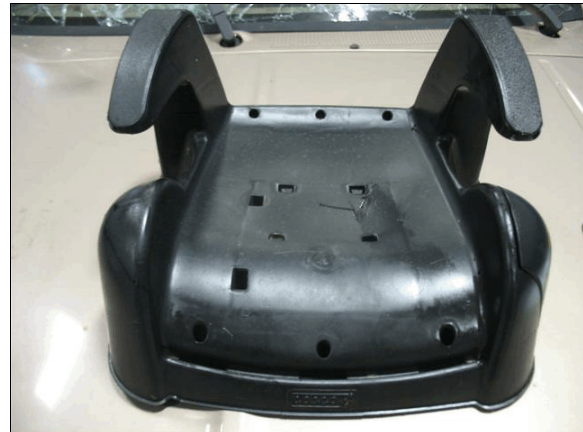
Figure 8: The Chevrolet's second row left passenger's CRS

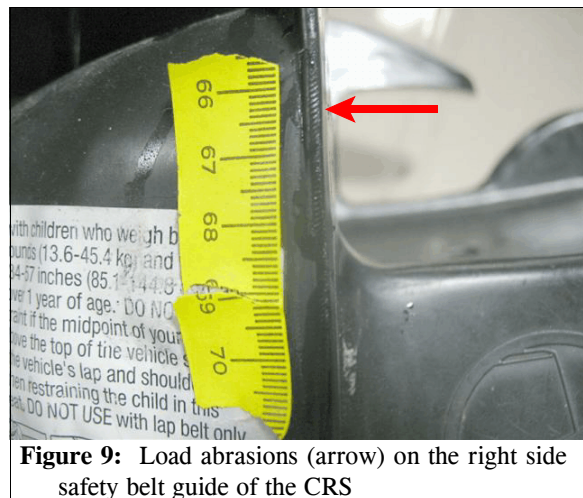
The CRS was constructed of plastic and had two fixed arm rests. The CRS typically has a padded cushion but no cushion was present at the time of the SCI inspection. Inspection of the CRS revealed no crash related damage. There were load abrasions from the safety belt on the edge of each belt guide (**Figure 9**).

Figure 9: Load abrasions (arrow) on the right side safety belt guide of the CRS
