ON-SITE OTHER INFLATABLE OCCUPANT PROTECTION INVESTIGATION

CASE NUMBER - IN10037

VEHICLE - 2009 TOYOTA PRIUS

CRASH DATE - July 2010

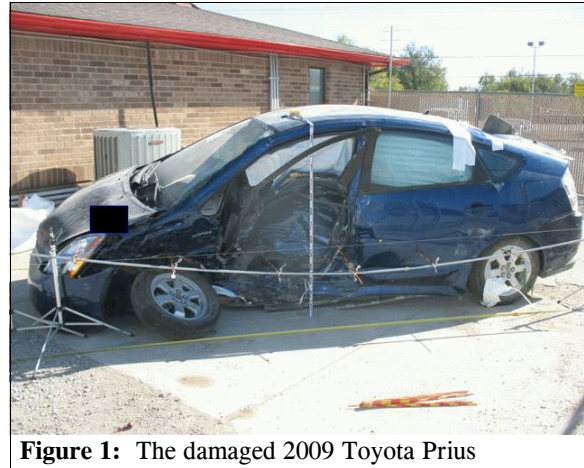
Figure 1: The damaged 2009 Toyota Prius

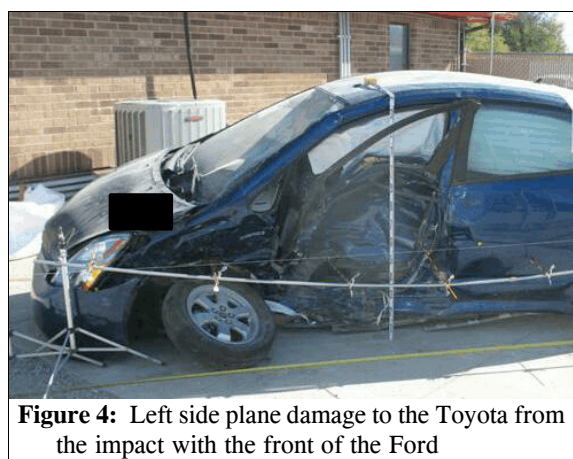
Crash: The left side plane of the Toyota (**Figure 4**) was impacted by the front plane of the Ford (event 1). The force direction on the Toyota was within the 9 o'clock sector and the impact force triggered deployment of the driver's seat-mounted side impact air bag and left Inflatable Curtain (IC) air bag. The impact caused the Toyota to rotate clockwise and the Ford to rotate counterclockwise. The left rear side of the Toyota was impacted by the right side of the Ford (event 2). The Toyota was redirected northwest and rotated clockwise as it separated from the Ford. The Toyota traversed approximately 64 m (210 ft) after impact and came to final rest heading northwest on the north roadside. The Ford departed the south side of the trafficway, into the median. It traversed approximately 19 m (63 ft) after impact and came to final rest heading southwest.

Figure 4: Left side plane damage to the Toyota from the impact with the front of the Ford

Exterior Damage Event 1: The Toyota sustained left side plane damage from the initial impact (event 1) with the Ford. The left fender, left side of the front bumper fascia, left front wheel, and left doors were directly damaged. The direct damage began at the front left bumper corner, 311 cm (122.4 in) forward of the left rear axle, and extended 203 cm (79.9 in) rearward along the left side plane. Since there was front door latch/striker separation, crush measurements were taken at the mid-door and sill levels and averaged based on the crush measurement protocol. The maximum residual crush was 67 cm (26.4 in) and occurred on the door at C₄ (Figure 5). The height of the sill and the maximum door crush was 24 cm (9.4 in) and 46 cm (18.1 in), respectively. The door sill differential was 16 cm (6.3 in). The Toyota’s left side wheelbase was reduced 23 cm (9.1 in) and the right side wheelbase was reduced 1 cm (0.4 in). There was induced damage to the hood, windshield, and roof. The table below presents the left side crush profile.

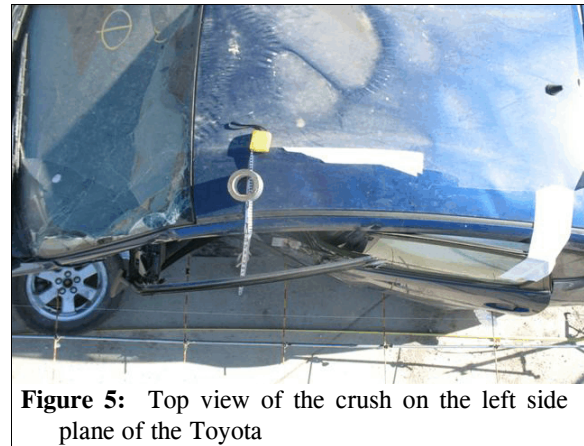
Figure 5: Top view of the crush on the left side plane of the Toyota

Damage Classification Event 1: The Collision Deformation Classification (CDC) for the Toyota’s left side impact with the Ford was 09LYEW4 (280 degrees). The WinSMASH missing vehicle algorithm calculated the total Delta V for this impact as 46 km/h (28.5 mph). The longitudinal and lateral velocity changes were -8 km/h (-5 mph) and 45 km/h (28 mph), respectively. Based on the damage to the Toyota, the results appeared reasonable.

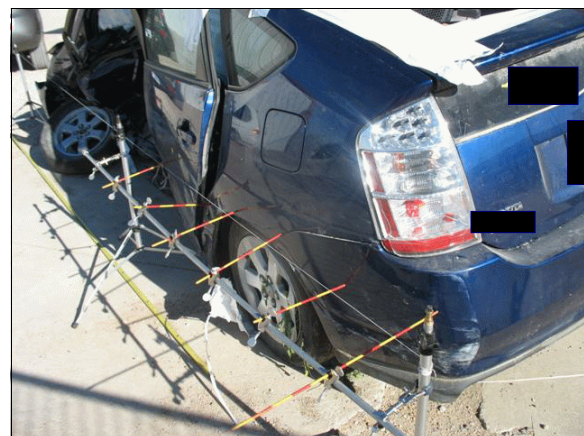
Exterior Damage Event 2: The Toyota sustained direct damage to the left rear door and left quarter panel during its secondary impact with the Ford. The direct damage began 60 cm (23.6 in) forward of the left rear axle and extended 130 cm (51.2 in) rearward along the left side plane. Crush measurements were taken at the mid door level and maximum crush was 1 cm (0.4 in) at C₅ (Figure 6). The table below presents the crush profile.

Figure 6 Secondary impact to left rear of Toyota

Damage Classification Event 2: The CDC for the Toyota's secondary impact was 09LZEW1 (270 degrees). The WinSMASH missing vehicle algorithm calculated the total Delta V for this impact as 5 km/h (3.1 mph). The longitudinal and lateral velocity changes were 0 km/h and 5 km/h (3.1 mph), respectively. The results appeared reasonable.

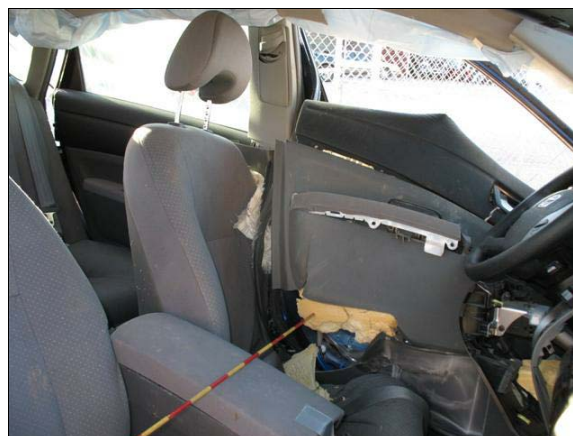
Figure 7 Intrusion of the Toyota's left front door

There were numerous intrusions to the passenger compartment. The most significant intrusion occurred at the left front door (**Figure 7**), which intruded laterally through the entirety of the left zone 52 cm (20.5 in), and 22 cm (8.7 in) into the middle zone. The lower A-pillar and side panel forward of the A-pillar intruded laterally 36 cm (14.2 in) and 40 cm (15.7 in), respectively.

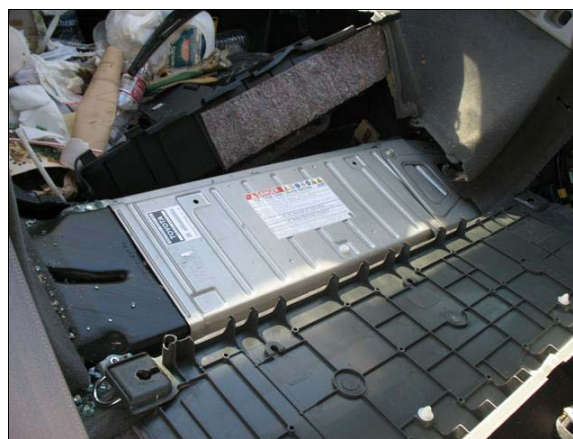
The Toyota's propulsion battery pack (**Figure 8**) was enclosed in a metal case and rigidly mounted to the cargo area floor pan cross member, immediately behind the second row seat. The battery pack consisted of 28, 7.2 volt NiMH modules connected in series in a water resistant stainless steel case. The battery cells contain an alkaline of potassium and sodium hydroxide, which is absorbed into the battery cell plates and will form a gel. The gel will not normally leak in the event of a crash¹. Inspection of the propulsion battery revealed no evidence of movement or leakage, nor any disturbance of any surrounding structures. The battery was equipped with a high voltage service disconnect switch, which was located on the back left corner the battery, but not accessible. An electrical isolation test was not conducted. There was no evidence of electrical arcing at the visible electrical connections near the battery (**Figure 9**).

Figure 8 The Toyota's propulsion battery pack

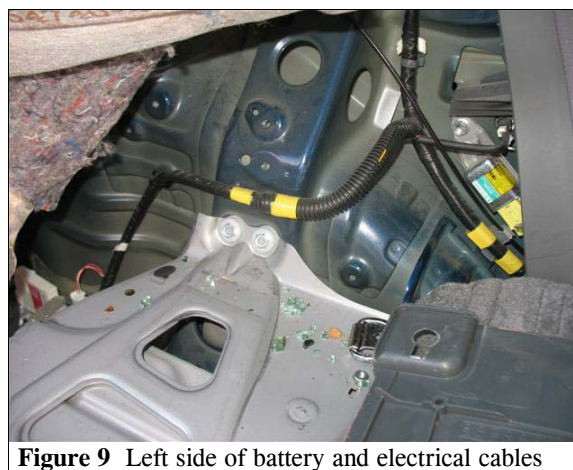
Figure 9 Left side of battery and electrical cables

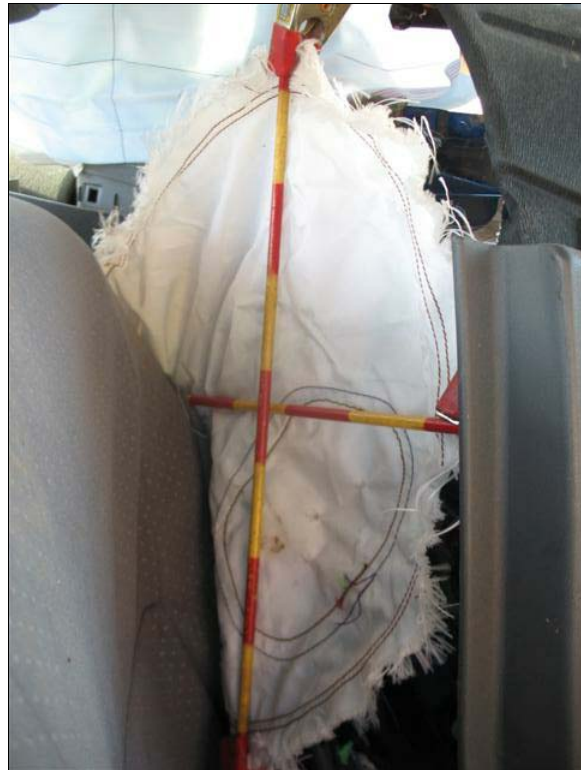
The Toyota's front seat-mounted side impact air bags were located within the outboard side of the seat back (**Figure 10**) and the driver's air bag deployed through a tear seam. The deployed air bag was oval and measured 22 cm (8.7 in) in width and 40 cm (15.7 in) in height. There were no vent ports and the air bag was sewn together at the lower forward portion. Inspection of the air bag revealed no discernable evidence of occupant contact and the air bag was not damaged.

Figure 10 The Toyota's driver's seat-mounted side impact air bag

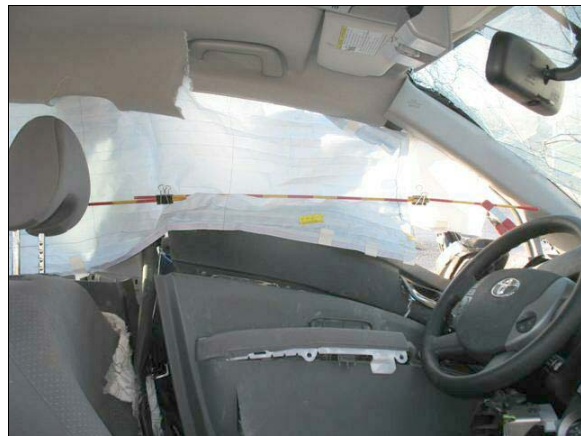
The Toyota's side impact IC air bags were located along the roof side rails inside the headliner, and extended from the top of the A-pillar to the C-pillar. The deployed left IC air bag (**Figures 11**) was 156 cm (61.4 in) in width and 39 cm (15.3 in) in height. The bottom edge of the IC extended 8 cm (3.1 in) below the belt line. The air bag was tethered to the A-pillar by a nylon sail panel 17 cm (6.7 in) in width. The air bag was designed with inflation chambers adjacent to the front and second row outboard seat positions. There was a possible blood stain on the lower front portion of the IC air bag. The IC air bag was not damaged.

Figure 11 Driver's IC air bag
