INDIANA UNIVERSITY

ON-SITE OFFICE OF DEFECTS INVESTIGATION SIDE AIR BAG NON-DEPLOYMENT INVESTIGATION

CASE NUMBER - IN10039
LOCATION - MISSISSIPPI
VEHICLE - 2010 HYUNDAI SONATA GLS
CRASH DATE - October 2010

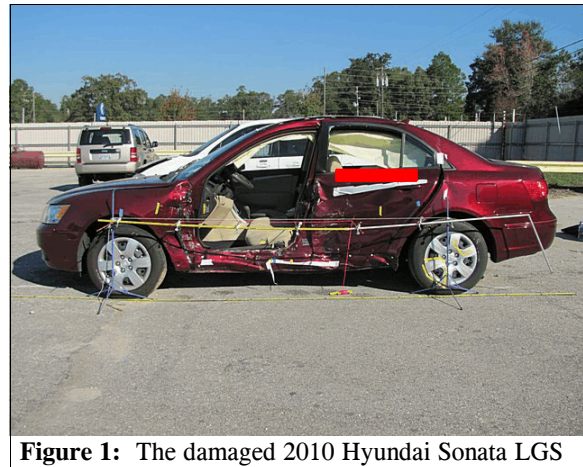
Figure 1: The damaged 2010 Hyundai Sonata LGS

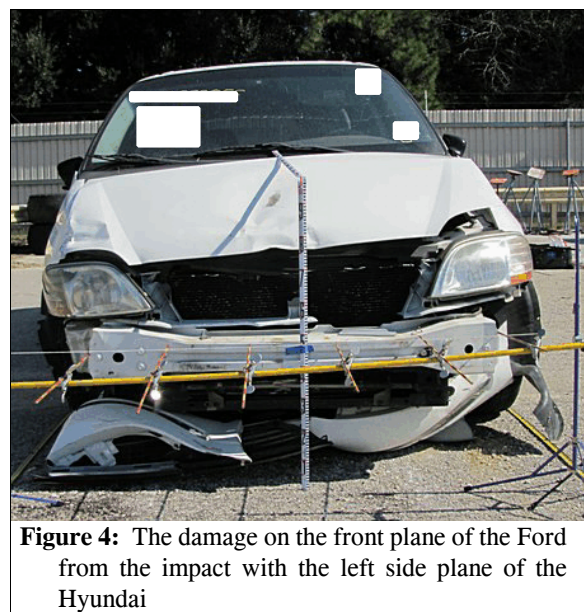
Figure 4: The damage on the front plane of the Ford from the impact with the left side plane of the Hyundai

Exterior Damage Event 1: The Ford sustained front plane damage during the initial impact with the Hyundai. The front bumper, hood, right fender, and right headlamp/turn signal assembly were directly damaged. The direct damage began at the right front bumper corner and extended 92 cm (36.2 in) across the bumper. The crush measurements were taken at the bumper level and the maximum residual crush was 2 cm (0.8 in) occurring at C₆. The right side wheelbase was reduced 1 cm (0.4 in), while the left side wheelbase was unchanged. The table below presents the front crush profile.

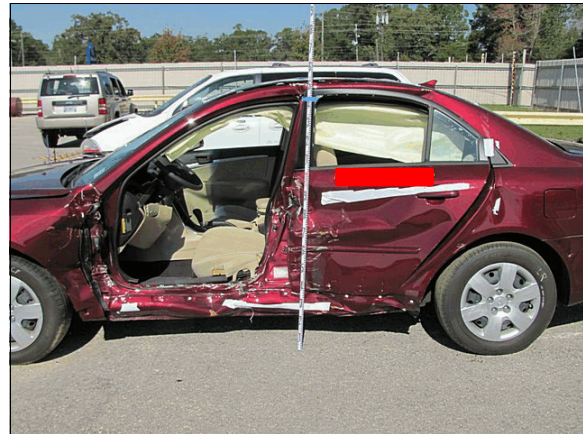
Figure 5: Damage on the left side plane of the Hyundai from the front plane impact by the Ford

Exterior Damage Event 1: The Hyundai sustained left side plane damage during the initial impact with the Ford. The left fender and both left side doors of the Hyundai sustained direct damage. The direct damage began 31 cm (12.2 in) rear of the left front axle and extended 186 cm (73.2 in) rearward on the left side. The crush measurements were taken at the mid-door level and the residual maximum crush was 35 cm (13.8 in) occurring at C₃ (**Figure 6**). The left front door had been removed from the vehicle and the crush measurements at C₃ and C₄ were estimated based on the crush to the A-pillar, B-pillar, and left rear door. The vehicle's sill height was 32 cm (12.6 in) and the height of the maximum crush was 60 cm (23.6 in). The door sill differential (DSD) was 9 cm (3.5 in). The vehicle's left side wheelbase was shortened 4 cm (1.6 in), while the right side wheelbase was unchanged. The induced damage involved the left fender, roof, and left quarter panel. The table below shows the left side crush profile.

Damage Classification Event 1: The Collision Deformation Classification (CDC) for the left side plane impact was 09LYEW3 (270 degrees). The Damage algorithm of the WinSMASH program calculated the Hyundai's total Delta V as 26 km/h (16.2 mph). The longitudinal and lateral velocity changes were 0.0 km/h and 26 km/h (16.2 mph), respectively. Based in the damage to both vehicles, the results appeared reasonable.

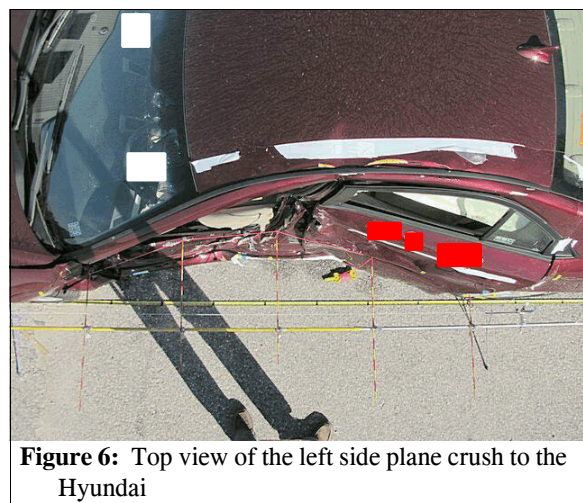
Figure 6: Top view of the left side plane crush to the Hyundai

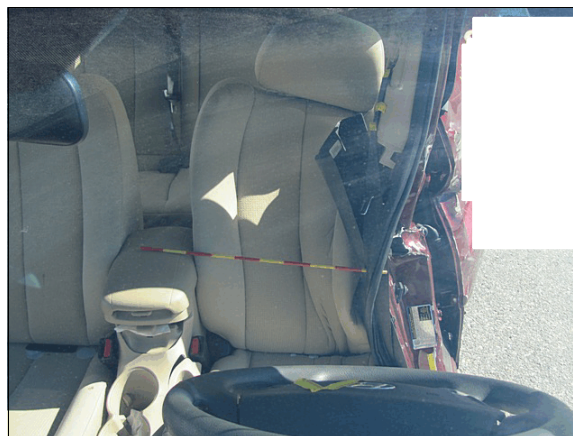
The passenger compartment sustained 11 intrusions. The most severe intrusions in the driver's seating area involved the B-pillar (**Figure 7**), the driver's seat back, and the left roof side rail, which intruded laterally 28 cm (11 in), 19 cm (7.5 in), and 10 cm (3.9 in), respectively. The left front door also intruded into the driver's space but the extent of intrusion is unknown. In the second row, the forward upper quadrant of the left rear door and the left roof side rail intruded laterally 15 cm (5.9 in) and 4 cm (1.6 in), respectively.

Figure 7: Intrusion of the Hyundai's left B-pillar into the driver's seating position

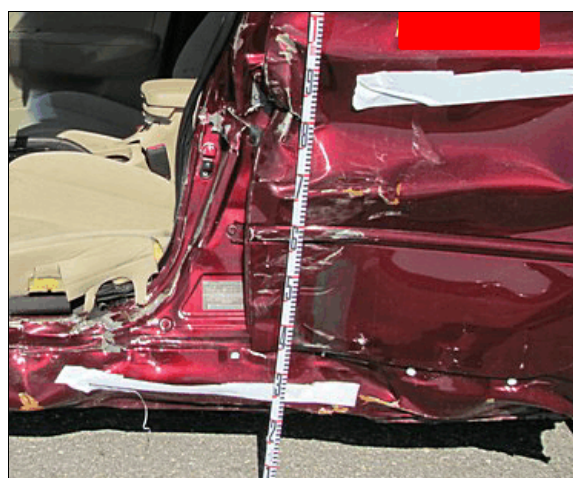
Figure 8: Direct damage on the left B-pillar of the Hyundai

The impact on the Hyundai involved direct contact to the left B-pillar (**Figure 8**) in the area where the sensor was located. The left IC air bag deployed in this crash, while the driver's seat-mounted side impact air bag did not deploy. The right IC air bag and front right passenger's seat-mounted side impact air bags did not deploy.

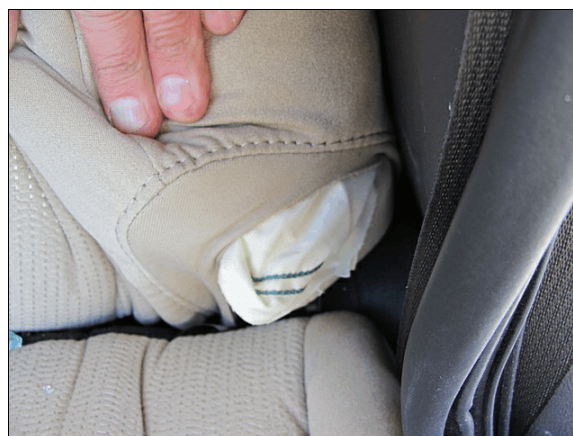
Figure 9: Small portion of the driver's seat mounted side impact air bag was protruding out of the bottom of the seat back

The driver's seat-mounted side impact air bag was located in the outboard side of the seat back. The left B-pillar had intruded 28 cm (11 in) against the driver's seat back and displaced it to the right 19 cm (7.5 in). Inspection of the outboard side of the driver's seat back revealed that a small portion of the side impact air bag was protruding out of the bottom of the seat back below the tear seam (**Figure 9**), which suggested that the air bag may have partially deployed. Access to the air bag was restricted by the intruded B-pillar. The seat material was cut to expose as much of the air bag as possible for inspection. The air bag appeared to be in partially unfolded condition (**Figure 10**). The fabric panel that separated the air bag from the seat material was not torn. The product number on the air bag was 312313 630d.

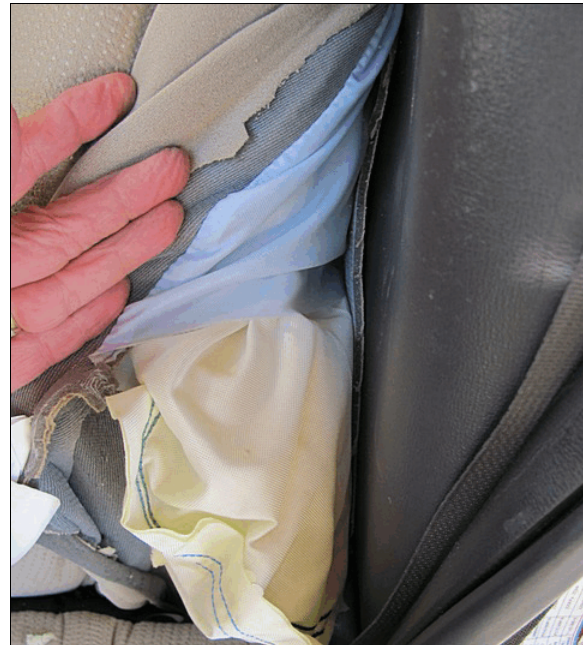
Figure 10: The partially unfolded condition of the driver's seat-mounted side impact air bag

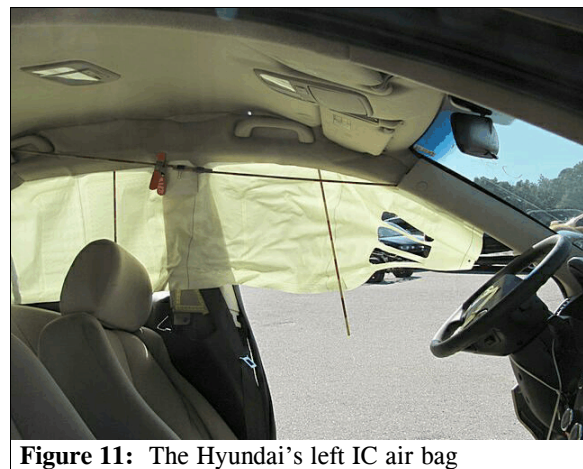
Figure 11: The Hyundai's left IC air bag

The left IC air bag (**Figure 11**) was located along the roof side rail inside the headliner and extended from the A-pillar to the C-pillar. The IC air bag was secured to the A-pillar by a nylon tether 15 cm (5.9 in) in length. There were no external vent ports. The deployed IC air bag was 167 centimeters (65.7 in) in length. Adjacent to the driver's seating position the IC air bag was 31 cm (12.1 in) in height. It was 35 cm (13.8 inches) in height adjacent to the second row left seating position. The gap between the IC air bag and the A-pillar at the bottom of the sail panel was 18 cm (7.1 in). The IC air bag did not extend below the beltline. Inspection of the deployed IC air bag revealed no discernable evidence of occupant contact and no damage.

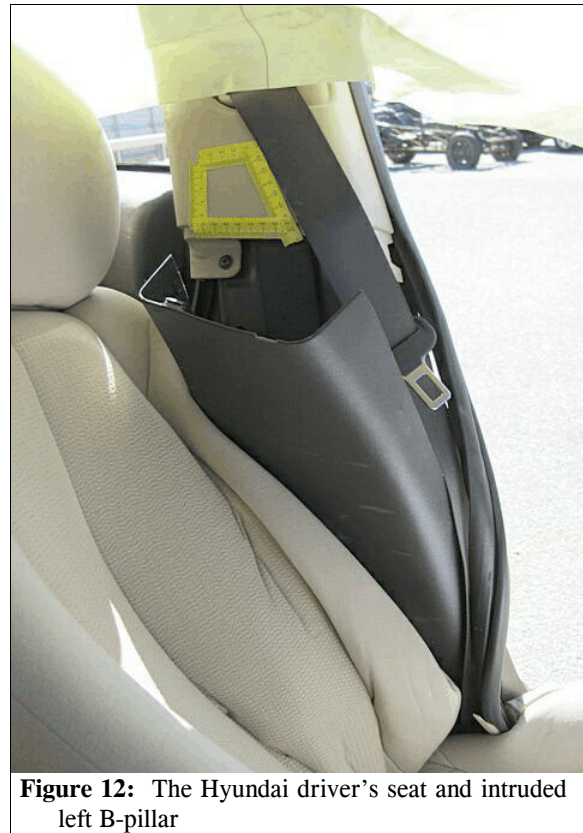
The impact on the left side plane of the Hyundai displaced the driver to the left. His head loaded through the left IC air bag and contacted the intruded left B-pillar (**Figure 12**), which caused subdural and subarachnoid hemorrhages of the brain. The left side of his upper torso also contacted the left B-pillar and he sustained fractures of left ribs 1-4 and 7-12 with bilateral hemothoraces. His left hip, contacted the intruded left front door, which fractured his left acetabulum and pubic ramus. He also sustained contusions, an abrasion, and a laceration from contacting the intruded left front door. Rescue personnel removed the left front door and extricated the driver from the vehicle.

Figure 12: The Hyundai driver's seat and intruded left B-pillar
