**CALSPAN ON-SITE SIDE IMPACT INFLATABLE OCCUPANT
PROTECTION SYSTEM CRASH INVESTIGATION**

SCI CASE NO.: CA11006

VEHICLE: 2010 TOYOTA COROLLA S

CRASH DATE: NOVEMBER 2010

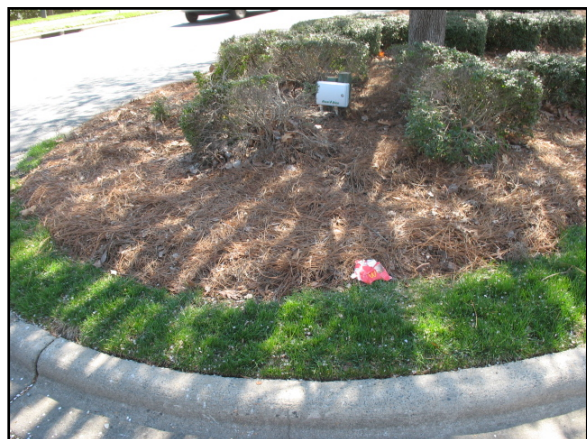
Figure 5: Event 2 POI (Irrigation control) and final rest location of the Toyota. Southward view of the south median.

Toyota then impacted a 10 cm (4 in) wood post that elevated a plastic irrigation control box (Event 2). The wood post was sheared off by the engagement, and the Toyota continued south for another 60 cm (23.6 in). The Toyota came to rest on the landscape median facing north. **Figure 5** depicts the Event 2 Point of Impact (POI) and the final rest position of the Toyota. The Ford was redirected 20 degrees to its left by the initial impact and traveled 13.2 m (43.3 ft) southeast before coming to rest with its front wheels against the curb line of the south median facing southeast.

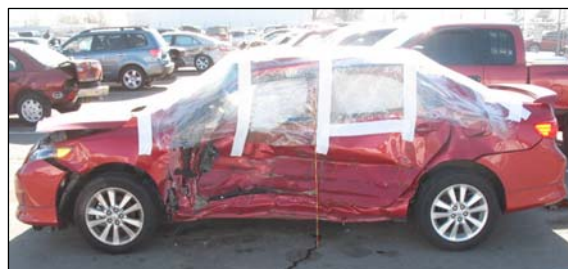
The left plane of the Toyota sustained moderate damage in the Event 1 impact (**Figure 6**). The direct contact damage began 41 cm (16.1 in) forward of the left front axle and extended rearward 303 cm (120 in). The combined direct and induced damage (Field L) began 41 cm (16.1 in) forward of the left front axle and extended

Figure 6: Event 1 impact damage to the left side of the Toyota.

rearward 323 cm (127.2 in). A residual crush profile was measured at the mid door level and was as follows: C1 = 0 cm, C2 = 19 cm (7.5 in), C3 = 44 cm (17.3 in), C4 = 45 cm (17.7 in), C5 = 5 cm (2 in), C6 = 0 cm. The maximum crush measured 54 cm (21.3 in) and was located on the left front door, 117 cm (46 in) aft of the left front axle. At that location, the Door Sill Differential (DSD) measured 34 cm (13.4 in). The height of the maximum crush was 57 cm (22.4 in). The sill height of the Toyota was 32 cm (12.6 in). The Missing Vehicle Algorithm of the WinSMASH program was used to calculate the severity of the crash (delta-V). The total delta-V for the Toyota was 48 km/h (29.8 mph), with longitudinal and lateral components of -24 km/h (-14.9 mph) and 42 km/h (26.1 mph), respectively. For comparison purposes, the maximum EDR-reported frontal delta-V was 24.1 km/h (15.0 mph) and the maximum EDR-

reported lateral delta-V was 32.8 km/h (20.4 mph). The left doors of the Toyota deformed and intruded into the passenger compartment. Both left side doors were jammed shut post crash. The left wheelbase was shortened by 3 cm (1.2 in). The windshield was fractured, and all left side glazing and backlight were disintegrated by impact forces. The right front glazing was removed by emergency personnel during extrication. The Collision Deformation Classification (CDC) for Event 1 was 10LDAW4.

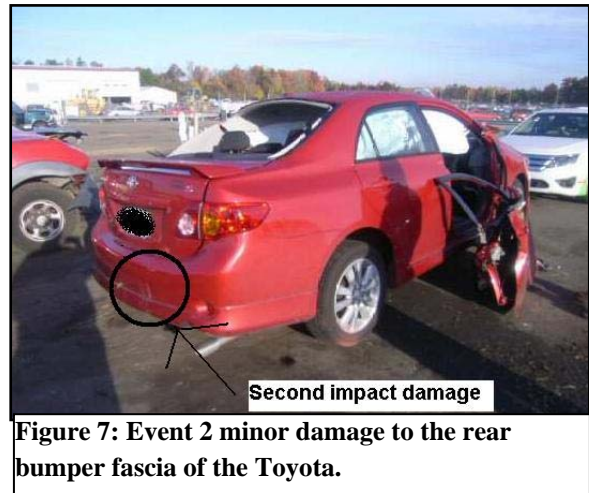
The secondary impact (Event 2) involving the back plane of the Toyota and the wood post resulted in minor abrasions to the rear bumper fascia. There was no residual deformation to the bumper. The abrasion marks in the fascia were located 16-28 cm (6.3-11 in) right of the vehicle centerline. The damage was limited to the fascia only and did not extend to the metal of the trunk lid. The CDC assigned for this impact was 06BZLN1. The lack of measurable deformation from this impact invalidated use of the WinSMASH program to determine the severity of the impact. The damage to the back plane is depicted in **Figure 7**.

Figure 7: Event 2 minor damage to the rear bumper fascia of the Toyota.

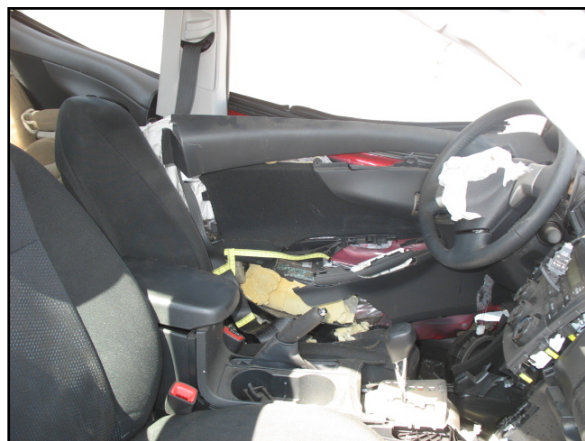
The Toyota sustained moderate-severity damage that was attributed to passenger compartment intrusion, occupant contact, and air bag deployment. **Figure 8** depicts the deformation to the driver’s interior. As a result of the initial impact to the left side of the Toyota, the left front and rear doors, A- and B-pillars, left roof side rail, and side panel forward of the A-pillar intruded laterally to the right. The side panel forward of the A-pillar intruded 9 cm (3.5 in). The upper area of the A-pillar intruded 15 cm (5.9 in). The rear upper and rear lower

Figure 8: Deformation of the front left seat as a result of intrusion.

quadrants of the left front door intruded 35 cm (13.8 in) and 24 cm (9.4 in), respectively. The door sill intruded 9 cm (3.5 in) laterally, and the front row left roof side rail intruded 22 cm (8.7 in). The B-pillar intrusion measured 19 cm (7.5 in). The forward lower quadrant of the left rear door intruded 23 cm (9.1 in) laterally.

The intrusion resulted in the displacement of the driver's seat 15 cm (5.9 in) to the right and compression of the seat cushion by 13 cm (5.1 in). The seat back deformed CCW 40 degrees. The rear left seat cushion was compressed 12 cm (4.7 in) by the lateral intrusion of the left rear door panel. The driver's head restraint was removed by EMS during the extrication of the driver.

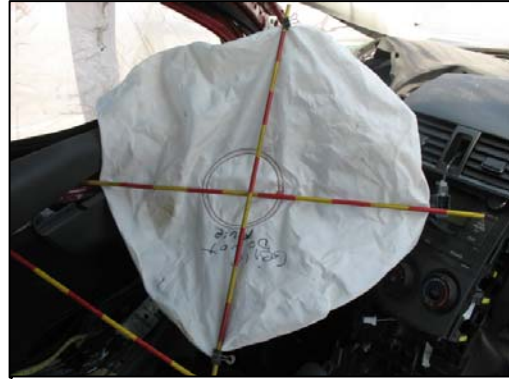
The driver's frontal air bag (**Figure 9**) was concealed within the center hub of the three-spoke steering wheel by a tri-flap design. The upper cover flap measured 12 cm (4.7 in) in width at the upper aspect, 7 cm (2.8 in) in width at the tear seam, and 7 cm (2.8 in) in height. The upper cover flap contained an oval-shaped Toyota logo that extended into the lower cover flaps. The lower flaps were 4 cm (1.6 in) in width and 10 cm (3.9 in) in height. None of the cover flaps were damaged. The driver's air bag measured 52 cm (20.5 in) in its deflated state. It was vented by two ports on the upper rear aspect of the air bag located at the 11 and 1 o'clock positions.

There were two internal tethers that attached to the 12 and 6 o'clock positions on an 11 cm (4.3 in) diameter center tether at the face of the bag. There was an area of post-crash smeared blood on the face of the air bag, located 7-13 cm (2.8-5.1 in) below the horizontal centerline and 3-7 cm (1.2-2.8 in) left of the vertical centerline.

Figure 9: Overall view of the driver's frontal air bag.

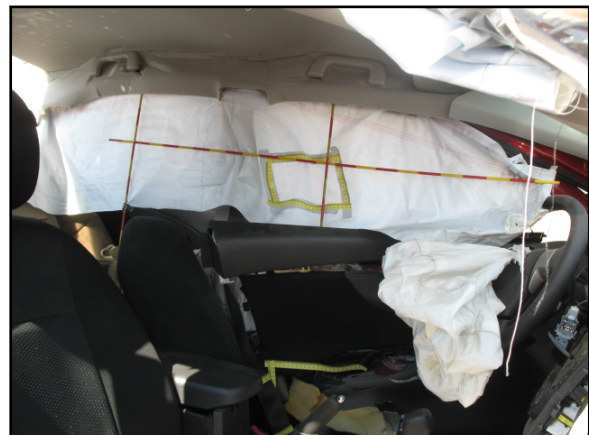
The inboard side of the left IC contained a scuff mark attributed to the driver's head in the area adjacent to the front left seating position. **Figure 10** depicts the inboard aspect of the left IC air bag. This scuff mark was located 18-28 cm (7.1-11 in) below the upper aspect of the IC and 46-62 cm (18.1-24.4 in) aft of the forward edge of the IC.

Figure 10: Inboard side of left IC air bag, including driver's head contact.

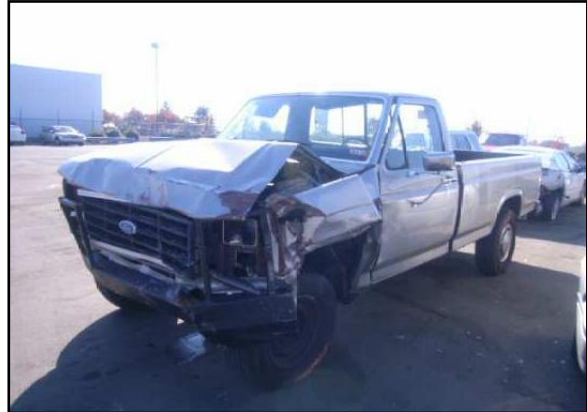
The front plane of the Ford sustained moderate damage as a result of the impact (Event 1), as depicted in **Figure 11**. Based on the supplied image, there was an aftermarket front bumper attached to the front of the Ford. The direct contact damage extended across the full width of the front bumper, with maximum crush located at the front left corner. The calculated total delta-V using the Missing Vehicle Algorithm of the WinSMASH program was 29 km/h (18 mph) with longitudinal and lateral components of -29 km/h (-18 mph) and -5 km/h (-3.1 mph), respectively. The CDC assigned for the impact with the Toyota was 12FDEW1.

Figure 11: Front/left oblique view of the Ford. Image supplied by the vehicle salvage facility.
