TRANSPORTATION RESEARCH CENTER

ON-SITE SIDE IMPACT INFLATABLE OCCUPANT PROTECTION INVESTIGATION

CASE NUMBER - IN11006
LOCATION - MISSOURI
VEHICLE - 2010 TOYOTA PRIUS
CRASH DATE - December, 2010

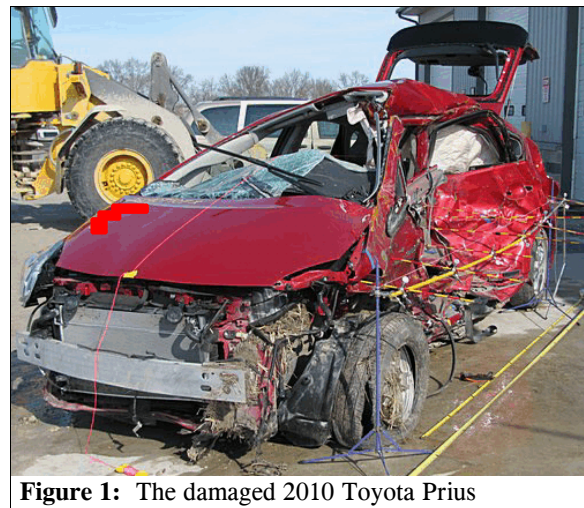
Figure 1: The damaged 2010 Toyota Prius

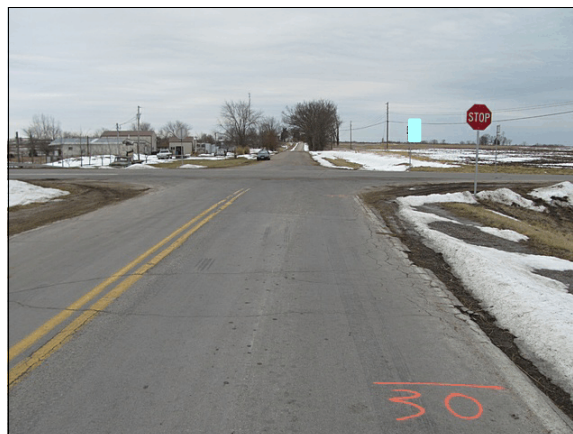
Figure 2: Approach of the Toyota traveling south to the intersection

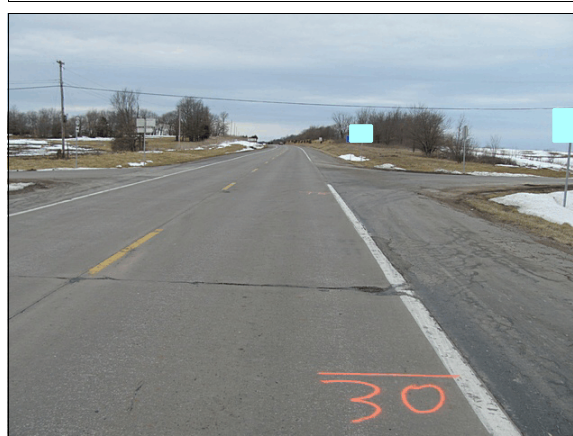
Figure 3: Approach of the Ford traveling west to the intersection

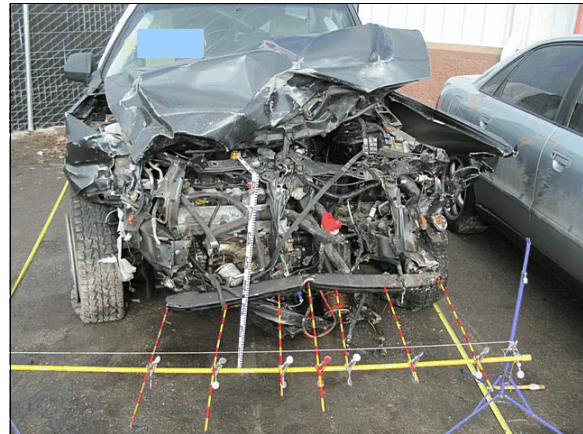
Figure 4: Damage to the front plane of the Ford from impact with the Toyota

Exterior Damage Event 1: The Ford sustained front plane damage during the impact with the Toyota. The front bumper, headlamp/turn light assemblies, hood, and both fenders were directly damaged. The direct damage began at the front left bumper corner and extended across the entire frontal plane. The crush measurements were taken at the bumper bar and the maximum residual crush was 31 cm (12.2 in) occurring 14 cm (5.5 in) right of C₃. Each frame rail was shifted to the left 20 cm (7.9 in).

Damage Classification Event 1: The CDC was 82FDEW2 (50 degrees). The force direction was incremented by 80 since each frame rail was shifted to the left 20 cm (7.9 in) The Damage algorithm of the WinSMASH program calculated the total Delta V as 46 km/h (28.6 mph). The longitudinal and lateral velocity changes were -30 km/h (-18.6 mph) and -35 km/h (-21.7 mph), respectively. Based on the damage to both vehicles, the results appeared reasonable.

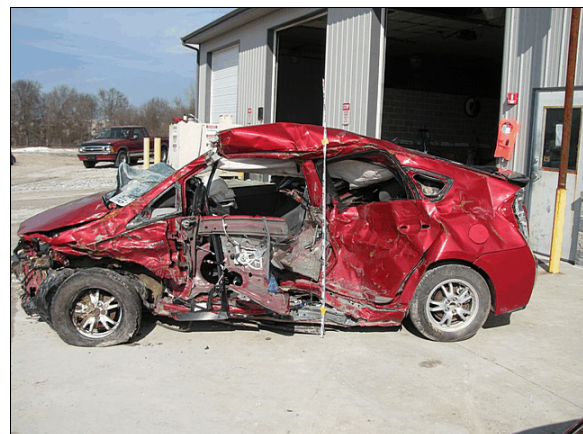
Figure 5: Damage on the left plane of the Toyota from the impact with the Ford

Exterior Damage Event 1: The Toyota sustained left side plane damage during the impact with the Ford. The left fender, hood, A-pillar, B-pillar, and left side doors were directly damaged. The direct damage began 50 cm (19.7 in) forward of the left rear axle and extended 224 cm (88.1 in) forward along the left side plane. The crush measurements were taken at the mid-door level and the maximum residual crush was 68 cm (26.8 in) occurring 90 cm (35.4 in) forward of the left rear axle (**Figure 7**). The height of the maximum door crush was 72 cm (28.3 in) and the

Damage Classification Event 1: The Collision Deformation Classification (CDC) was 11LYAW4 (320 degrees). The Damage algorithm of the WinSMASH program calculated the total Delta V as 51 km/h (31.7 mph). The longitudinal and lateral velocity changes were -39 km/h (-24.2 mph) and 33 km/h (20.5 mph), respectively. Based on the damage, the results appeared reasonable. The Toyota's EDR reported the longitudinal velocity change as 41 km/h (25.5 mph). The lateral velocity change at the B-pillar was reported as 96.2 km/h (59.8 mph).

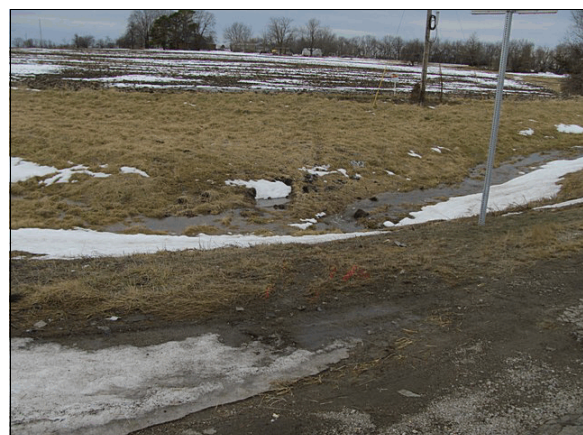
Figure 6: View southwest to the area of final rest of the Toyota and Ford

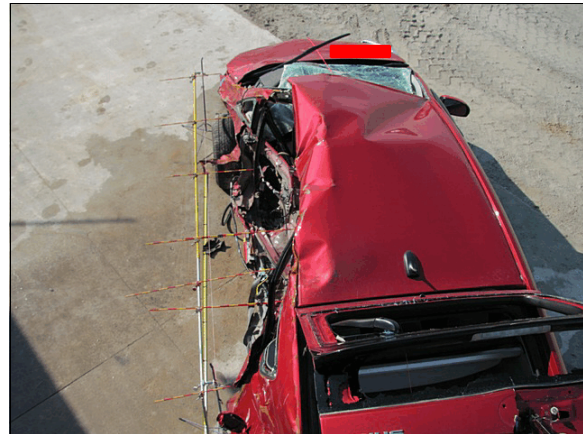
door sill differential was 41 cm (16.1 in). The height of the sill was 28 cm (11 in). The vehicle's left side wheelbase was reduced 6 cm (2.4 in).

Figure 7: Top view of the left side plane crush to the Toyota; each increment on rods is 5 cm (2 in)

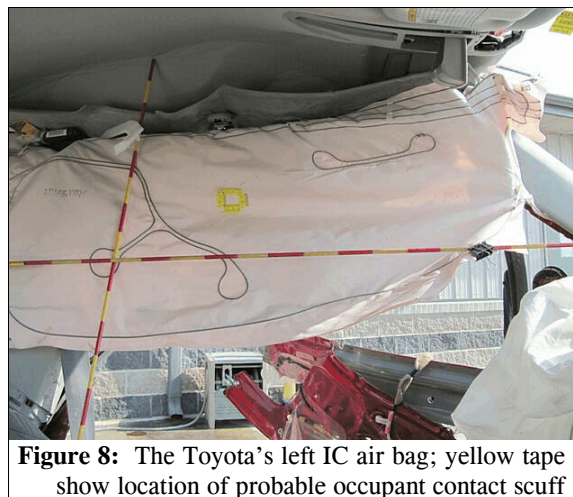
The deployed left IC air bag (**Figure 8**) was 168 cm (54.3 in) in width and 38 cm (14.9 in) in height and was attached to the A-pillar by a nylon tether 22 cm (8.7 in) in length. Inspection of the IC revealed a small scuff from probable contact by the driver's head. The scuff was located 45 cm (17.7 in) rear of the front of the IC and 24 cm (9.4 in) above the bottom of the IC. The IC was not damaged during the crash.

Figure 8: The Toyota's left IC air bag; yellow tape show location of probable occupant contact scuff

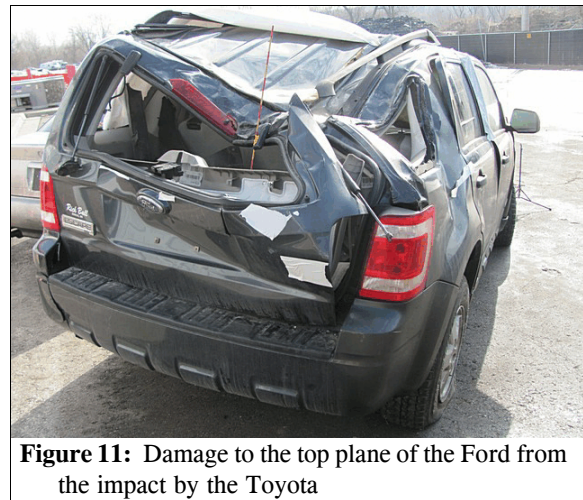
Exterior Damage Event 2: The Ford sustained top plane damage (**Figure 11**) when the Toyota touched down on the top of the Ford as the vehicle’s came to final rest. The top of the back hatch, roof, right roof side rail, right C-pillar, and right D-pillar were directly damaged. The direct damage extended 102 cm (40.2 in) across the roof. The maximum crush to the roof was 38 cm (15 in).

Figure 11: Damage to the top plane of the Ford from the impact by the Toyota

Damage Classification Event 2: The CDC was 00TBDW4. WinSMASH could not be used on this impact since non-horizontal impact are out of scope for the program. Based on the extent of crush to the roof, the severity of the damage was severe.
