## ON-SITE AIR BAG INVESTIGATION

CASE NUMBER - IN97-015

LOCATION - MISSOURI

VEHICLE - 1997 VOLKSWAGEN JETTA GT

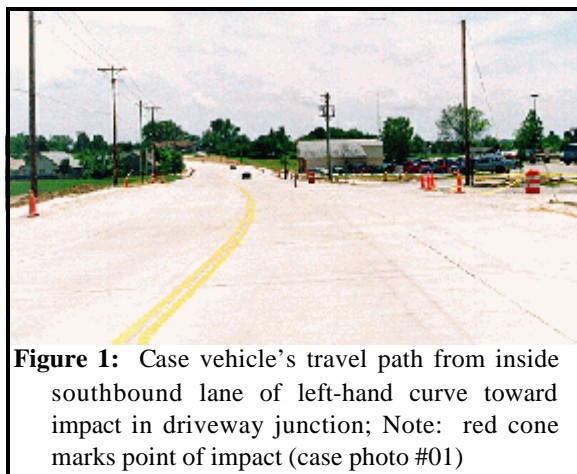
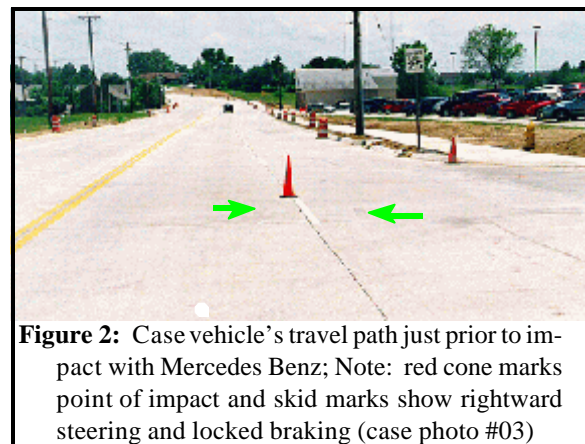
**PRE-CRASH:** The case vehicle (Jetta) was traveling south in the inside lane of a four-lane, undivided, city street and had just exited a left-hand curve (**Figures 1 and 2**), intending to continue straight ahead in its southward direction of travel (i.e., there were two southbound and two northbound through lanes). The Mercedes Benz had been traveling north in the inside, northbound lane of the same, four-lane, undivided, city street and was in the process of turning left into the driveway of an elementary school (**Figures 3 and 4**). The driver of the case vehicle attempted to avoid the crash by braking and steering to the right. The case vehicle moved to the right, straddling the two southbound through lanes, and continued forward just prior to impact (**Figure 2**). The driver of the Mercedes Benz made no known pre-crash avoidance maneuvers. The crash occurred in the middle of the two southbound through lanes in the junction of the driveway access (**Figure 4**).

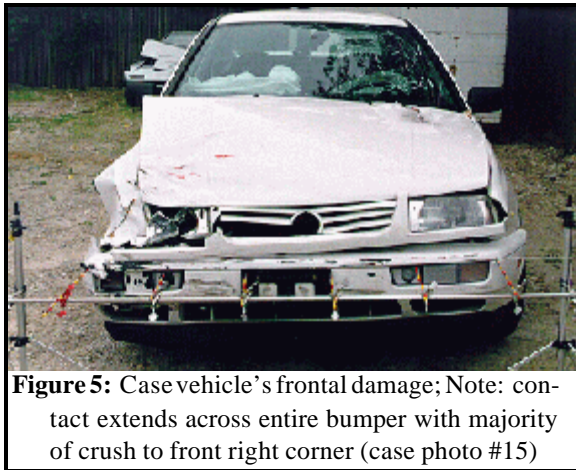
The front right (**Figures 5 and 6**) of the case vehicle impacted the right side of the Mercedes Benz (**Figure 7**), causing both the driver and front right supplemental restraint systems (air bags) to deploy. In addition, see **Figures 14, 15, and 16** in the **SELECTED PHOTOGRAPHS** section below. The case vehicle rotated approximately 75 degrees clockwise and came to rest sideways in the driveway junction straddling the two southbound through lanes. The Mercedes Benz was knocked sideways, in a southwesterly direction, approximately 2.5 meters (8.3 feet) and came to rest adjacent to the apex of the curb on the southwest side of the driveway heading primarily west (**Figure 8**).

**Figure 5:** Case vehicle's frontal damage; Note: contact extends across entire bumper with majority of crush to front right corner (case photo #15)

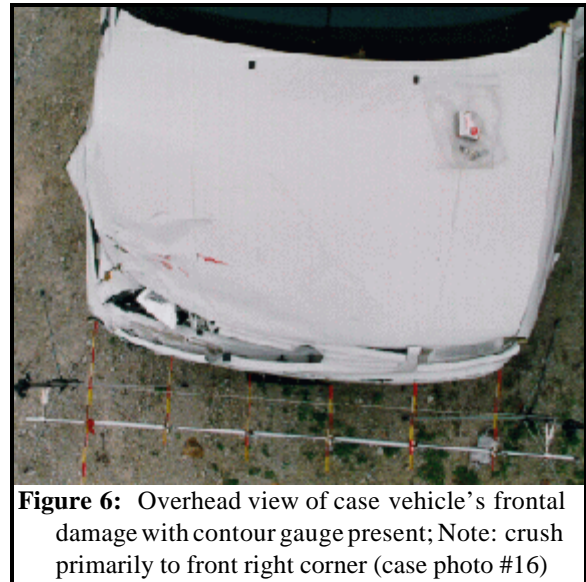
**Figure 6:** Overhead view of case vehicle's frontal damage with contour gauge present; Note: crush primarily to front right corner (case photo #16)

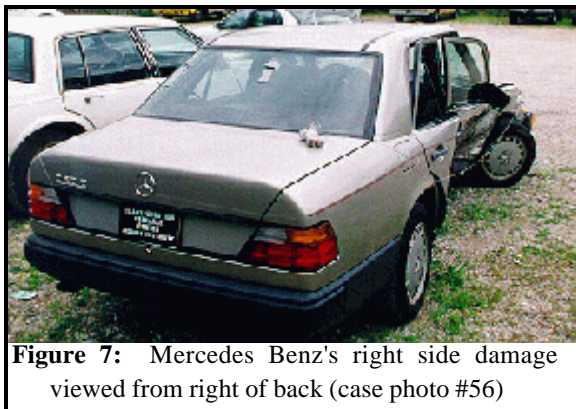
**Figure 7:** Mercedes Benz's right side damage viewed from right of back (case photo #56)

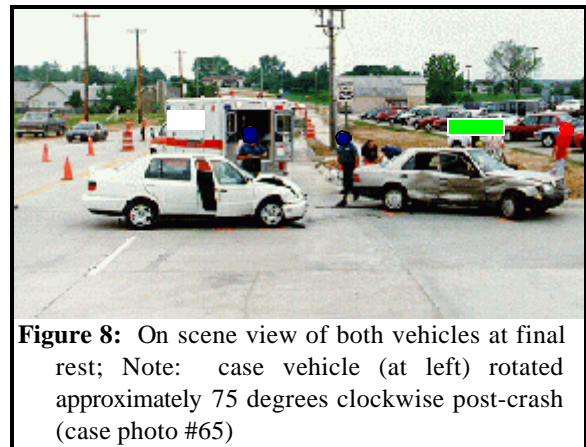
**Figure 8:** On scene view of both vehicles at final rest; Note: case vehicle (at left) rotated approximately 75 degrees clockwise post-crash (case photo #65)

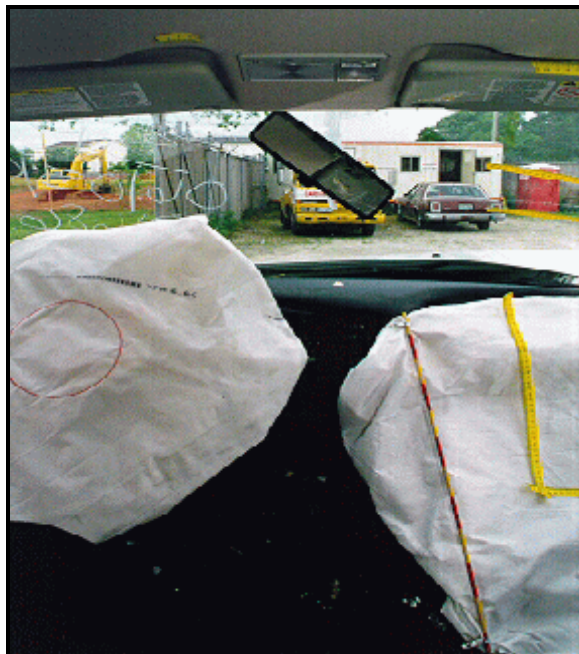
**Figure 9:** Case vehicle's deployed air bags viewed from back seat; Note: rear view mirror knocked askew by front right air bag (case photo #34)

The case vehicle's impact with the Mercedes Benz enable the driver to continue forward and upward toward the 350 degree Direction of Principal Force as the case vehicle decelerated. An inspection of the driver's air bag (**Figure 9** above) revealed ice cream spots on the air bag; however, there was no visible evidence of occupant contact found on the air bag (**Figure 10** above). Also, there was no evidence of occupant contact on either of the air bag module's cover flaps. Because she was not using her available safety belt and because of her close proximity to the driver air bag module (i.e., seated between the center and forward-most positions) and the position of the tilt steering wheel (i.e., up-most position), the brunt of the deploying driver air bag's force struck her in her chest. This explains the absence of facial skin evidence on the driver's air bag and is consistent with the abrasions the driver sustained to her arms. The left knee bolster showed evidence of occupant loading and the driver sustained a self-reported "scrape" to her right knee which is consistent with the interior deformation.

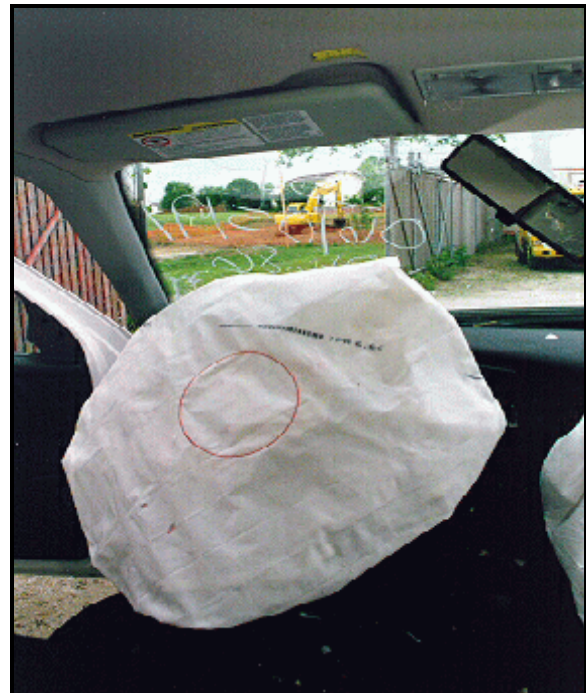
**Figure 10:** Case vehicle's deployed driver air bag showing no clear evidence of driver contact (case photo #28)

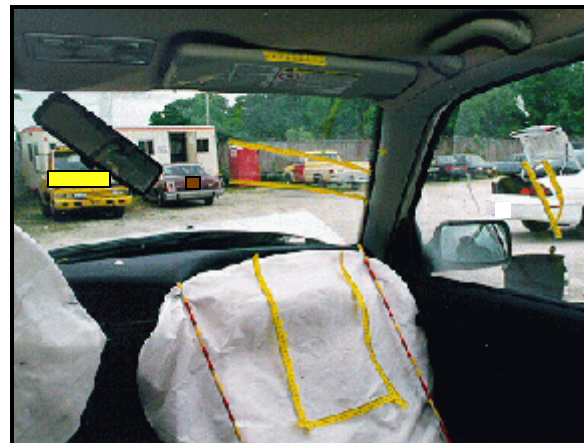
**Figure 11:** Case vehicle's deployed front right air bag showing occupant contact evidence to upper center portion of air bag, sun visor, and right front glazing (case photo #44)

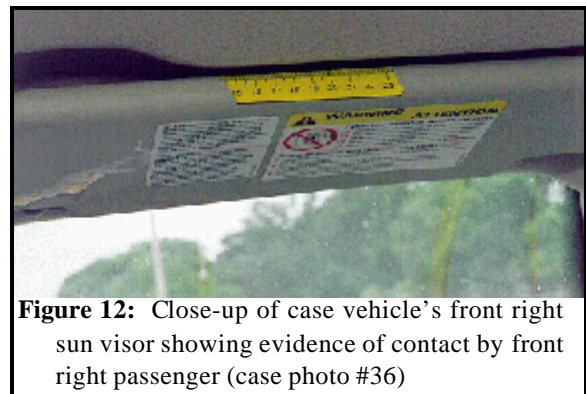
**Figure 12:** Close-up of case vehicle's front right sun visor showing evidence of contact by front right passenger (case photo #36)

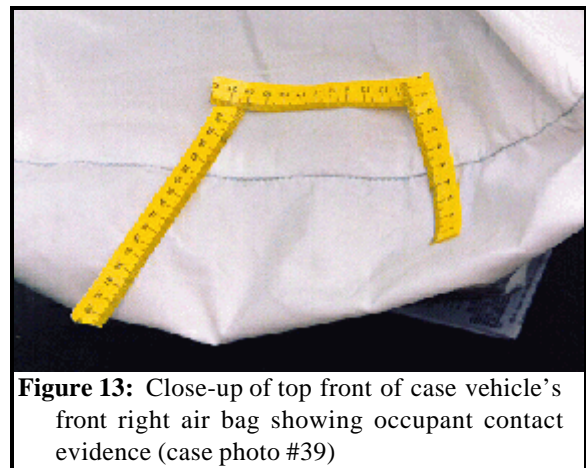
The case vehicle's driver steered to the right and braked, attempting to avoid the crash. As a result of these attempted avoidance maneuvers and the nonuse of the available safety belts, the front right passenger moved forward, near the front right air bag module, just prior to impact. The case vehicle's impact with the Mercedes Benz enabled the front right passenger to continue forward and upward as the case vehicle decelerated. As the front right air bag deployed (**Figure 11** above) it engaged the front right passenger at and underneath the chin lifting him upwards into the sun visor/roof area (**Figure 12**). As the air bag continued to expand, the brunt of the bag's force struck him in the lower face, anterior neck, and chest. An inspection of the front right passenger's tethered air bag, which was located in the middle of the instrument panel, revealed an area [21 centimeters wide by 36 centimeters high (8.3 x 14.2 inches)] of skin and most likely blood to the top (**Figure 13**) and center right portion.

**Figure 13:** Close-up of top front of case vehicle's front right air bag showing occupant contact evidence (case photo #39)

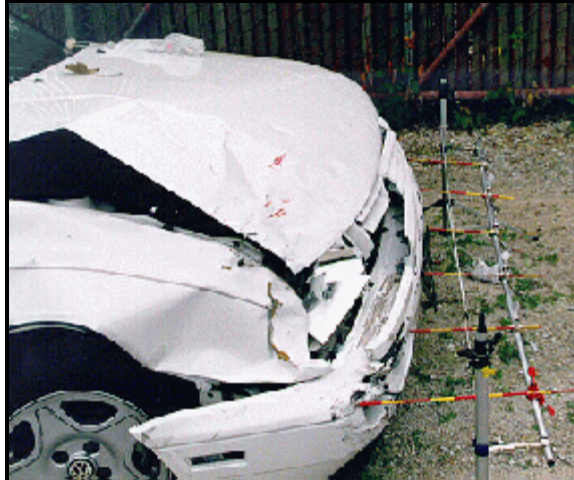
**Figure 14:** Reference line view of case vehicle's frontal damage from right; Note: crush primarily to front right corner (case photo #22)

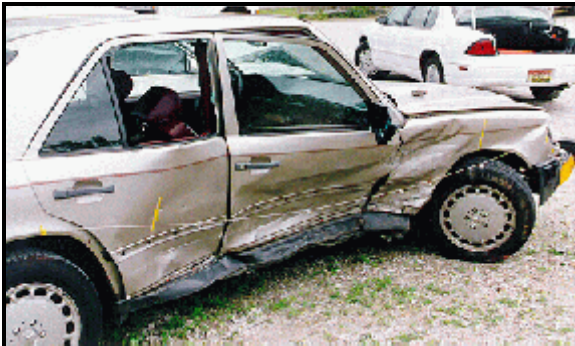
**Figure 15:** Mercedes Benz's right side damage view-ed from back of right; Note: vertical yellow tape marks width of direct damage (case photo #59)

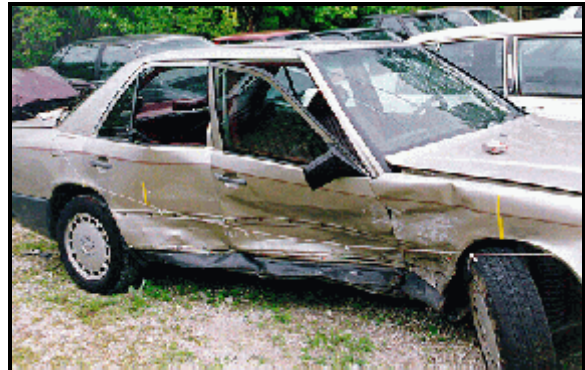
**Figure 16:** Mercedes Benz's right side damage viewed from right of front; Note: yellow tape marks width of direct contact (case photo #61)
